## Asset Assessment Report

Dr. W.R. Keir Barrhead Continuing Care Centre B2042A

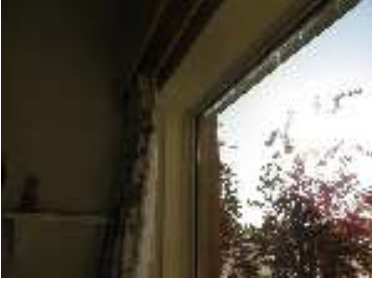
Aluminum windows have worn out gaskets.

(1985) South Wing (Patient Room 117) - aluminum window has worn out gaskets.

Replace gaskets. (approx. 236 windows)

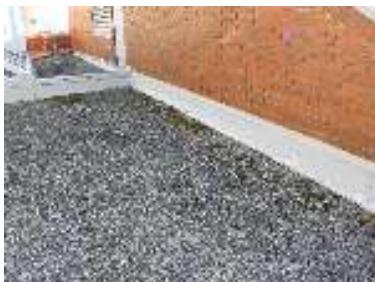
<b>Concern</b>	Roof has blisters and moss.
<b>Recommendation</b>	Replace built-up roofing with SBS roofing. (approx. 4520 square metres)

(1985) East Wing (Roof) - has blisters and moss.

<u>Details</u>	<u>Values</u>
Short Title	Replace built-up roofing. (approx. 4520 square metres)
Cost	\$678,000.00
Start Year	2012
Impact	Minor
Probability	Likely
Budget Type	Unspecified
Event Status	Not Approved

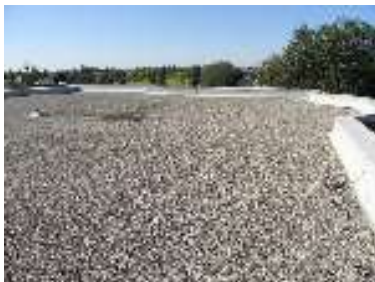
(1985) South Wing (Roof) - has blisters.

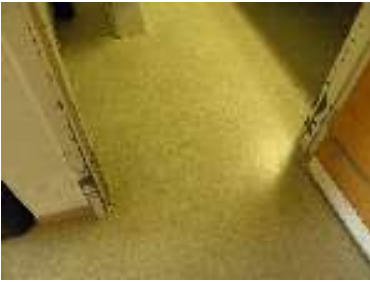
Patient Room - Washroom.

Wood door are damaged and paint has peeled off metal frames.

Replace wood doors and hardware. (approx. 50 doors)

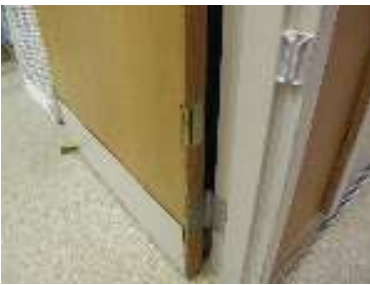
(1985) East Wing (Office 276) - has damaged wood door.

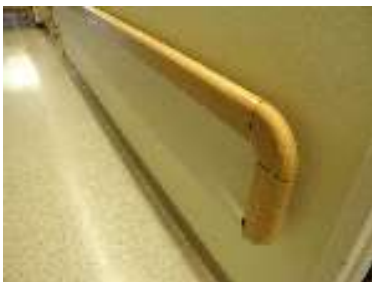
(1985) Southwest Wing (Corridor 166) - has damaged wood handrails.

(1985) Southwest Wing (Corridor 166) - has damaged wood handrail.

Repair wood handrails. (approx. 5 linear metres)

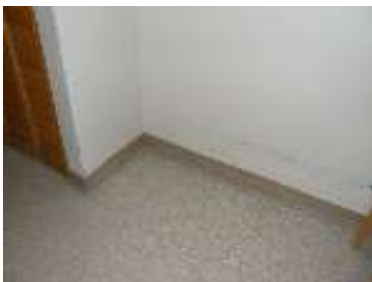
Building has damaged gypsum board walls.

(1985) Patient Rooms - have damaged gypsum wall boards.

Repair gypsum board walls. (approx. 100 square metres)

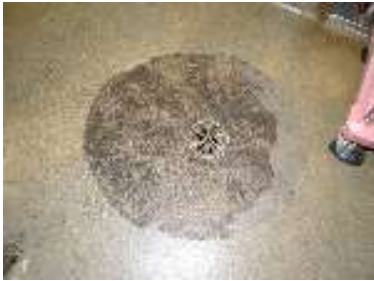
(1985) East Wing (Nourishment 259) - has damaged epoxy flooring. (approx. 5 square metres)

Repair epoxy flooring. (approx. 5 square metres)

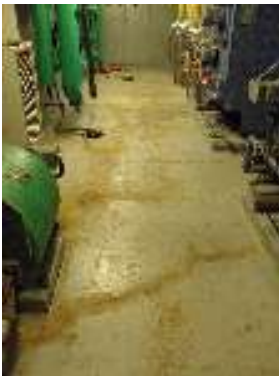
(1985) Penthouse (Equipment P02) - paint on concrete floor has faded.

Repaint concrete floor. (approx. 325 square metres)

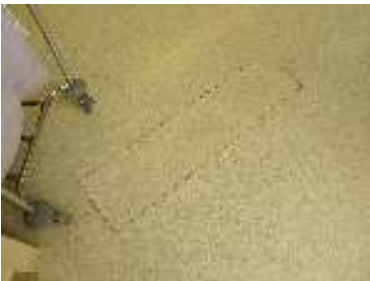
Linoleum flooring has worn out.

(1985) Northwest Wing (Corridor 175) - linoleum flooring has worn out.

Replace resilient flooring. (approx. 1500 square metres)

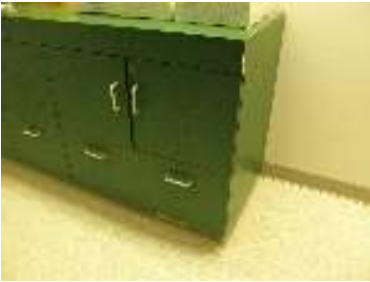
(1985) South Wing (Nourishment 105) - has damaged millwork.

Repair millwork. (approx. 20 linear metres)
