Investigation Report
Worker Fatality by Drowning
March 14, 2014

Incident summary

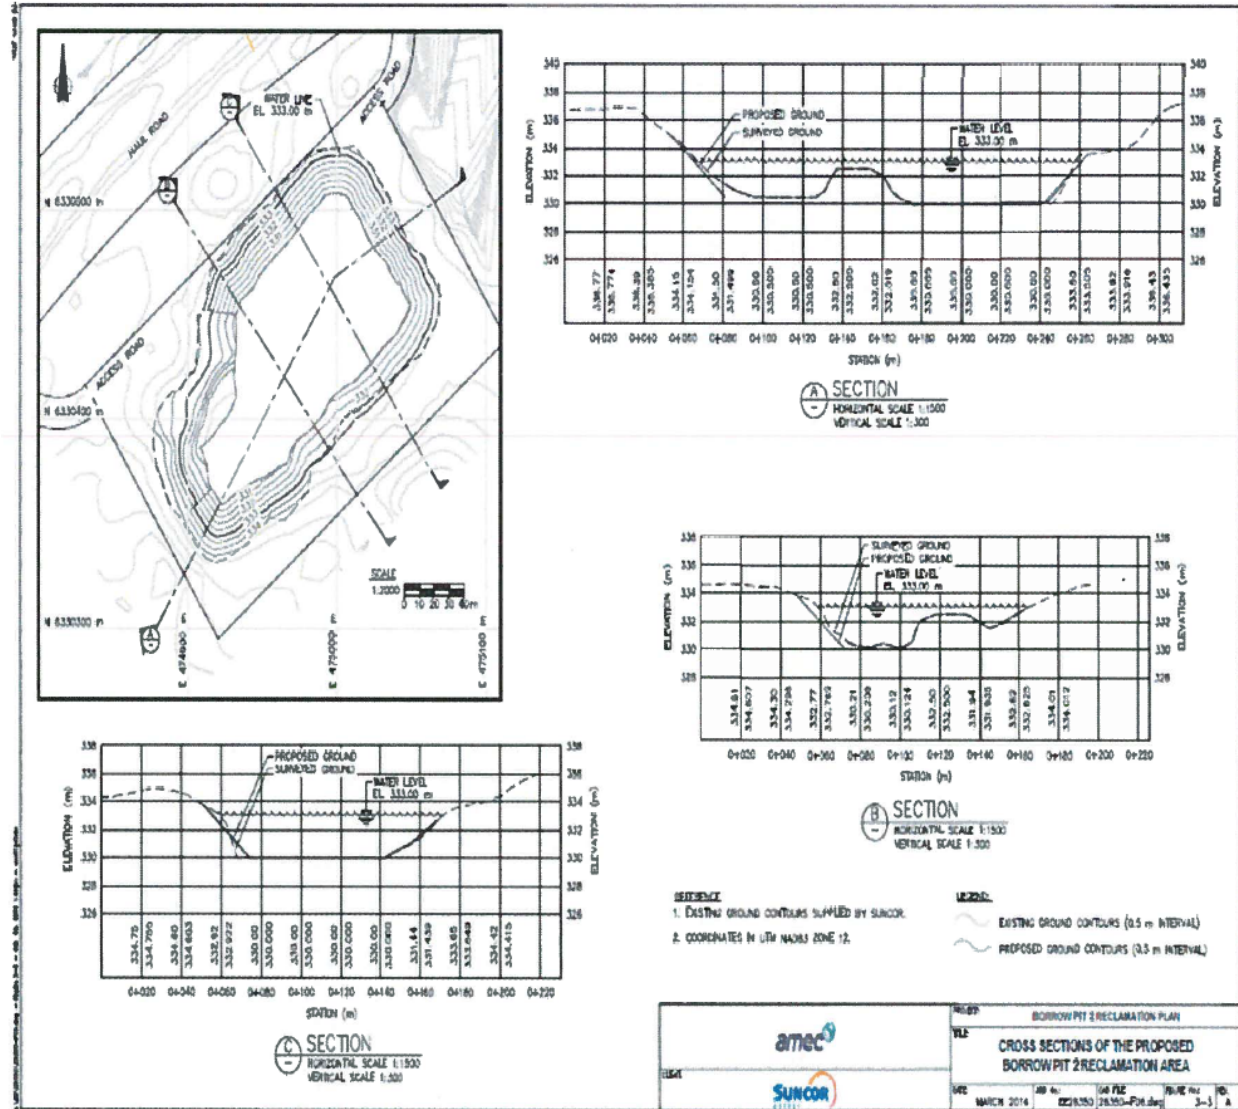
Figure 2. Engineering plan of borrow pit #2.

Borrow pit #2 was located on Crown land located at LSD 32-093-9-W4M. The location was parallel to the EAH, near kilometre marker 16, north of Fort McMurray, Alberta (Figure 1). Borrow pit #2 was 240 metres (m) by 135 m with two access roads, each approximately 70 m in length and connected to the EAH from the northeast and northwest corners. The total area of borrow pit #2 was 3.81 hectares (Figure 2)

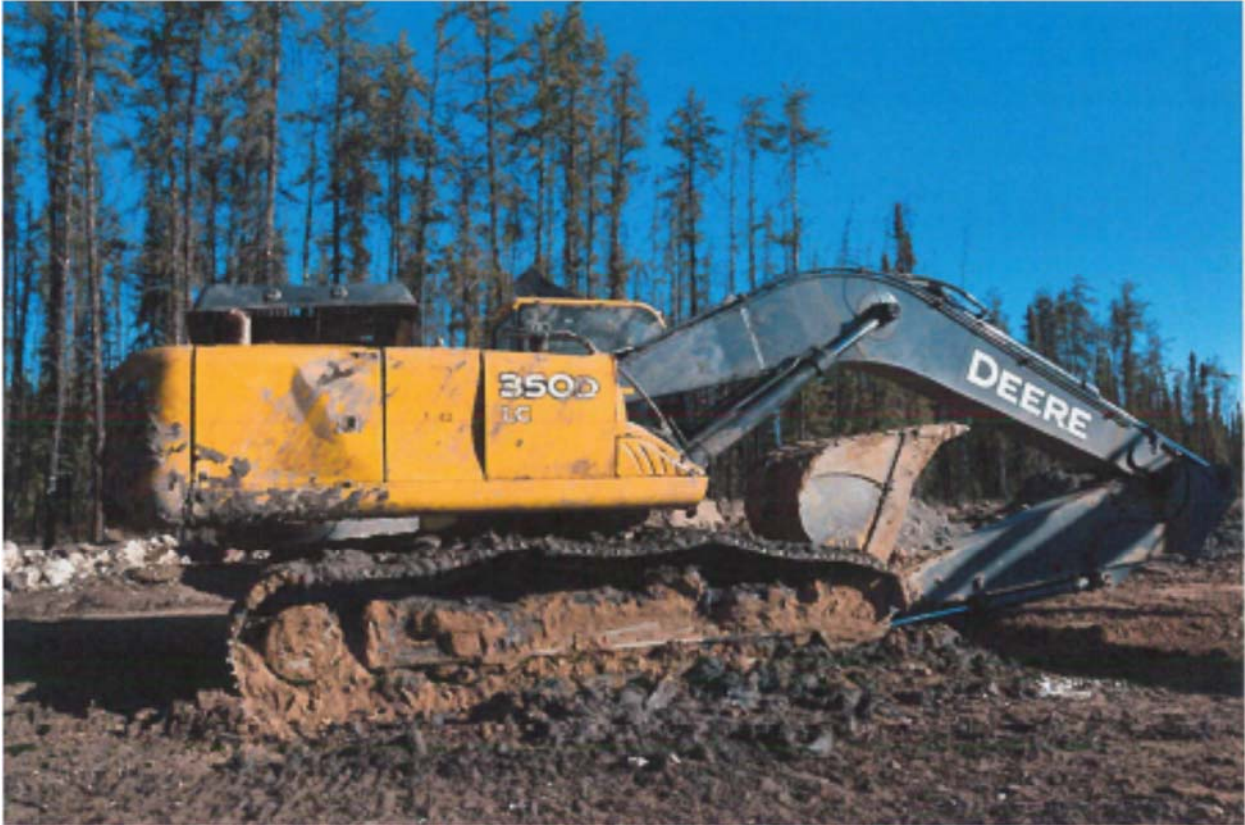
Figure 3. Recovered JD 3500 excavator

The John Deere 3500 LC Excavator (JD 3500 excavator) was owned and operated by Brayford (Figure 3). The JD 3500 excavator was a piece of heavy construction equipment consisting of a boom, stick, bucket, and cab that rotated on a track platform. The JD 3500 excavator weighed 35,367 kilograms (kg) and had 271 horsepower. The height from the ground to the top of the cab was 3.14 m, the width of the tracks were 3.39 m, and the length of the arm was 3.2 m.

Shortly after 3:30 p.m., operator 2 in the JD 290 excavator scooped up some ice chunks and rotated the excavator 180 degrees to dump the ice chunks. Upon returning the JD 290 excavator to its original position facing northeast, operator 2 noticed the JD 3500 excavator was not visible. Operator 2 thought the JD 3500 excavator had moved further east up the slope embankment. Operator 2 then saw the exposed boom and bucket of the JD 3500 excavator sticking out of the ice. Operator 2 got on the radio and called that the JD 3500 excavator went through the ice.

Rescue efforts from Brayford's construction superintendent and site foreman allowed for the stabilization of the submerged JD 3500 excavator as well as the recovery of operator 1 from the sunken excavator.
