**WORKER CRUSHED BY
EXCAVATION WALL COLLAPSE**

Type of Incident: Fatality

Date of Incident: February 14, 2008

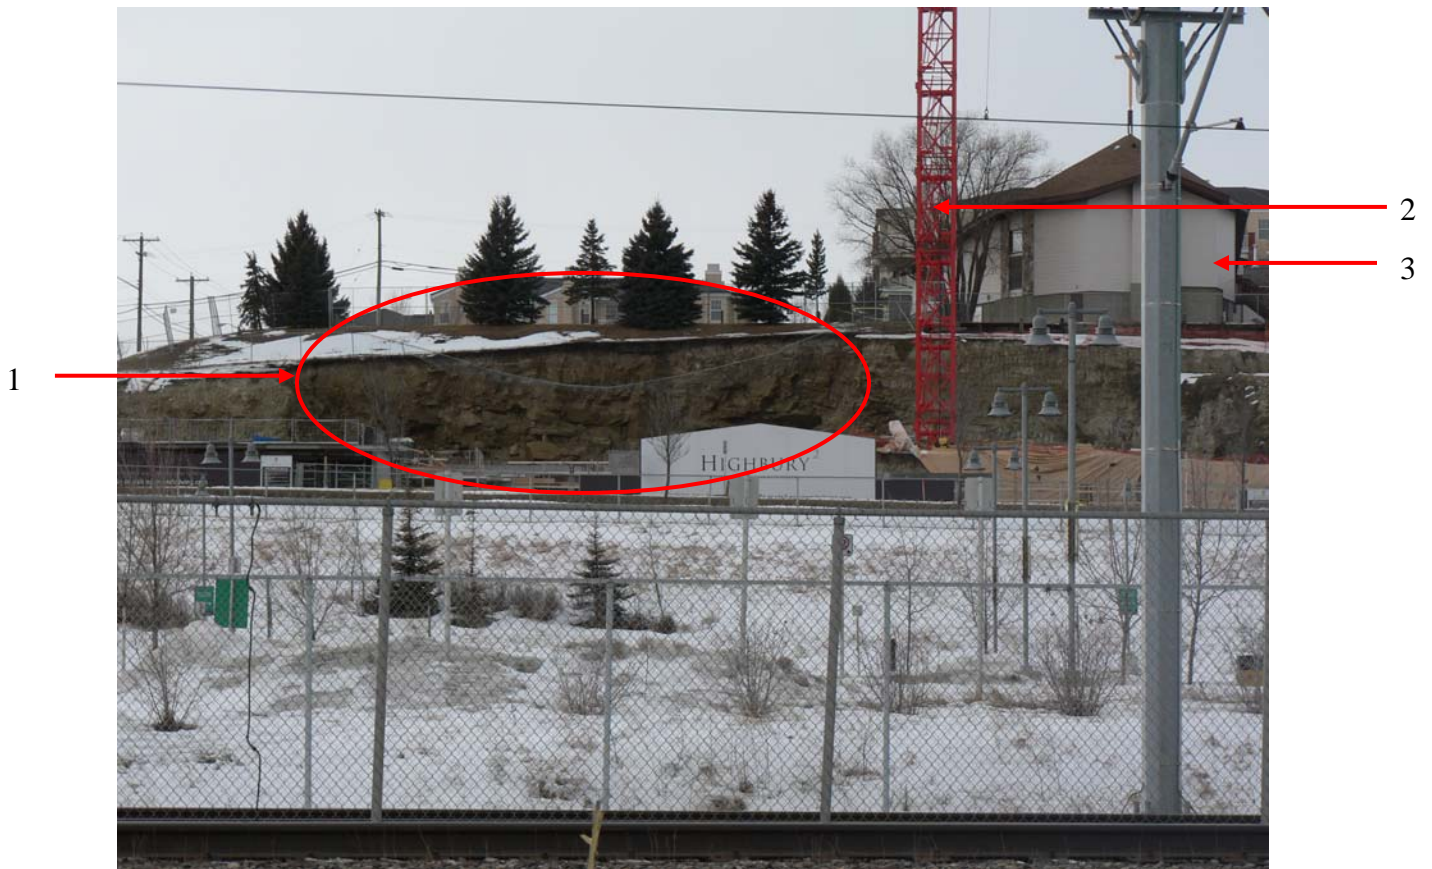
- 5.1.1 The incident occurred in phase 2 of the Highbury Towers Construction Project where a section of approximately 36.0 metres long of an excavation wall collapsed. The excavation wall was approximately 65.0 metres long and 15.0 metres deep. The excavation wall was not stabilized either by shoring or cutting back (Refer to Attachment B – Photographs 1 and 2).

- 7.2.1 The excavation wall was 65.0 metres long and 15.0 metres deep and was not stabilized either by shoring or by cutting back.
- 7.2.2 The prime contractor did not follow the recommendations of the geotechnical engineer for shoring or sloping of excavation walls deeper than 1.5 metres.
- 7.2.3 The prime contractor was aware that there was a crack along the top ledge of the excavation wall and did not take any action to control a possible cave-in hazard.

Photograph 1: Shows an overview of the incident

1. Collapsed section of the excavation wall that buried the dump truck
2. Tower Crane
3. Church

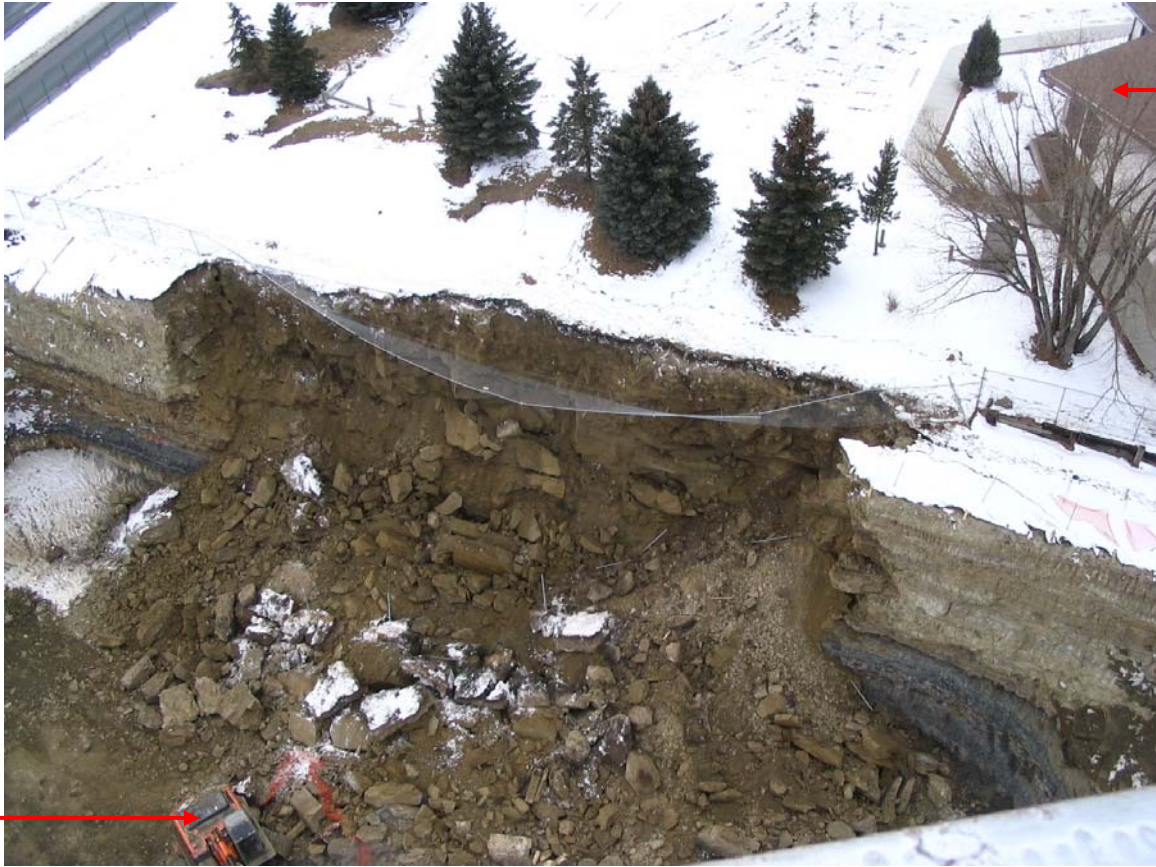
Photograph 2: Shows the collapsed section of the excavation wall in the phase 2 area of the project. This photograph was taken by the tower crane operator ([REDACTED]) after the incident

1. Excavator used to load the dump truck
2. Church

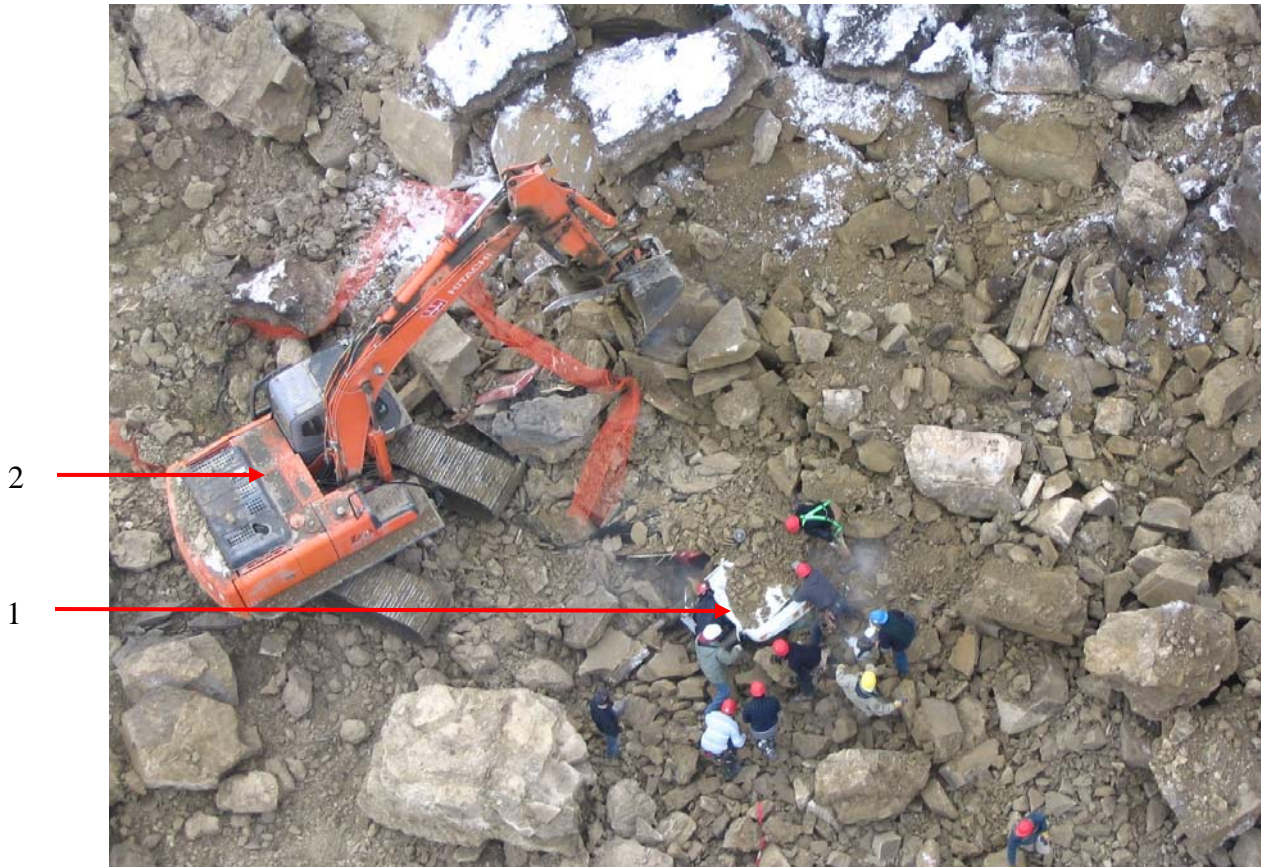
- 5.1.2 The dump truck involved in the incident was owned and operated by Steph Trucking & Welding Co. Ltd. The dump truck was a white 2001 International Model 9200 Diesel, 39,900 kilogram capacity, vehicle identification number (). The dump truck was parked approximately 12 metres away from the excavation wall. The dump truck was buried and crushed when the section of the excavation wall collapsed (Refer to Attachment B – Photographs 2, 3, and 4 and Attachment C – Photograph 3).
- 5.1.3 The excavator used to load the dump truck involved in the incident was owned and operated by On Track Excavating Ltd. The excavator was a Hitachi ZAXIS ZX200LC. This excavator sustained minor damage during the incident (Refer to Attachment B – Photographs 2, 3, and 4 and Attachment C – Photograph 1).

- 7.1.1 The dump truck operator ([REDACTED]) was fatally crushed in the cab of his dump truck when a section of the excavation wall collapsed and buried the dump truck.

Photograph 3: Shows excavator and buried dump truck. This photograph was taken by the tower crane operator ([REDACTED]) after the incident

1. Cab of the dump truck
2. Excavator

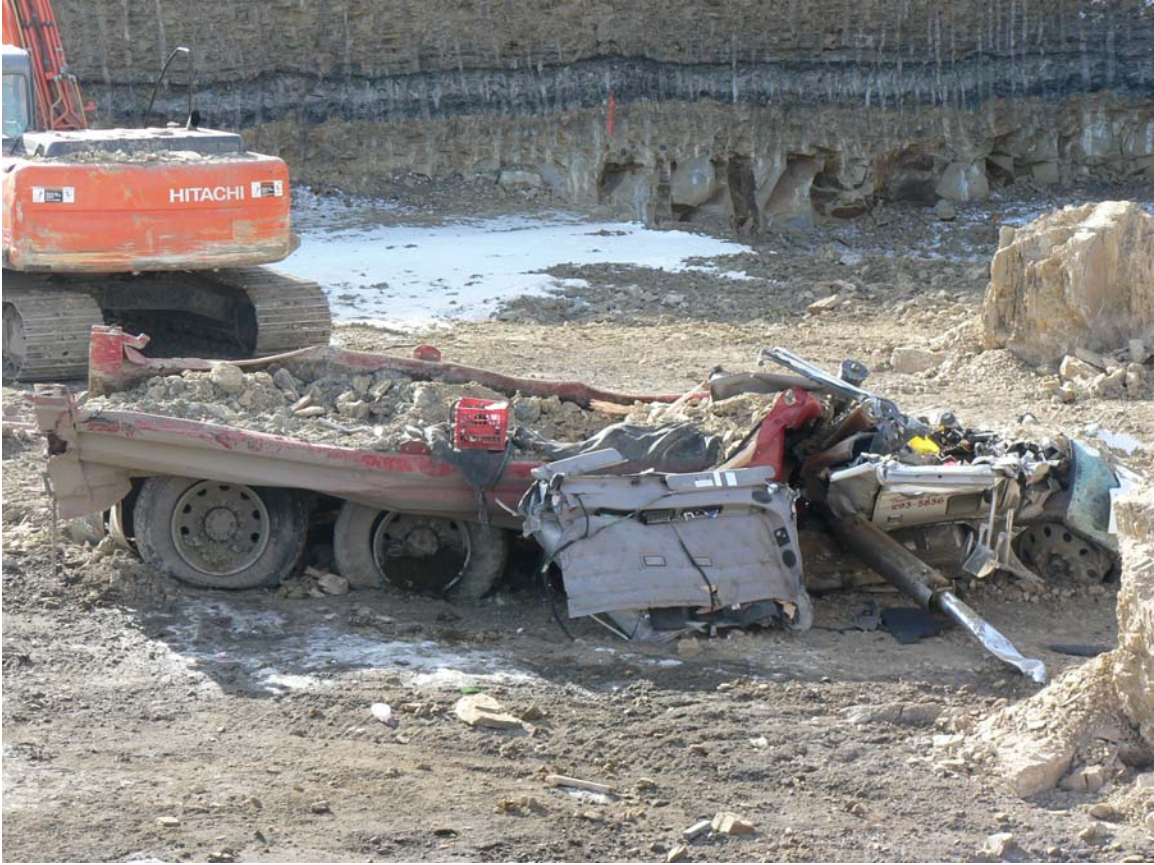
Photograph 4: Shows excavator and damaged dump truck

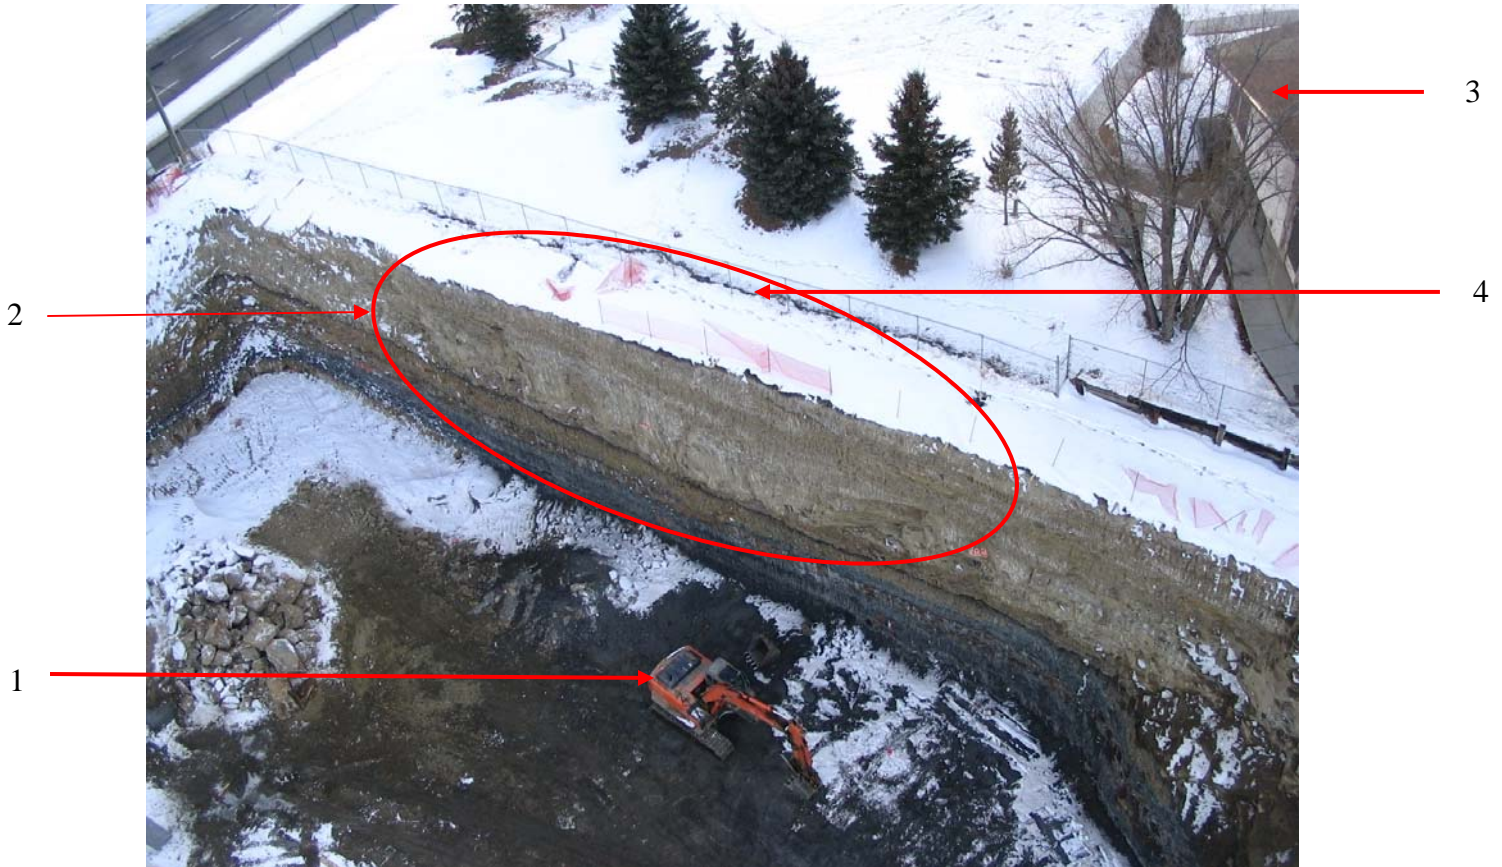
On February 13, 2008 a survey crew observed a long and deep crack running along the fence line on the top ledge of the excavation wall. The survey crew discussed the crack with the site superintendent ([REDACTED]) on the same day (Refer to Attachment C – Photographs 1 and 2).

of by the survey crew on February 13, 2008. The site superintendent () and the excavator operator () measured the crack and determined it to be in the range of 0.6 to 3.0 metres deep along its length. Perera Development Corp. did not take any action to control a possible cave-in hazard.

Photograph 1: This photograph was taken by the crane operator ([REDACTED]) on February 13, 2008 prior to the collapse of the wall

1. Excavator
2. This section of the wall collapsed during the incident
3. Church
4. Crack along the top ledge of the excavation wall

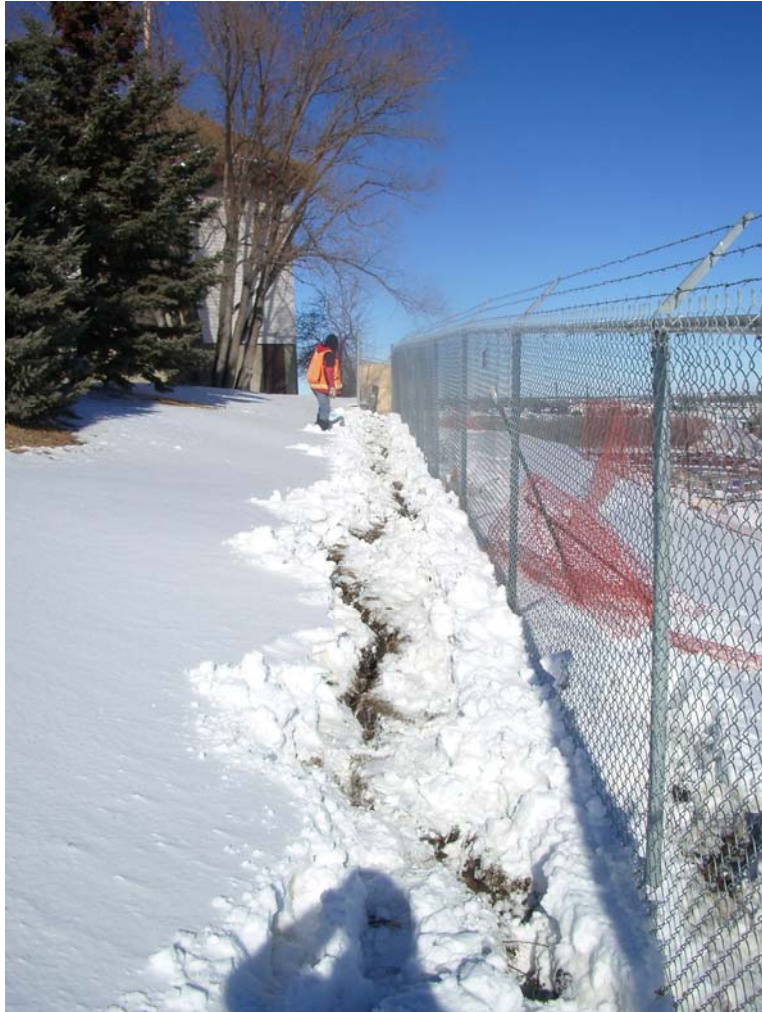
Photograph 2: Shows the crack running along the top ledge of the excavation wall. This photograph was taken by the survey crew on February 13, 2008

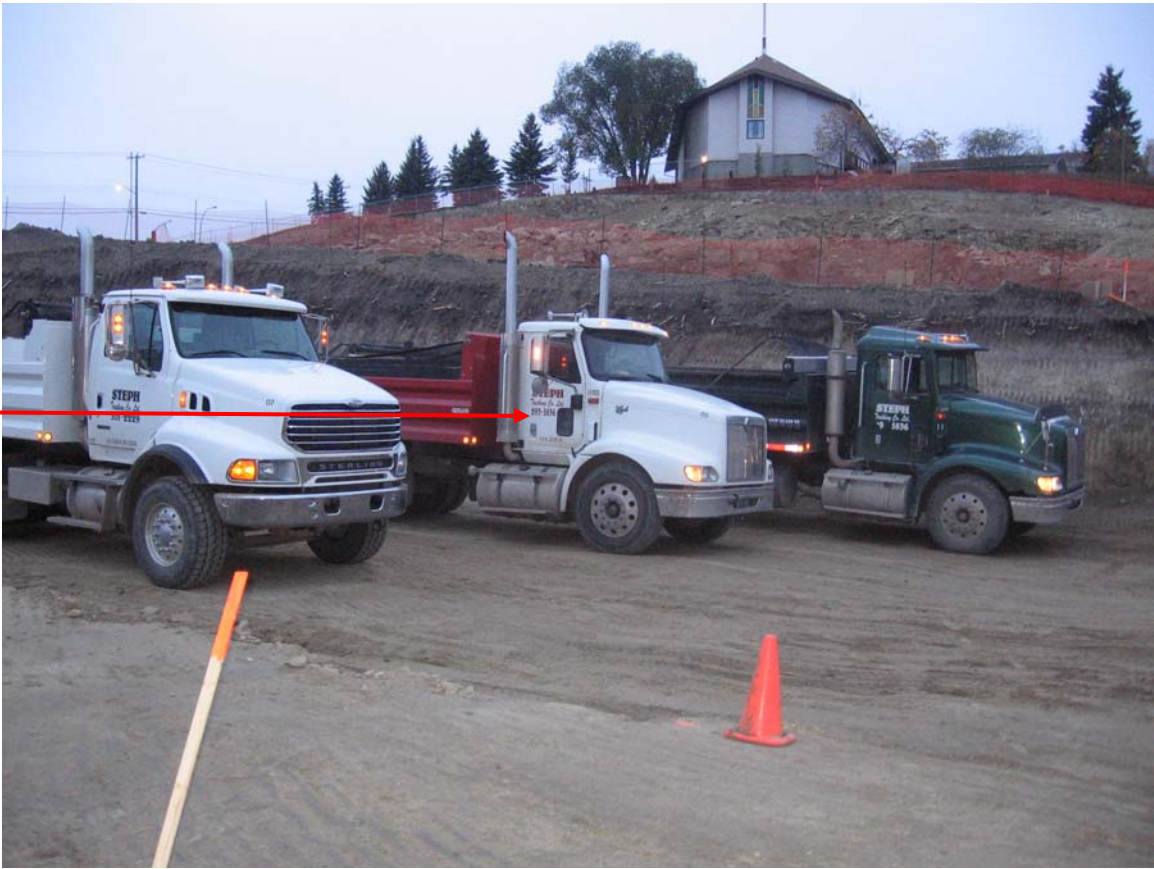
Photograph 3: This photograph was taken in November, 2007 by Steph Trucking and Welding Co. Ltd.

1. Dump truck involved in the incident
