# **RECAPP Facility Evaluation Report**

## **David Thompson Regional Health Authority**

### **Stettler Community Health Services**

B2041A  
Stettler

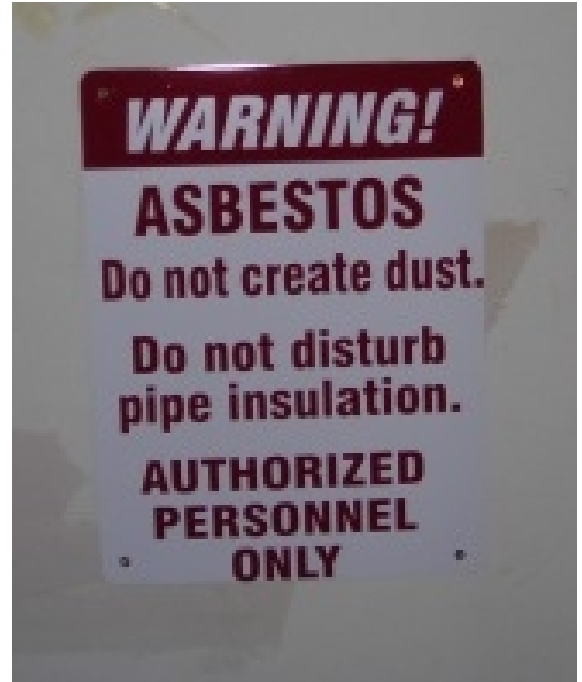
The basement is inaccessible due to asbestos contamination. There is a hazard warning on the door to the basement.

Sign on door to basement

<u>Type</u>	<u>Year</u>	<u>Cost</u>	<u>Priority</u>
Hazardous Materials Abatement	2009	\$100,000	High
