# Worker fatally injured when crushed by falling pipe

October 30, 2021

# Summary of investigation and outcomes

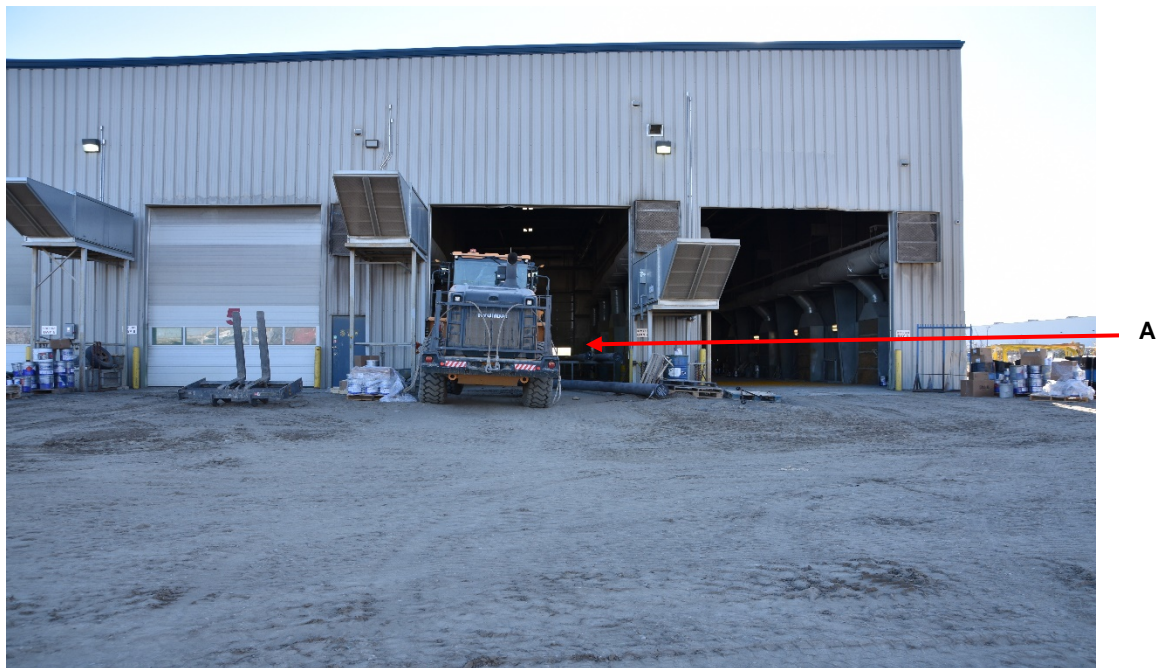
**Figure 3.** Paint bay 4 entrance.

- A. Paint bay 4. This is where the incident occurred.

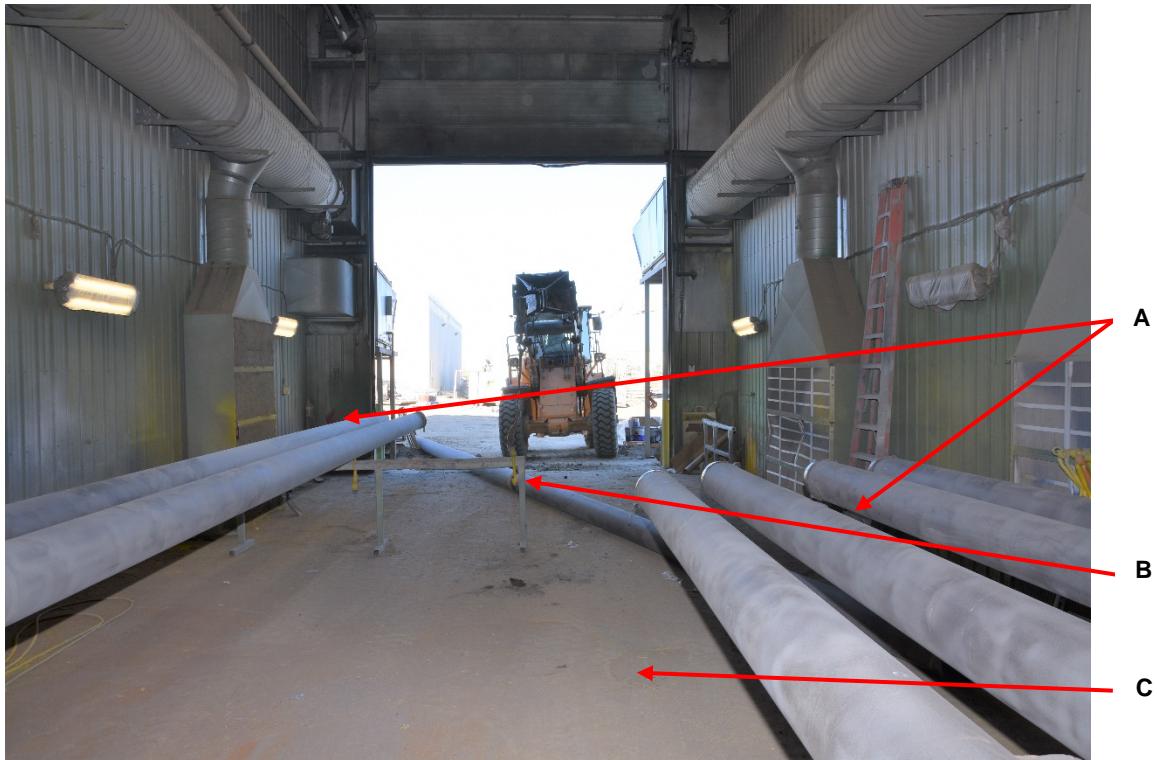
**Figure 4.** Interior of paint bay 4 with bunks and previously moved pipe sections.

- A. Pipe sections.
- B. Bunks for loads.
- C. Unmarked area allocated as the walkway for worker access.

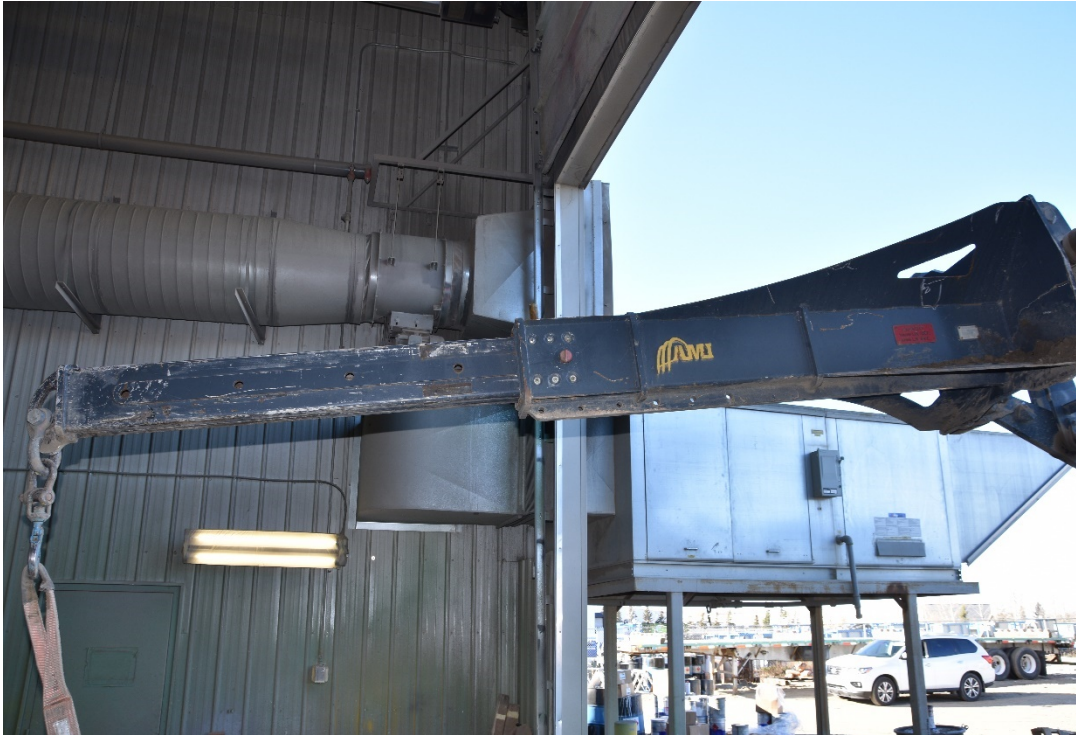
An AMI Attachments Model: 757TM-9 Q mechanical boom pole (jib boom) (Figure 6) was affixed to the quick coupler of the wheeled loader boom. The dimensions of the jib boom were 2.7 metre (m) retracted and 4.4 m extended. The weight of the jib boom was 725 kilograms (kg). The jib boom had a rated capacity of 4535 kg retracted and 2720 kg extended. Affixed to the front of the jib boom were the attachment points for the load.

**Figure 6.** AMI Attachments jib boom.

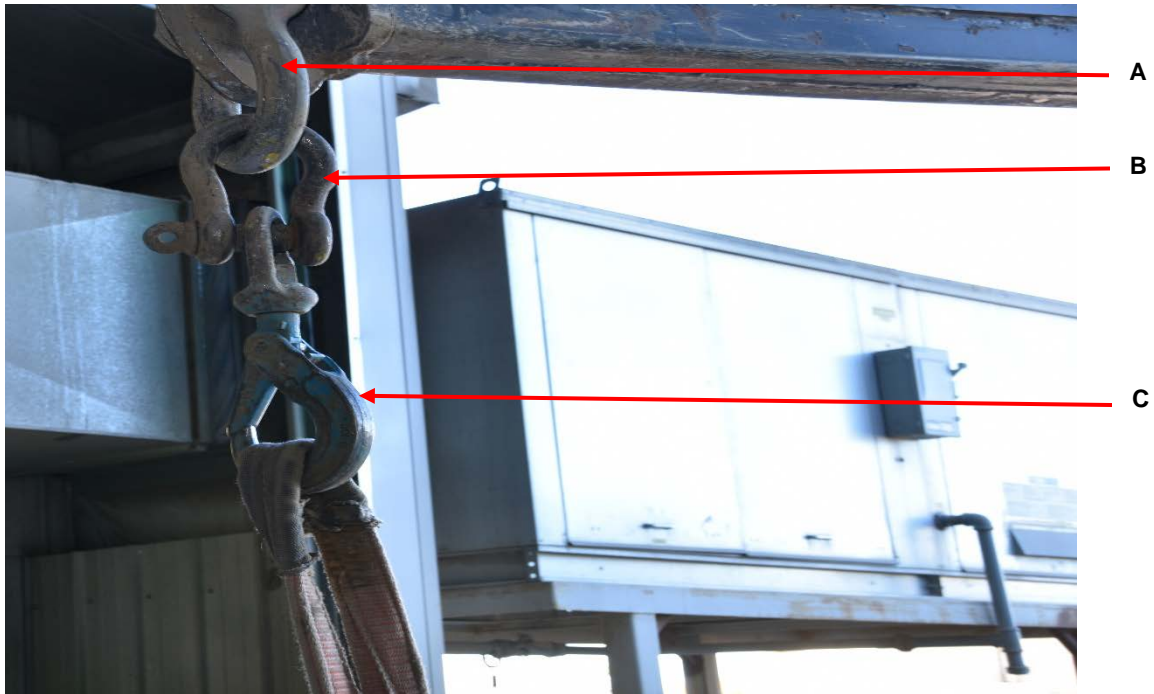
**Figure 7.** Load attachment points.

- A. Crosby shackle.
- B. Gunnebo shackle.
- C. Gunnebo safety swivel.

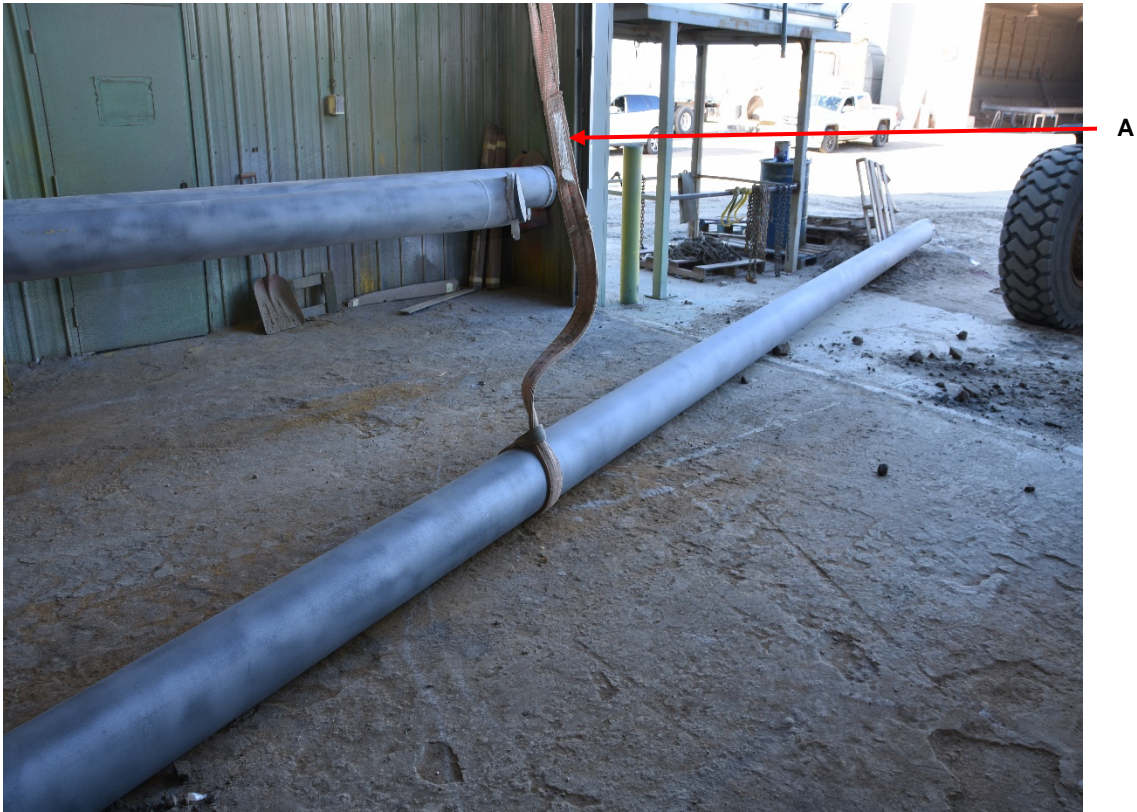
A Tufflift, Model EE4-904 10-foot, type 4 synthetic fibre sling (sling) secured to the pipe choker style, was the final attachment point for the load (Figure 8). The rated capacity of the sling in this configuration was 7983 kg.

**Figure 8.** Synthetic fibre sling secured to pipe.

A. Synthetic sling.

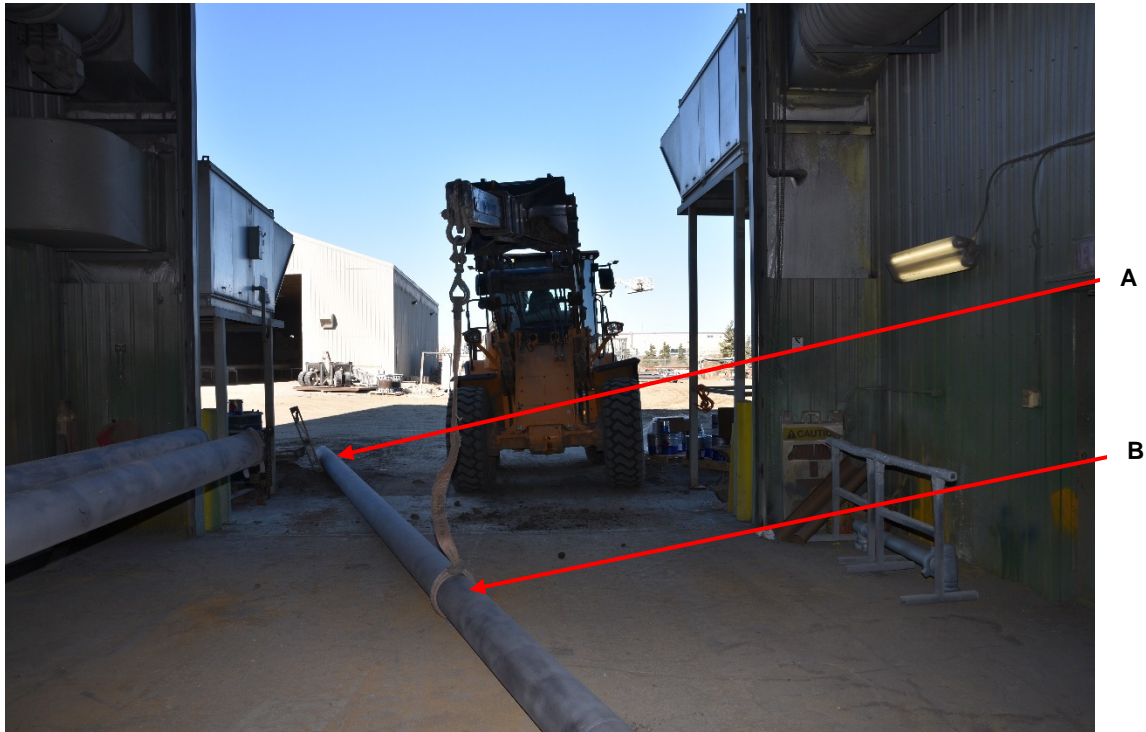
The load being moved was a section of steel pipe (pipe) to be painted (Figure 9). The pipe dimensions were 18 m length and 28 cm outside diameter. The pipe weight was 1494 kg.

**Figure 9.** Section of pipe involved in incident.

- A. The area where the worker was when they were struck.
- B. Section of pipe that struck worker.

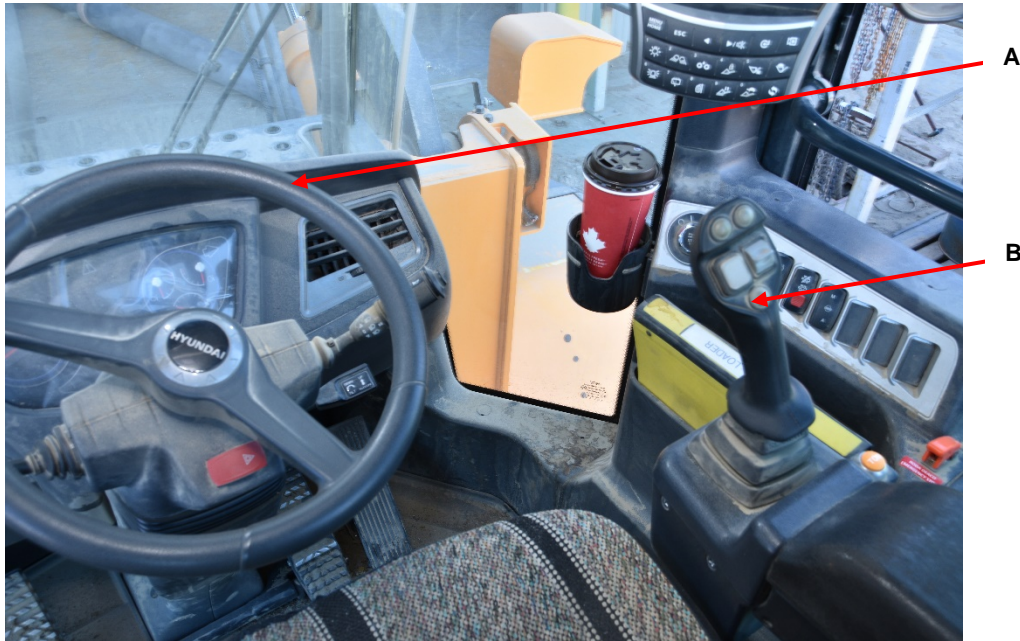
The movement of the load was controlled by the joystick located in the operator's compartment (Figure 10). The joystick was powered on when the wheeled loader was started and remained live as it was not equipped with a "deadman" switch, which would have prevented accidental activation.

**Figure 10:** Operator's compartment of Wheeled Loader.

- A. Wheeled loader steering wheel.
- B. Joystick.

- The abrasive blaster was positioned in an area of significant restricted visibility on the right side of the loader when struck by the pipe.
- The jib boom control joystick was not equipped with a 'deadman' switch, which would have prevented accidental activation.
- The movement of the loader operator caused them to strike the jib boom control joystick, which caused the load to drop.

The loader operator inadvertently contacted the jib boom controls. This caused the pipe to drop and strike the worker.

- System for identifying new workers on shift.
- Competency program for each position (labourer, coater, abrasive blaster, operator, rigging and spotting).
- A supervisor training handbook was created for supervisors as well as an associated competency form.
- An annual review of managers and supervisors was to be implemented along with a yearly safety meeting.
- Sonic stopped accepting work involving pipe sections that were considered too long to safely move from the abrasive blasting building to a paint bay.
- Sonic ceased business operations shortly after the incident and filed for bankruptcy.
