Workplace Health and Safety Fatality Report

WORKER RUN OVER BY GRAVEL TRUCK

Date of Incident: June 22, 2007

Type of Incident: Fatal

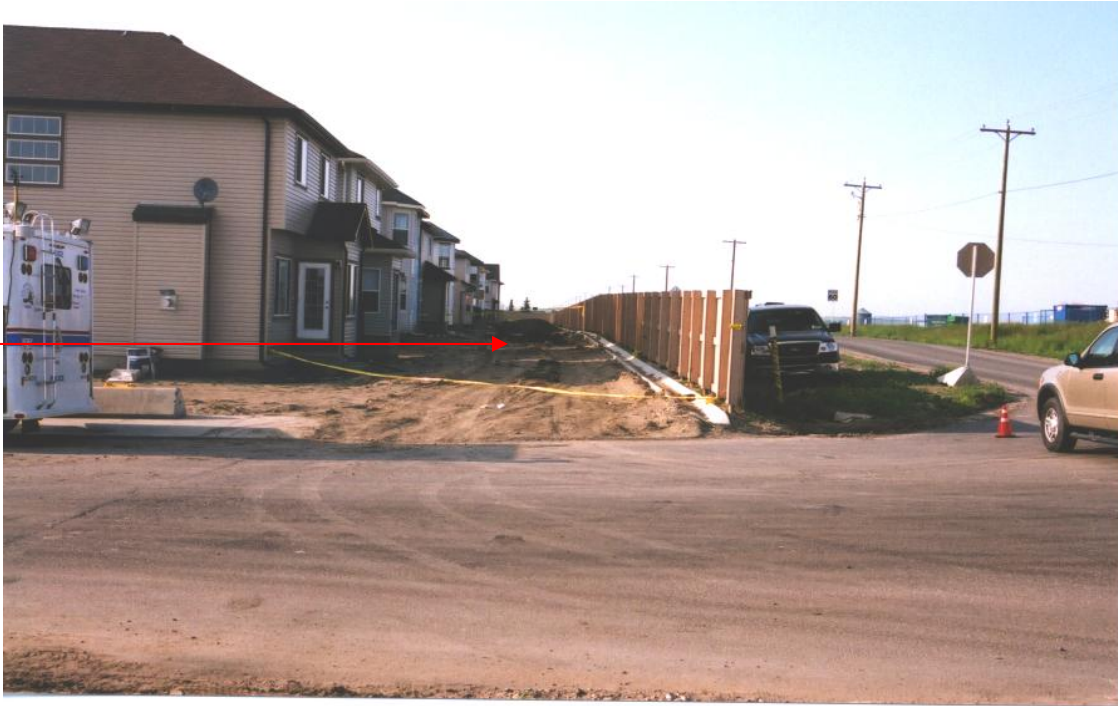
- 6.3 The driver moved the gravel truck forward and backed up again to get closer to the house. The driver was backing up the gravel truck over the mud pool where no gravel had been laid over the mud. The gravel truck got stuck and the driver could not drive it out of mud pool.

Photograph 1: Shows the location of the incident. Arrow shows the mud pool where the gravel truck was stuck.

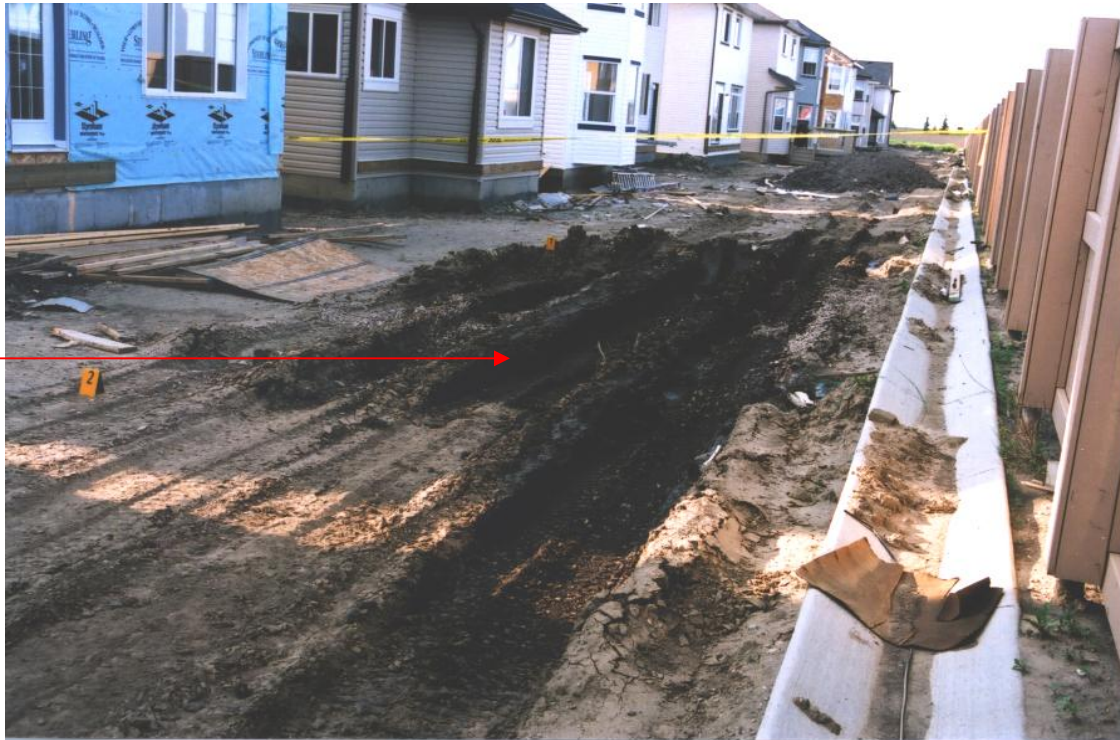
Photograph 2: Shows a close up view of the mud pool where the gravel truck was stuck.

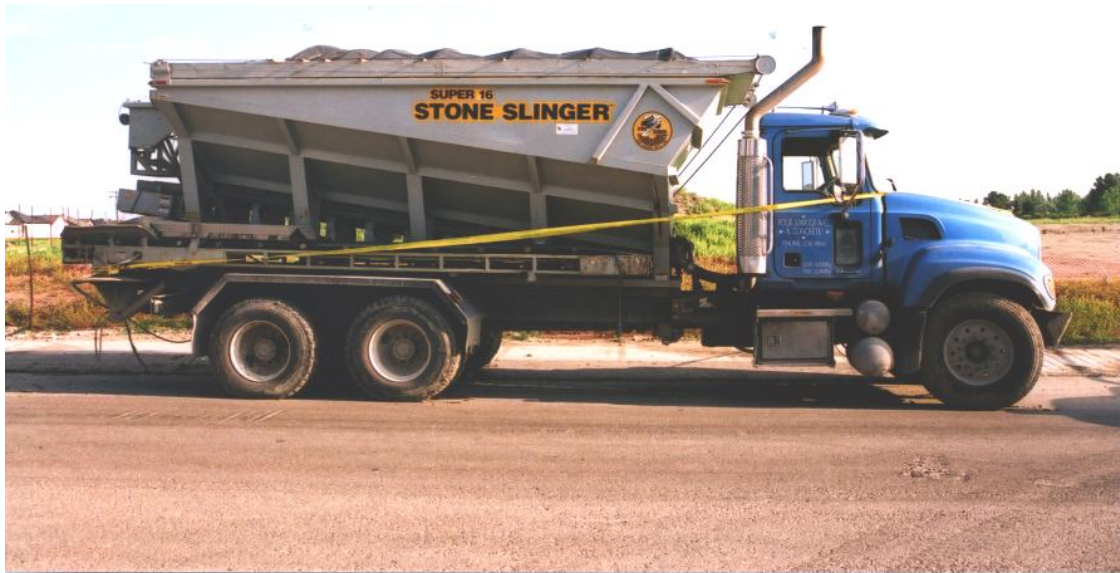
- 5.1.1 The gravel truck involved in the incident was a Mack Granite CV713 equipped with a Stoneslinger and was loaded with gravel. The vehicle owned by Four Star Gravel & Concrete Ltd. had identification number 1M2AGA2C05M025215. The gross weight of the gravel truck was 27300 Kilograms (Refer to Appendix B-Photographs 3 and 4).
- 5.1.2 The Vehicle Mechanical Report prepared by the Calgary Police Service did not identify any mechanical defects in the gravel truck, related to the incident.
- 5.1.3 The towing strap used to pull the gravel truck out of the mud pool was two ply, 5.8 metres long, 10.2 centimetres wide (Refer to Appendix B- Photograph 5).
- 5.1.4 A freightliner dump truck was used to pull the stuck gravel truck out of the mud pool.

Photograph 3: Shows the gravel truck involved in the incident.

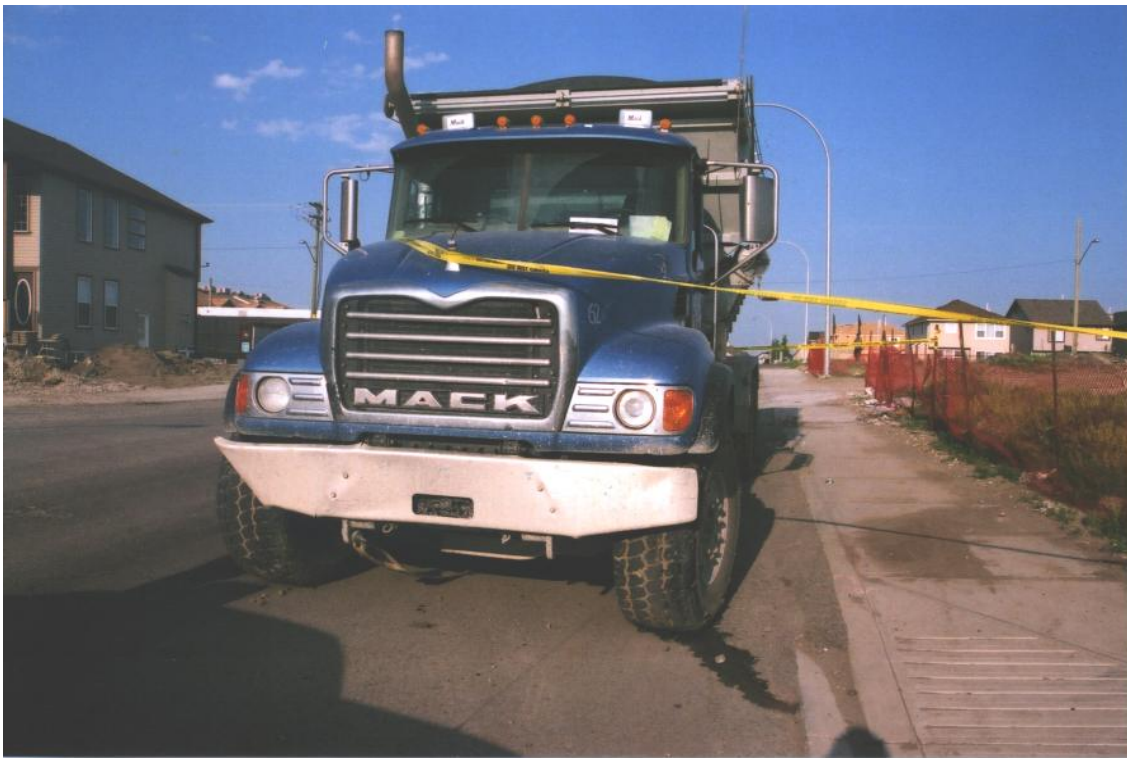
- 5.2.1 The bracket that attached the towing strap to the gravel truck was half way open.
- 5.2.2 It was a clear and sunny day with a temperature of approximately 25 °C

Photograph 4: Shows front view of the gravel truck involved in the incident.
