Worker fatally injured in fall from an aerial platform

July 8, 2020

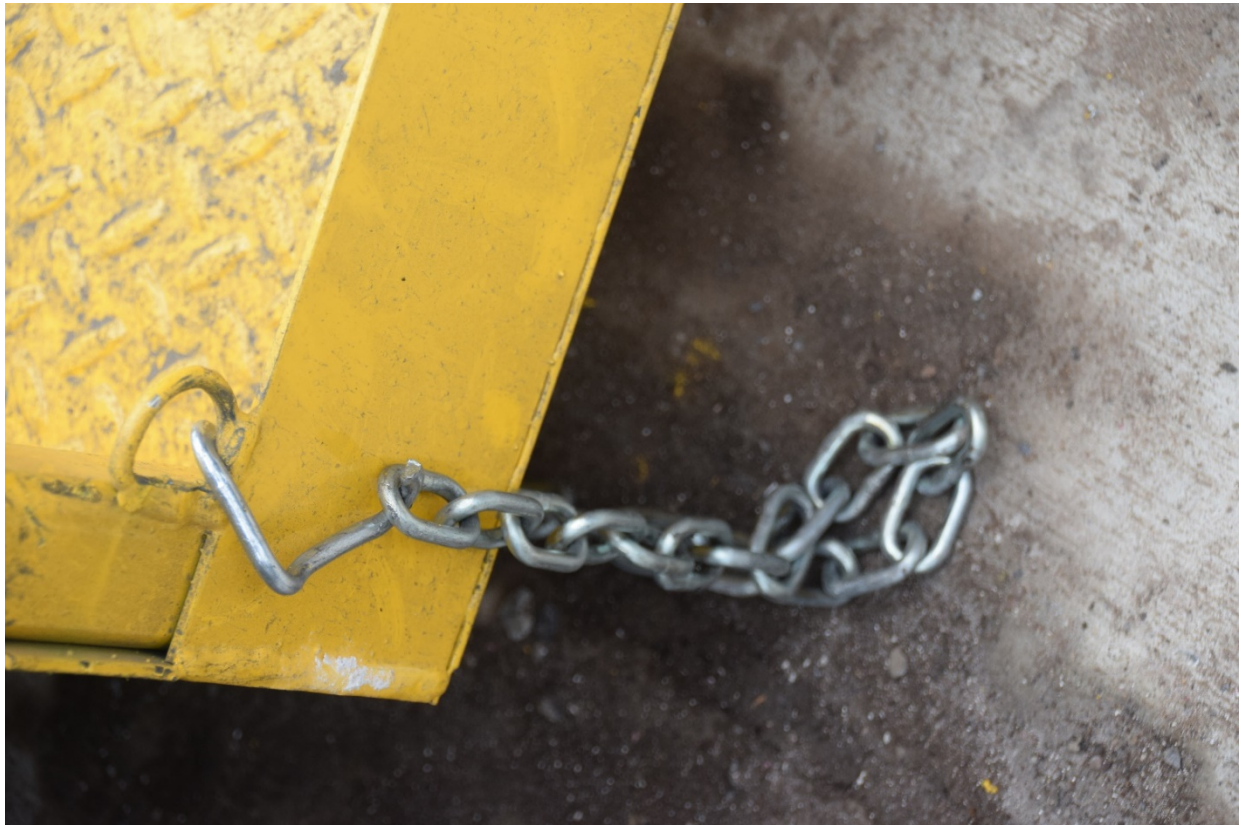
Figure 5. The broken retainer chain attached to the aerial platform
