**Driller Caught and Crushed between Tracked  
Drill and Truck**

Type of Incident: Fatality

Date of Incident: December 16, 2010

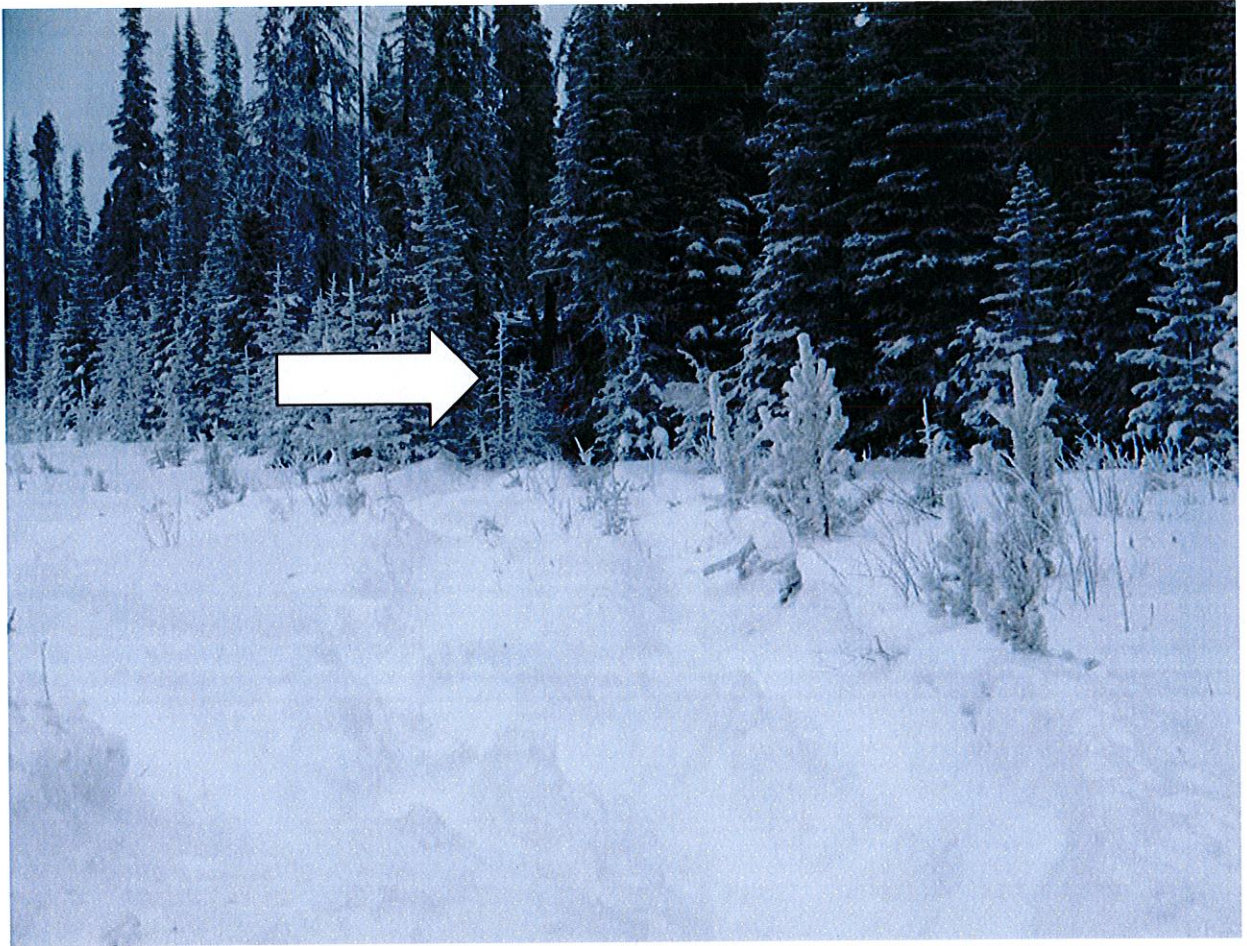
Photograph #1      Looking approximately west from where the shot hole drill left the Staging Area 2 access road. The photograph shows tracks left in the snow by the shot hole drill. Arrow shows the shot hole drill in the bush where it stalled out.

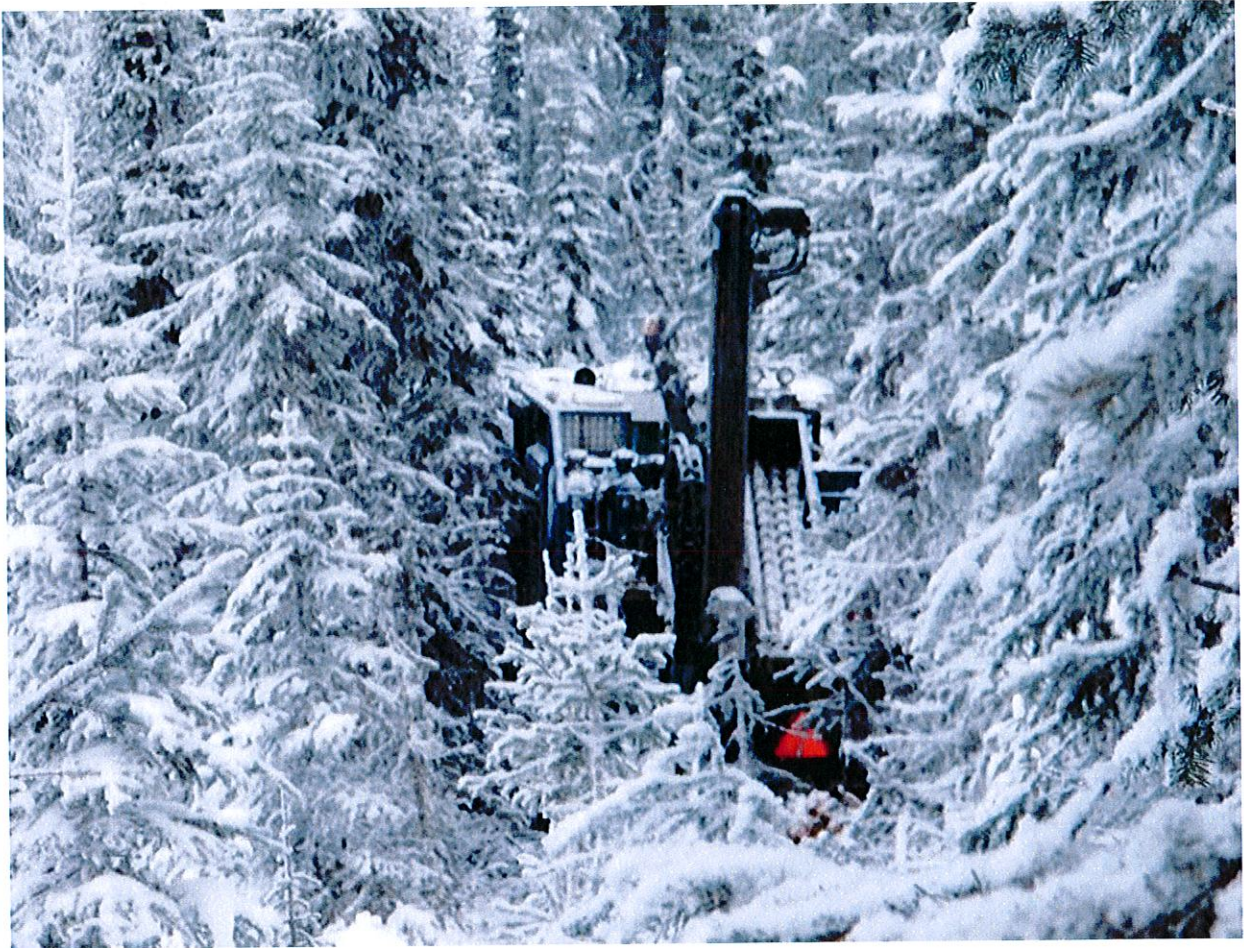
Photograph #2      Shows a rear view of the shot hole drill stalled out in the bush. Photograph shows the track through the bush created by the shot hole drill.

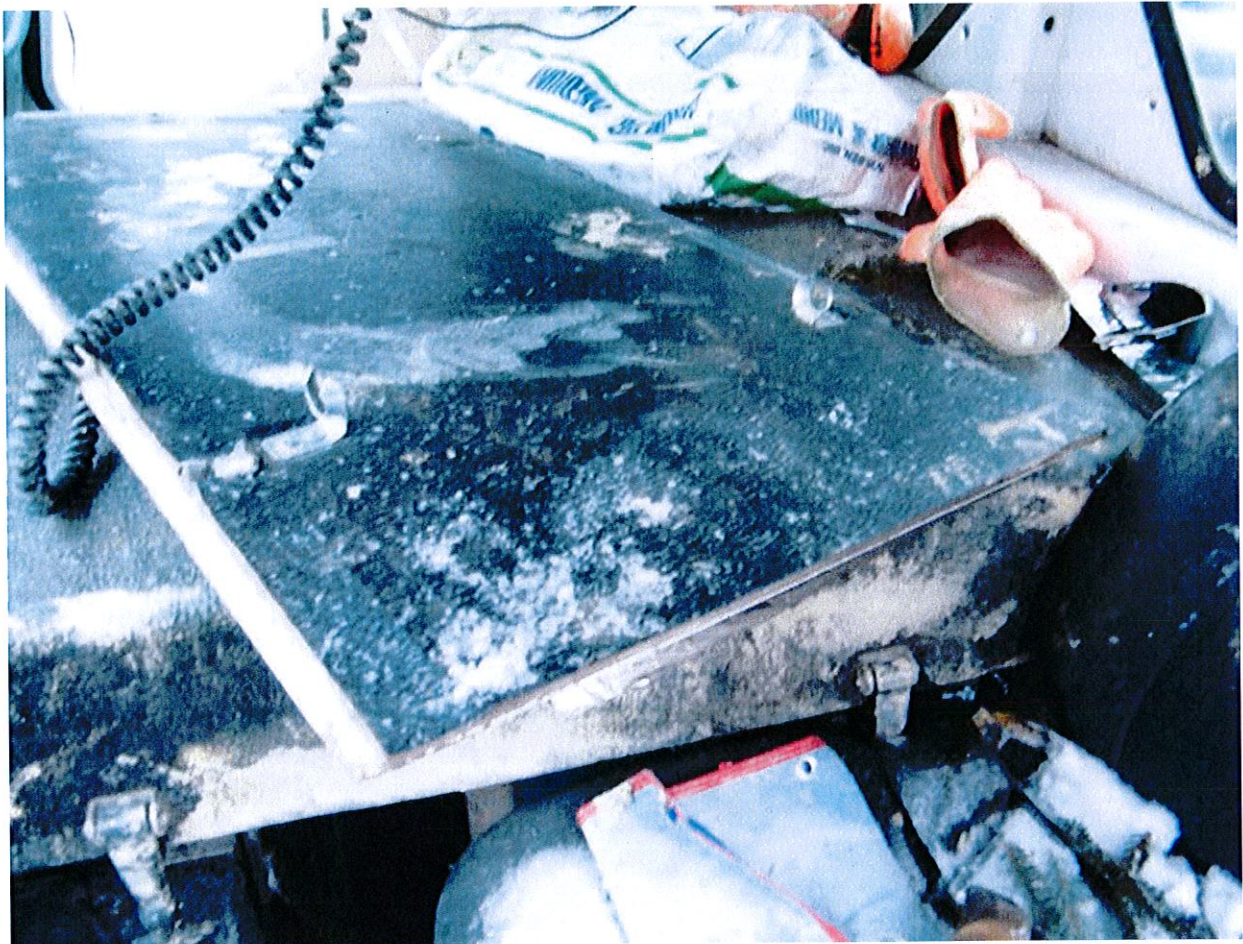
- 6.5 Since the engine on the shot hole drill had stalled out after running out of fuel, it was necessary to bleed the fuel system on the engine before it could be restarted. To access the engine, which was located between the seats in the cab of the shot hole drill, panels were removed from the sides of the engine cover and then the engine cover was raised. The side panels were removed by the Driller ( ) and handed to the Water Hauler ( ) who was outside the cab. The Water Hauler ( ) placed the panels onto the bumper at the front of the seismic drill rig. (Attachment C – Photographs #3, #4)

- 7.1.1 A self-propelled shot hole drill was left running with the control lever in the “Drive” position. The Driller ( ) threw an engine cover panel into the cab from the outside. The panel landed on and depressed the track control levers, causing the seismic drill rig to move forward. The Driller was caught and crushed between the seismic drill rig and another vehicle, causing injuries that proved fatal.

**Photograph #3** Shows the interior of the shot hole drill cab looking from the driver's side door. The side panel from the driver's side of the engine cover is resting on top of the engine cover, depressing the track control levers.

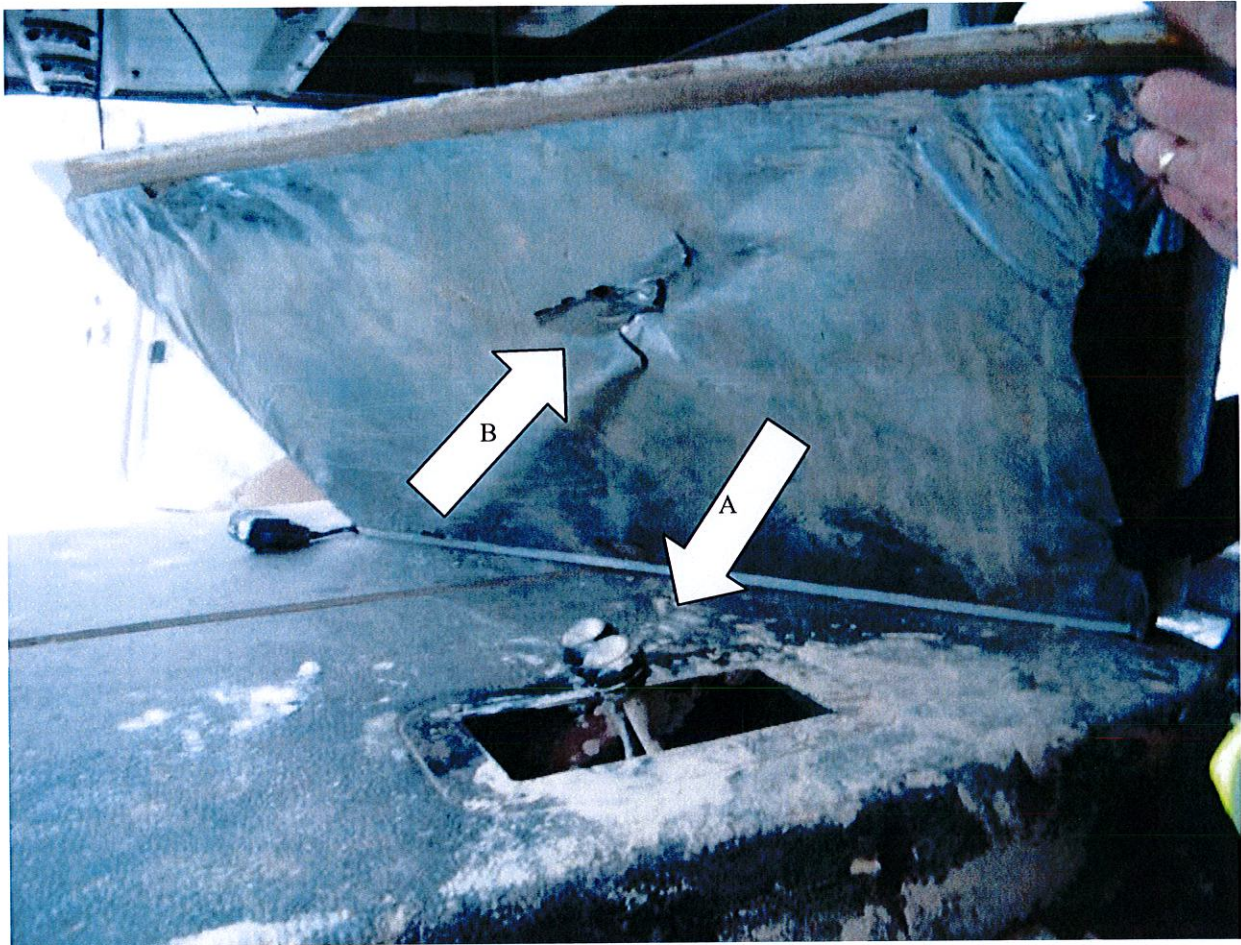
Photograph #4      Shows the side panel lifted from the top of the engine cover. Arrow "A" shows the track control levers. Arrow "B" shows a hole left in the insulation lining the side panel made by the track control levers.

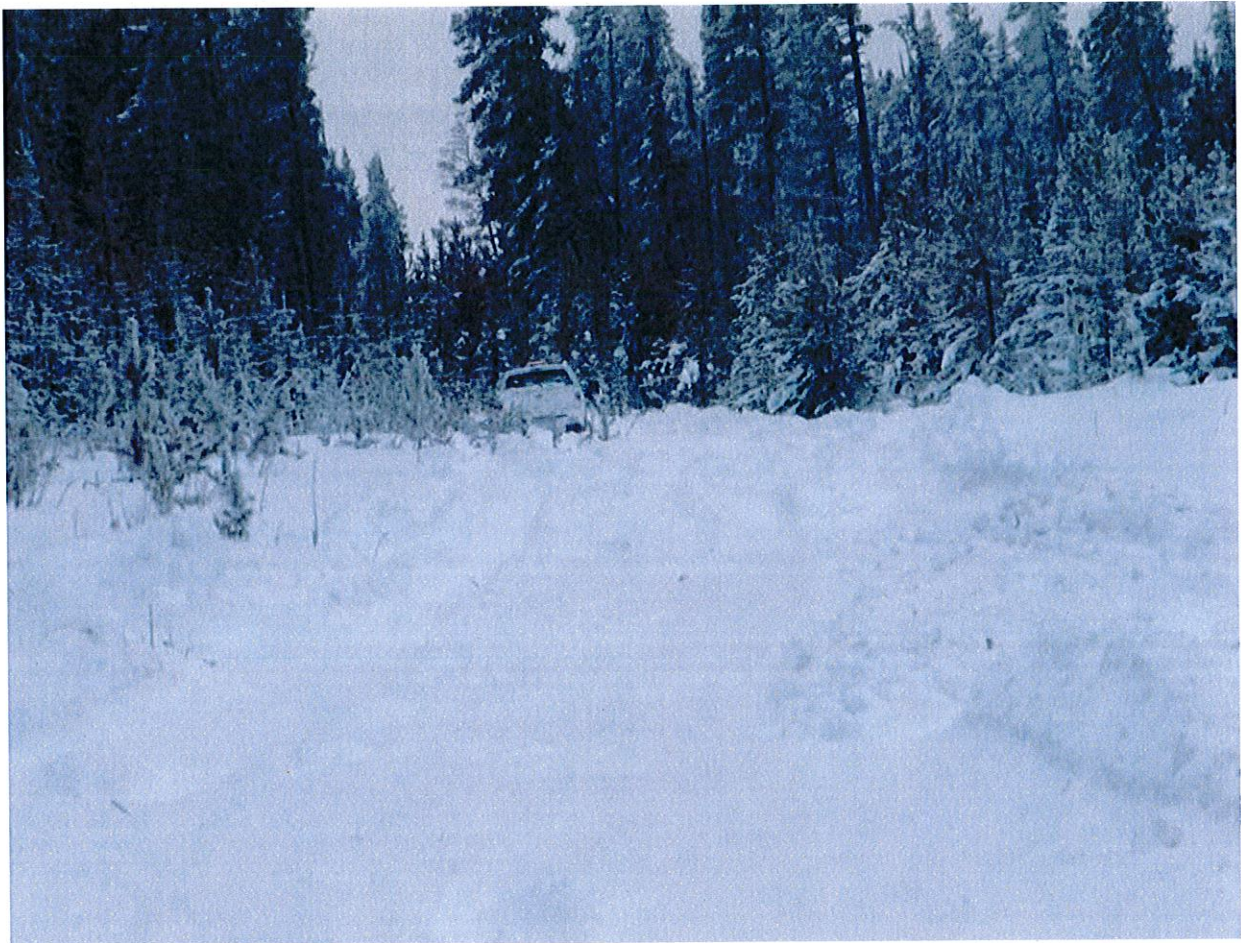
- 6.9 The Driller ( ) attempted to jump back into the cab to stop the shot hole drill, but the front of the shot hole drill caught the driver's door of the truck and the Driller ( ) was caught between the truck and the moving shot hole drill. The shot hole drill pushed the truck, with the Driller ( ) caught between the two vehicles, approximately 10 m before the truck broke free. The shot hole drill continued to head towards Staging Area 2 and the Driller ( ) was left lying on the ground behind the truck. The incident occurred at approximately 6:30 p.m. (Attachment C – Photographs #5, #6, #7, #8)

Photograph #5      Looking approximately southwest from where the shot hole drill left the staging Area 2 access road. Shows where the Ford F350 pickup truck was left after the incident.

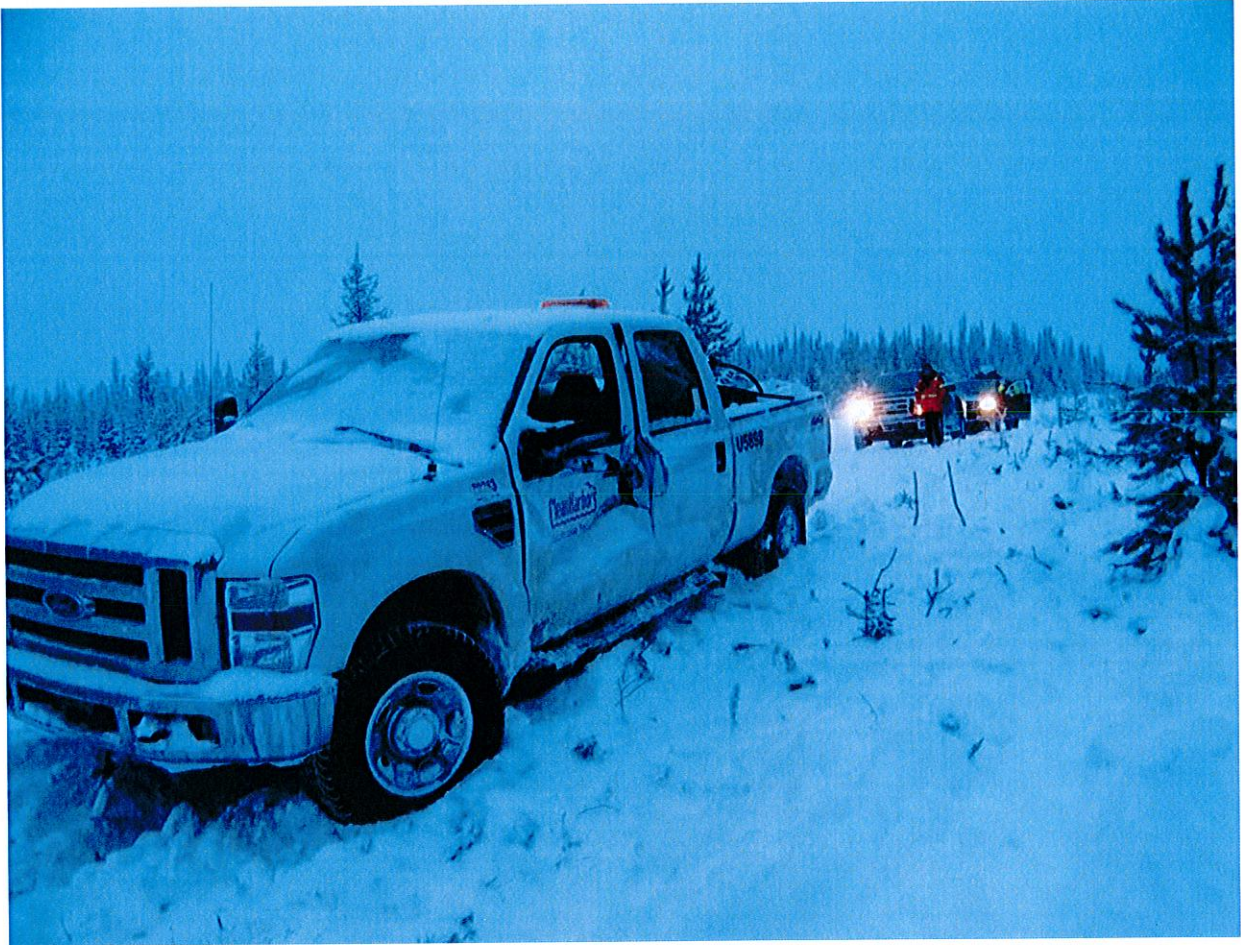
Photograph #6      Showing damage on the driver's side of the pickup truck. The Driller was caught and crushed between this side of the truck and the driver's side of the shot hole drill.

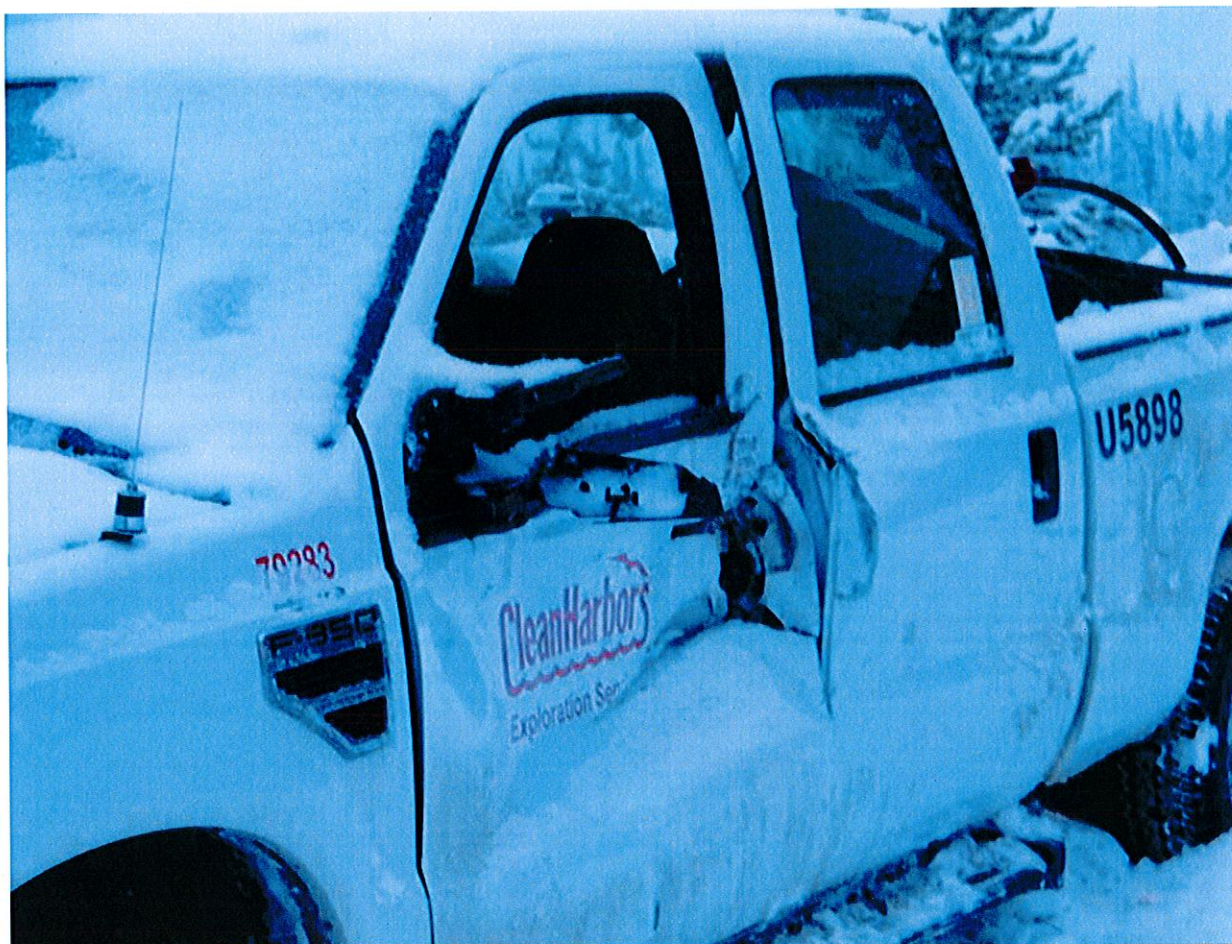
Photograph # 7 Shows a close-up view of the damage to the pickup truck.

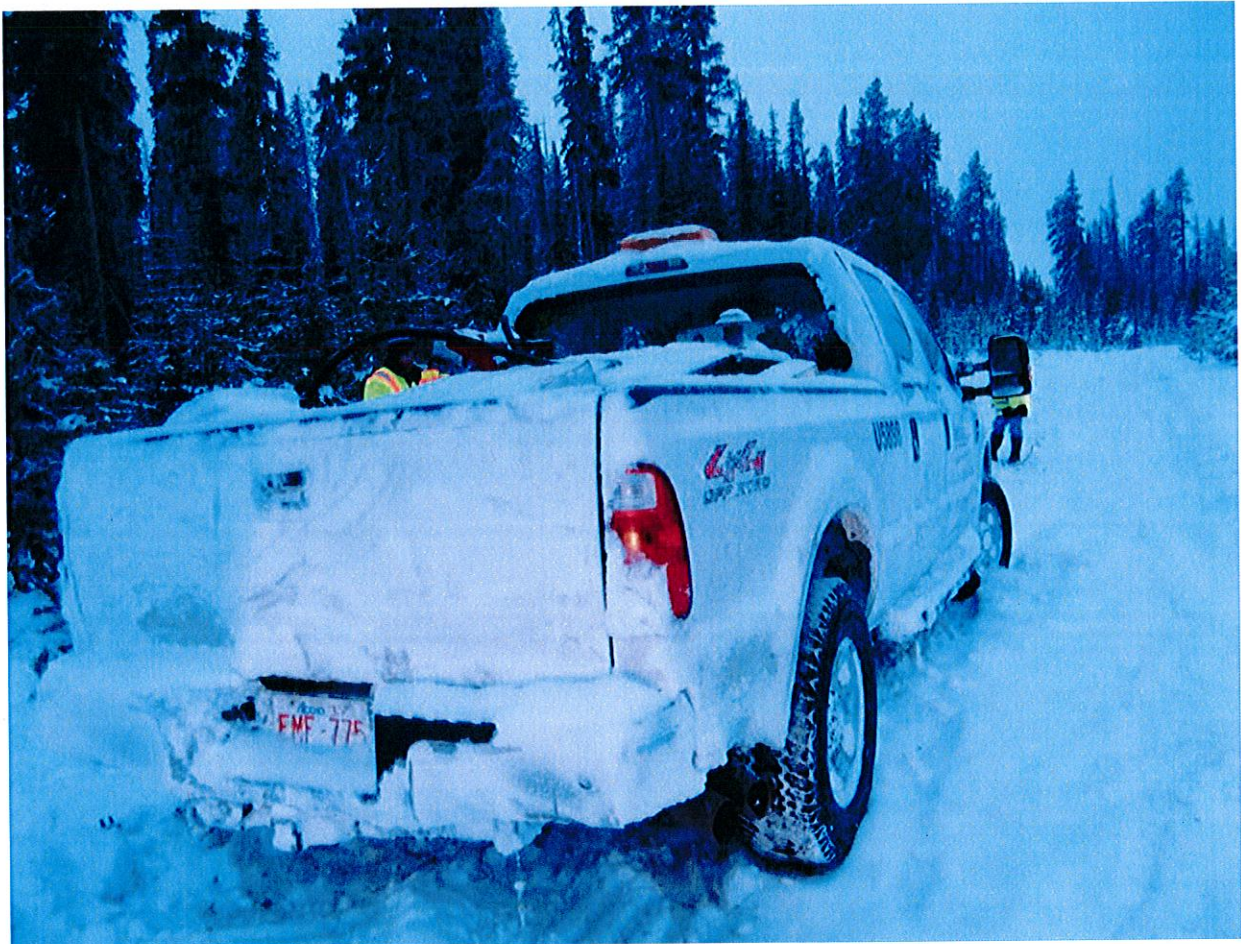
- 5.1.2.1 The Ford F350 pickup truck involved in the incident was manufactured in 2007. The vehicle was identified by VIN Number 1FTWW31R08EC29882 and Alberta license plate EMF-755. The Owner's Identity Number was 79283. The vehicle was fitted with an auxiliary fuel tank in the truck bed with a capacity of 429 l of diesel fuel.

Photograph #8 Shows the auxiliary fuel tank and pump in the box of the pickup truck.

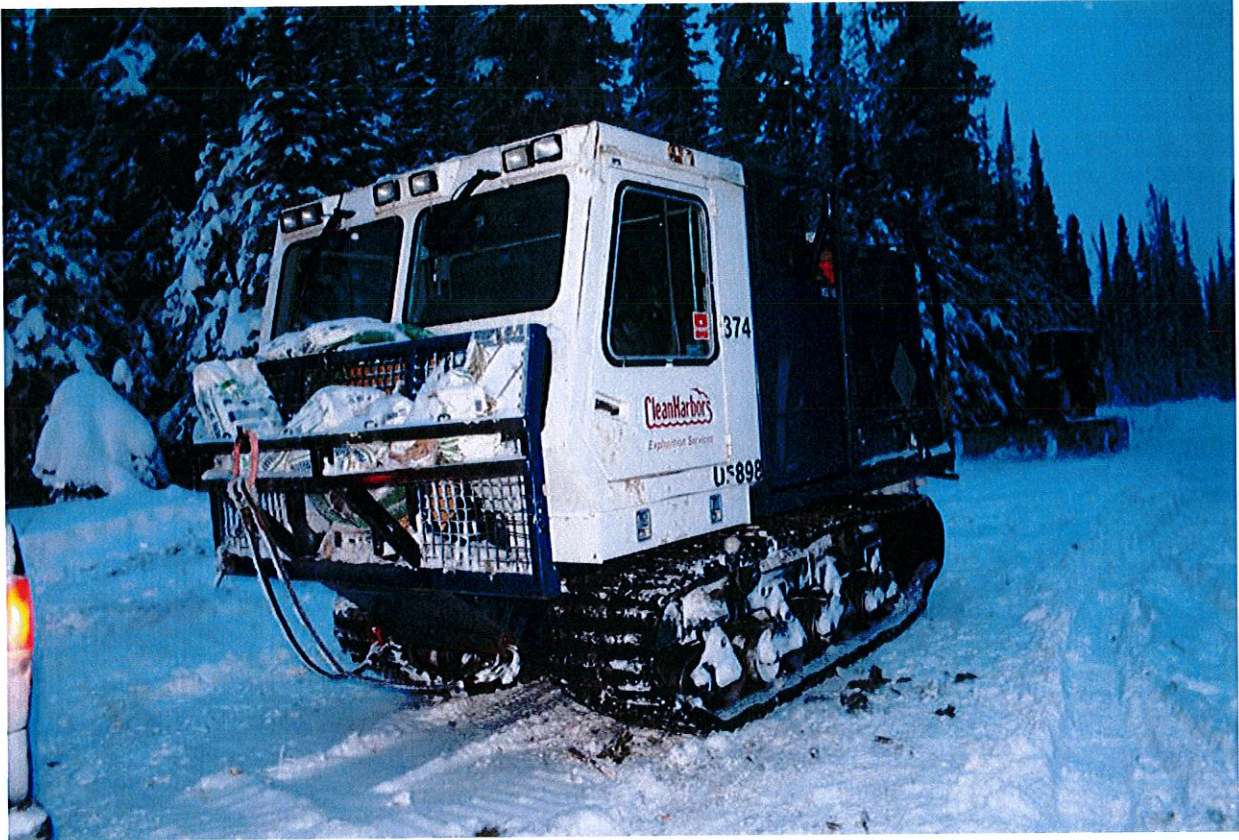
- 5.1.1.1 The shot hole drill was one of a fleet of vehicles based on a rubber tracked carrier vehicle manufactured by Morooka in Japan. The shot hole drill was manufactured by Multi-Power Products Ltd. using Morooka parts but specifically built to Multi-Power Products Ltd.'s designs in accordance with Clean Harbors Exploration Ltd. specifications. (Attachment C – Photograph #9)

- 7.2.1 The shot hole drill had a three-position switch at the driver’s side of the cab. With the switch in the down “Drive” position the switch sends hydraulic power from the engine to the track control levers to drive the tracks. In the centre “Park” position the vehicle is in neutral and in the up “Drill” position the switch sends hydraulic power to the controls for the seismic drill at the back of the unit. After the Driller ( ) had repositioned the shot hole drill the switch had been left in the “Drive” position, so that when the panel landed on and depressed the track controls the vehicle started to move. If the switch had been left in the “Park” position this incident could not have occurred.

Photograph #9 Shows another shot hole drill the same as the vehicle involved in the incident.
