**FLOORHAND CRUSHED BETWEEN
EXCAVATOR AND STATIONARY
EQUIPMENT**

Type of Incident: FATALITY

Date of Incident: October 19, 2012

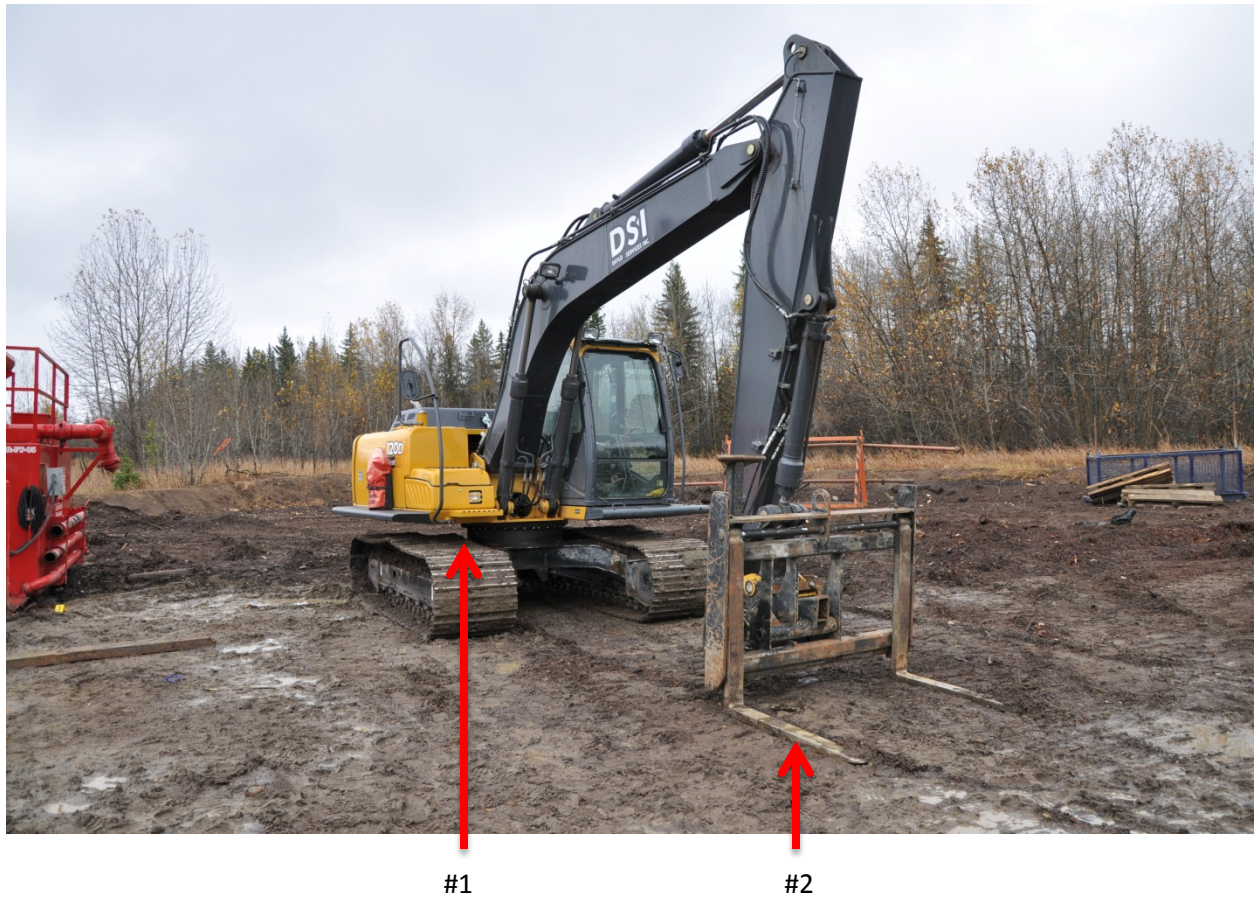
Photograph 1

- 5.1.1 Excavator (Refer to Attachment C – Photograph 1)
 - Make: John Deere 120 D
 - Unit # 7517
 - Serial Number *****
 - Hour reading: 714.8
 - Attachment: Pallet fork with pipe clamp
 - Attachment certification: March 1, 2011

#1 Shows the John Deere 120 D excavator owned by Daylo Services Inc.

#2 Shows the pallet fork attachment connected to the John Deere 120 D excavator.

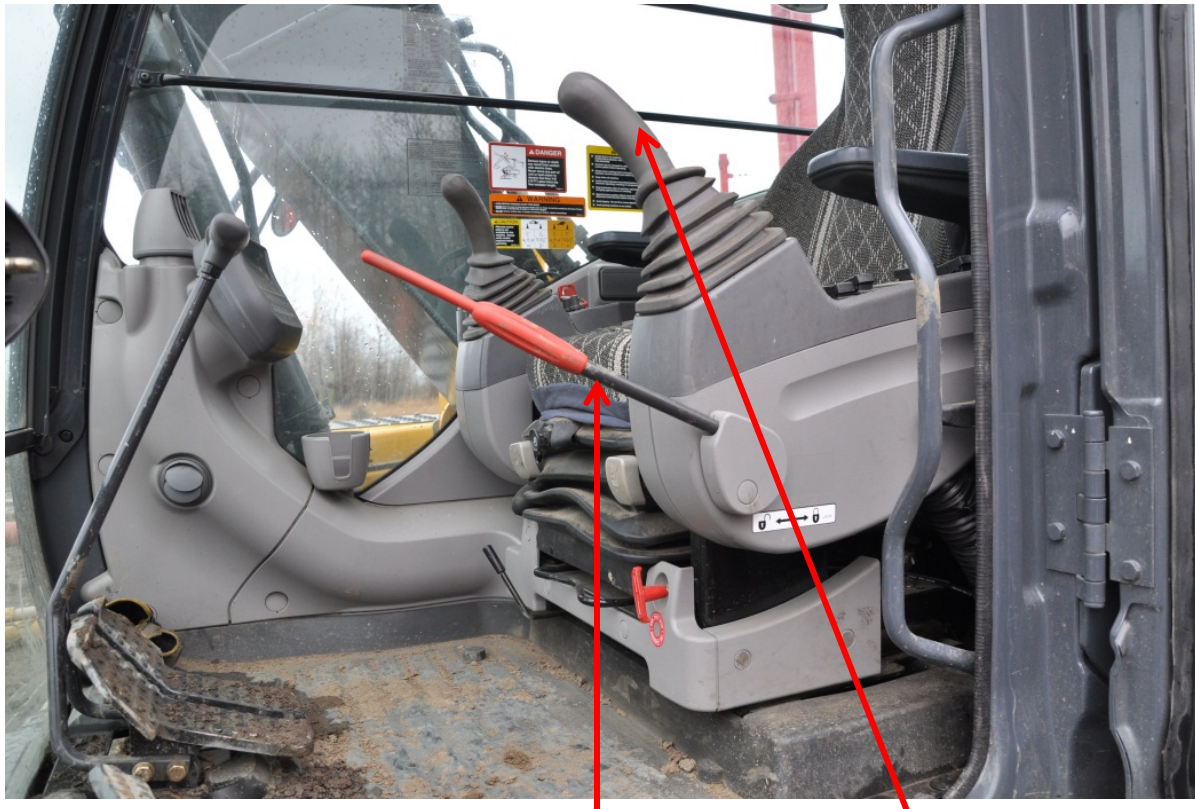
Photograph 2

- 6.13 At approximately 4:45 a.m., the equipment operator (**** *) locked out the excavator and proceeded to get out of the machine. While exiting the cab of the excavator, the lockout mechanism was disengaged and the controls were activated.

- #1 Shows the pilot control shut off lever in the cab of the John Deere 120 D excavator. It is shown in the off position which enabled the controls to move the excavator as required.
- #2 Shows the operator's left side control handle that allowed the excavator boom to move.

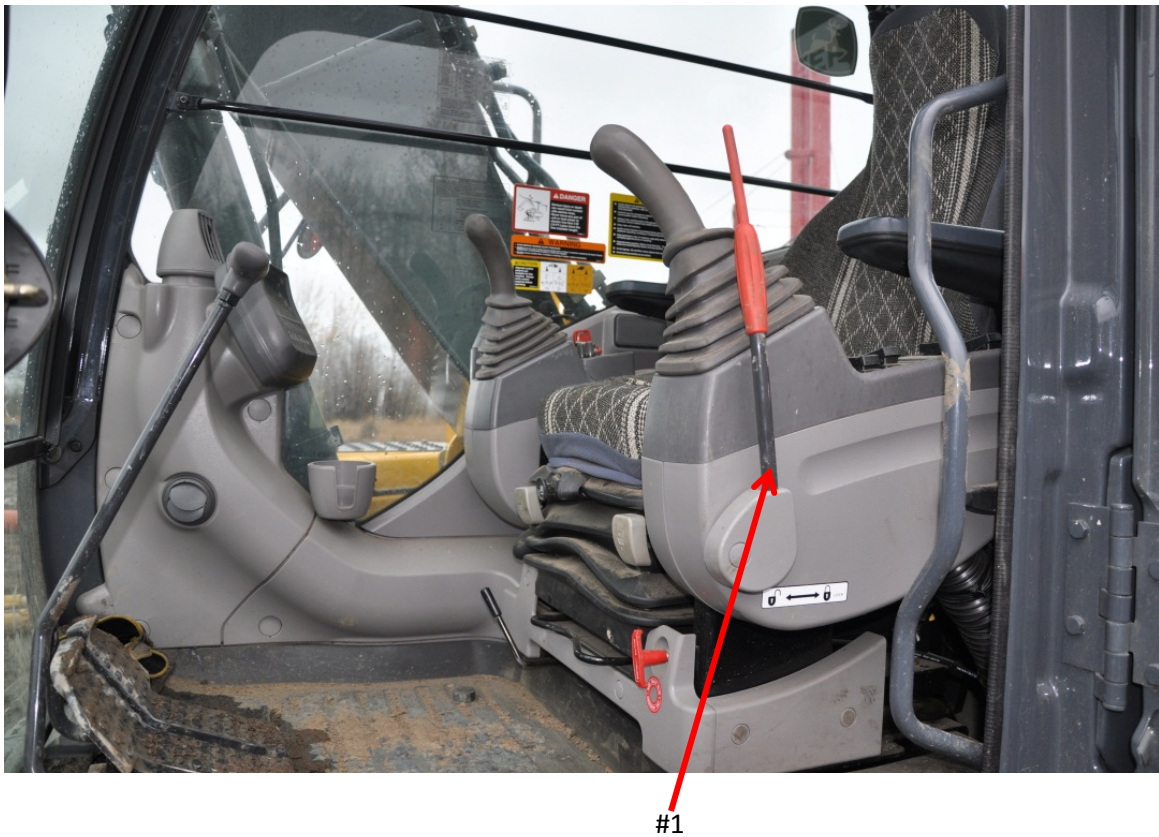
Photograph 3

5.2.4 At 2:30 p.m., the Daylo Services Inc. owner operator (**** *) was directed by OHS investigators to start the excavator and demonstrate the pilot control lock out. OHS investigators observed the controls on the excavator were rendered inoperable when the pilot control was moved into the locked position.

- #1 Shows the pilot control shutoff lever in the on or locked position. This disabled the hydraulic pressure to all controls rendering them inoperable.

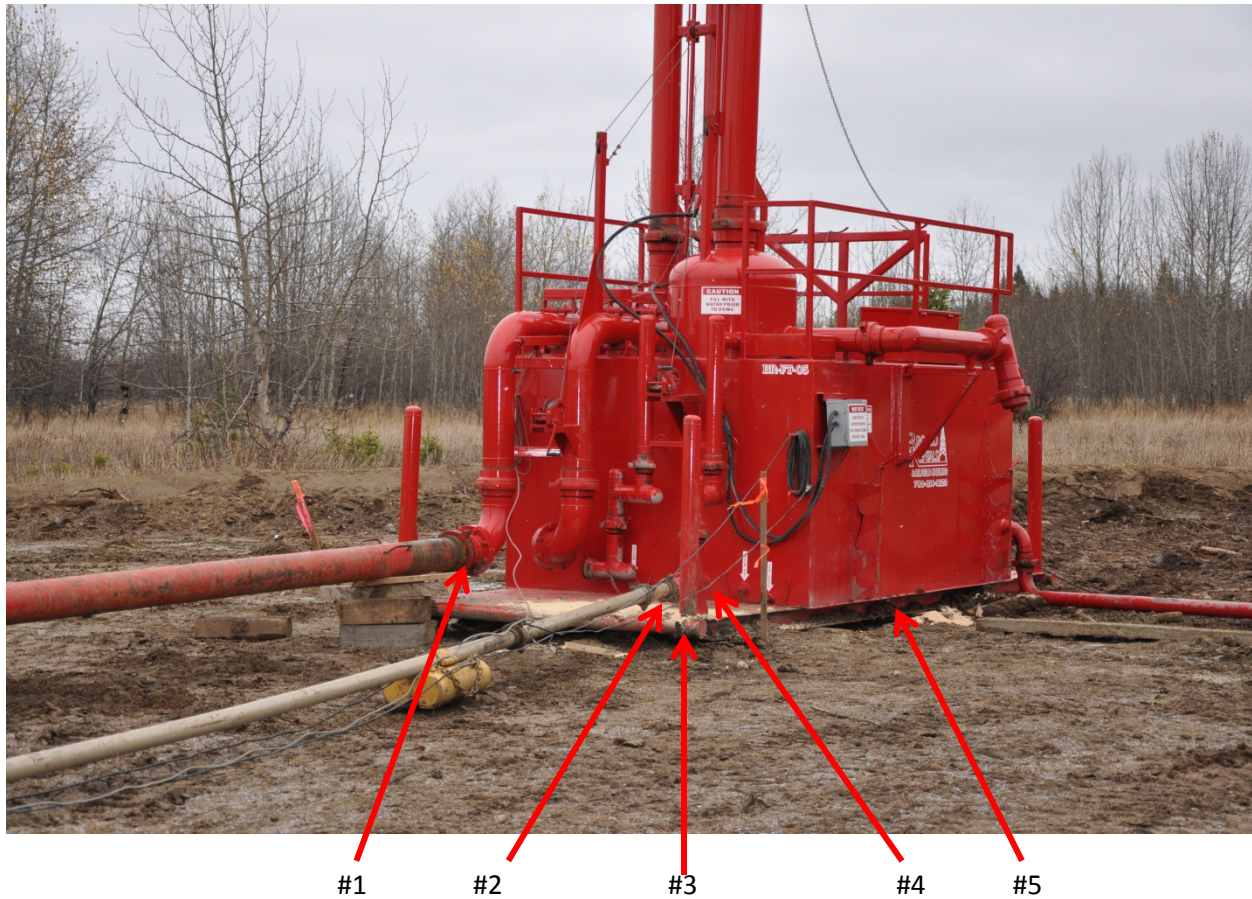
Photograph 4

- 5.1.2 Portable Flare Tank (Attachment C – Photograph 4)
 - Size: 15 metres³ (m)
 - Serial Number: *****
 - Weight: 15 769 pounds
 - Unit: BR-FT-05

Shows the degasser and flare line connected to the portable flare tank. The workers were attempting to move the portable flare tank forward to make the connections as shown.

#1 The connection point for the degasser line to the portable flare tank

#2 The connection point for the flare line to the portable flare tank

#3 Lifting point of the portable flare tank skid

#4 Stationary post on the portable flare tank skid

#5 The skid the portable flare tank was mounted to

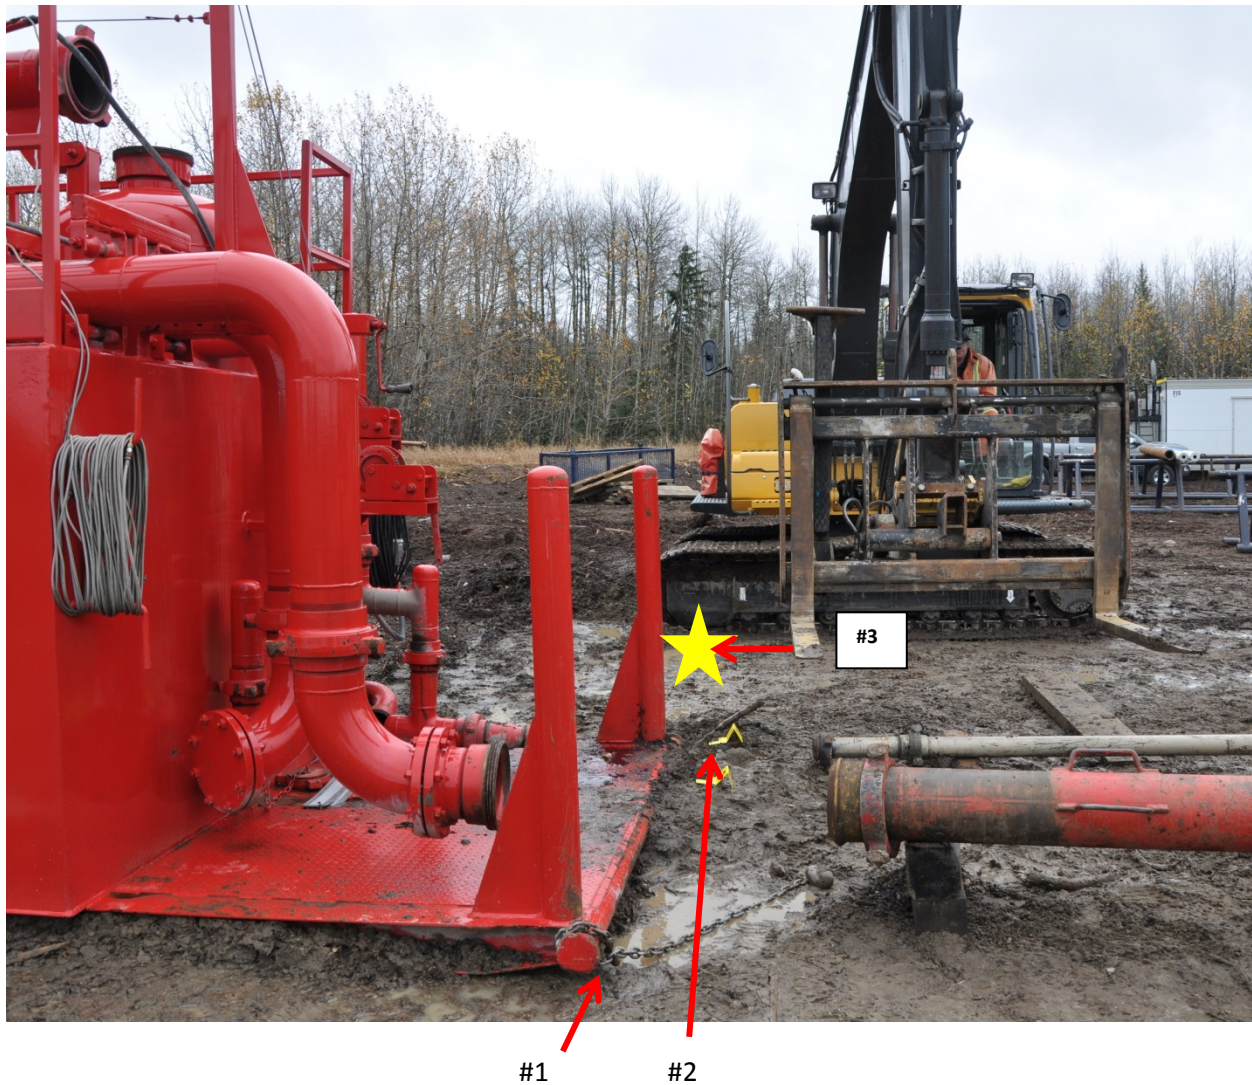
Photograph 5

The rigging, used to connect the portable flare tank to the excavator pallet forks, consisted of 4.2 m of L7 transport chain with two forged G70 3/8 inch hooks at each end. The hooks of the ends of the chain were to be hooked onto the attachment points on the flare tank skid and wrapped around the excavator pallet forks so that it could be moved into position (Attachment C – Photograph 5).

- 6.14 When the excavator controls were activated, the boom and the fork attachment moved towards the portable flare tank and crushed floorhand 1 (**** *) between the fork attachment and the stationary post on the flare tank. Floorhand 2 (**** *) was struck in the head and knocked over backwards.

Shows the portable flare tank and the unconnected degasser and flare line. Workers were attempting to rig the portable flare tank lifting points onto the fork of the excavator. The plan was to use the excavator to move the portable flare tank forward to connect the degasser and flare lines.

#1 Shows the chain rigged around the lifting point on the portable flare tank skid

#2 Shows the lifting point on the portable flare tank skid that was buried in the mud. Floorhands 1 and 2 (***** and *****) were attempting to dig lifting the point out of the mud to hook the chain onto it.

#3 Shows the direction the forks moved while Floorhand 1 (*****) was positioned in-between the stationary post and the excavator forks. The yellow star indicates where Floorhand 1 (*****) was positioned at the time of the accident.

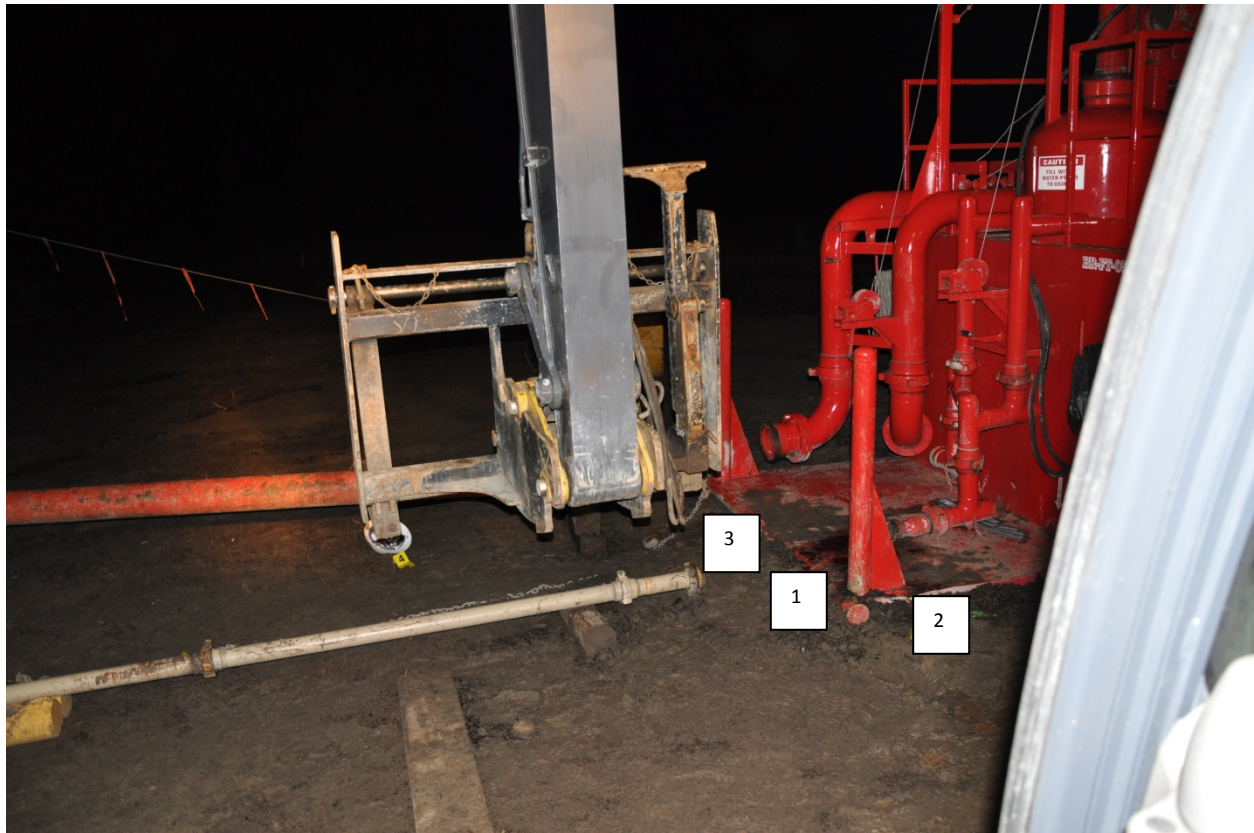
Photograph 6

- 6.11 Floorhand 1 (**** *) and floorhand 2 (**** *) hooked the north side of the flare tank skid and wrapped the chain around the excavator fork. They couldn't connect the south side of the flare tank skid since that area was buried in the mud. Floorhand 1 (**** *) and floorhand 2 (**** *) tried to clear the mud away from the hook up point. They didn't have a shovel readily available to dig out the area. Floorhand 1 (**** *) found a stick and was using it to clear the mud out from the hook up point. In doing so, floorhand 1 (**** *) was positioned between the excavator forks and a post on the flare tank skid. Floorhand 2 (**** *) was positioned along the south side of the flare tank skid and assisted digging the area out with both hands. The motorman (**** *) was positioned in front of the excavator forks and waited for floorhand 1 (**** *) and floorhand 2 (**** *) to finish rigging up the chain to the flare tank (Attachment C – Photograph 6).

Shows the view of the work area from the excavator operator's seat and the approximate position of the workers just prior to the incident.

- #1 Floorhand 1 (***** *)
- #2 Floorhand 2 (**** *)
- #3 Motorman (***** *)
