Investigation Report
Worker Fatally Injured When Pinned by Workpiece
November 17, 2018

This document reports Occupational Health and Safety's investigation of a workplace fatality in November 2018. It begins with a short summary of what happened. The rest of the report covers this same information in greater detail.

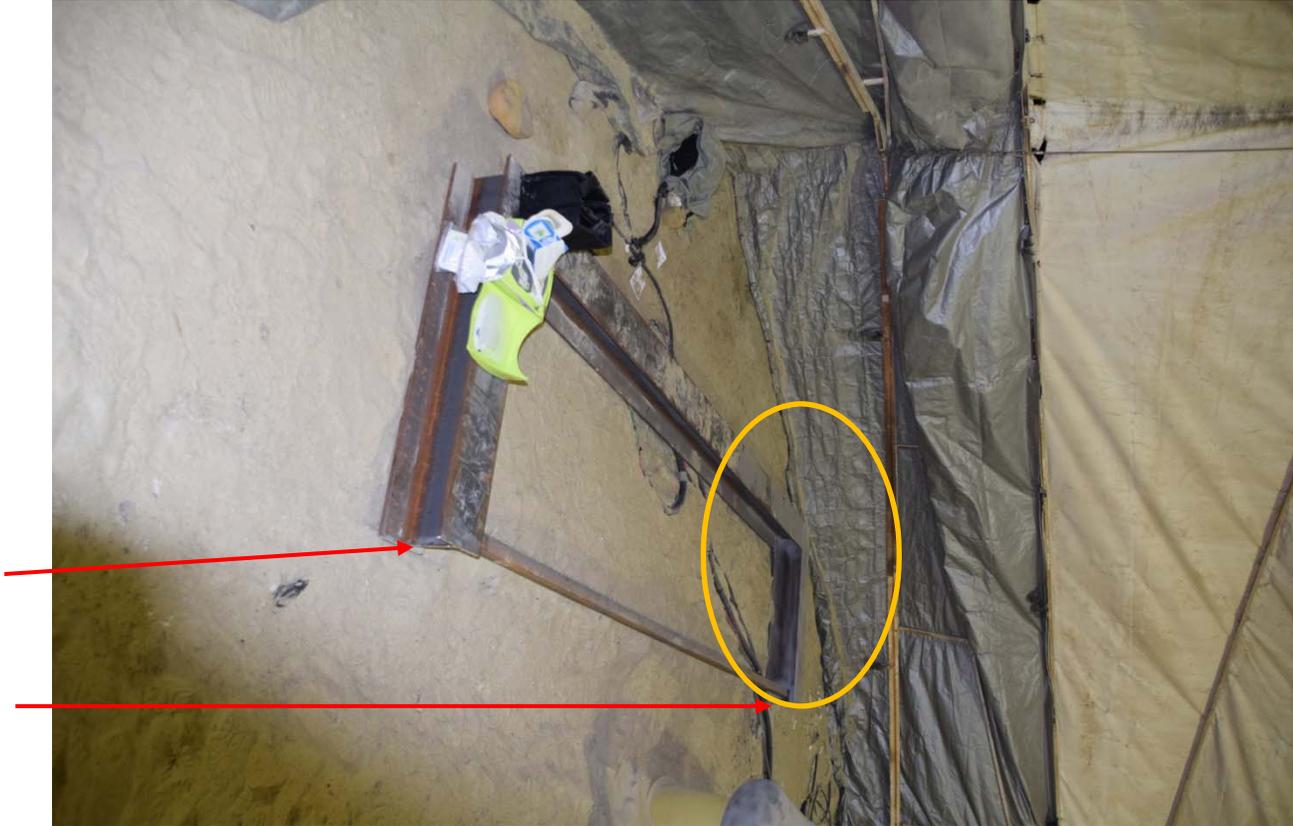
The steel frame section was composed of I-beam sections welded together. The frame was 4.50 metres (m) long and 1.23 m wide. The I-beam sections were 0.20 m by 0.21 m. The approximate weight of the frame section was 399 kilograms (880 pounds).

Figure 3. Frame section lying on ground in sandblasting area. Prior to the incident, the steel frame had been positioned in an upright manner on the ends of the short sections of the frame (indicated by arrows). The area in the circle showed indications of abrasive blasting on the surface.

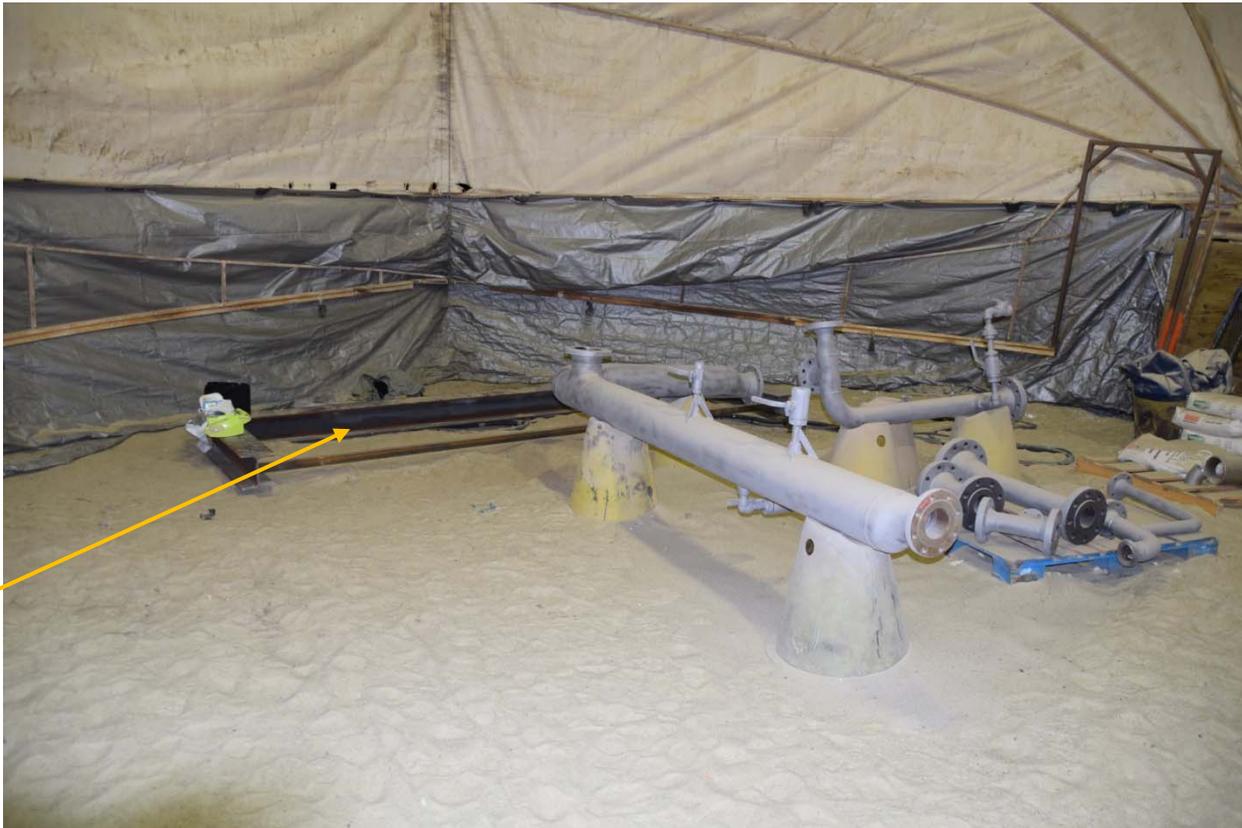
Figure 4. Sandblasting area showing the frame (indicated by arrow) the sandblaster/painter was working on as well as other work pieces supported on stands.
