Asset Assessment Report

Athabasca Healthcare Centre B0985A

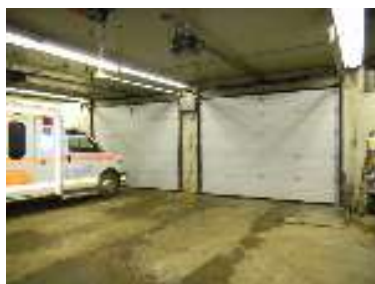
Significant cracking

Existence Yes

Concrete floor is cracked and flaked. There is no drainage system (sump pit), water collects in various areas creating a slip hazard.

Replace ambulance garage floor and install sump pit and pump for drainage.

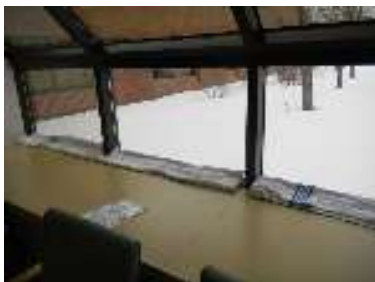
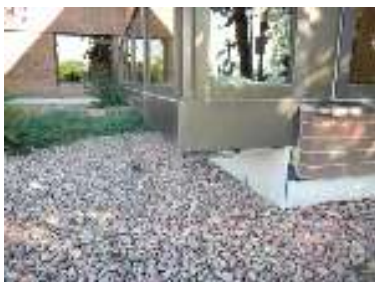
Canopy windows have evidence of leaking. The window units are installed over a cantilever that has inadequate insulation and thermal barrier. During winter months the window units have extensive frost and occupants place blankets on the lower section to prevent cold transfer to the interior space. The cladding below one unit is open exposing the plywood.

Replace canopy window system and ensure adequate insulation below window unit.

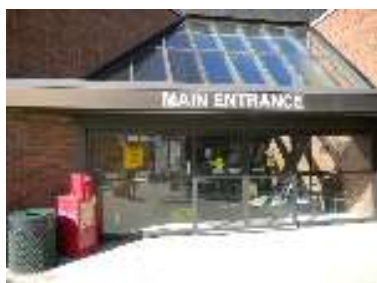
The caulk joints are brittle and loose for skylight glazing at frames.

Replace caulk and seals at affected areas.

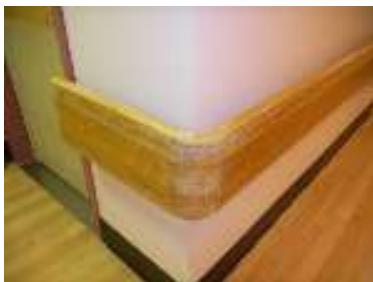
Lacquered surface is worn and pealed. Wood surface is no longer sealed. Areas of railing have splitters which are a safety risk.

Sand and refinish lacquer surface.

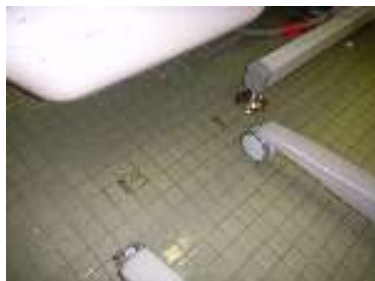
Tile floor is cracked and some tiles missing. Tile is slippery when wet, therefore not a suitable application for tub room.

Remove and replace tile floor with vinyl safety floor.

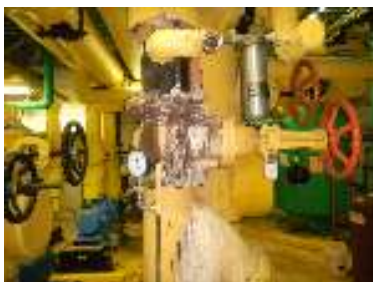
Assessment Criteria **Existence****Leaks or corrosion (ask operator)**

Existence Yes

Replace Grooved Piping/Gasket Fittings and Valves on Heating System.
