Investigation Report

Worker fatally injured after fall from barn roof trusses

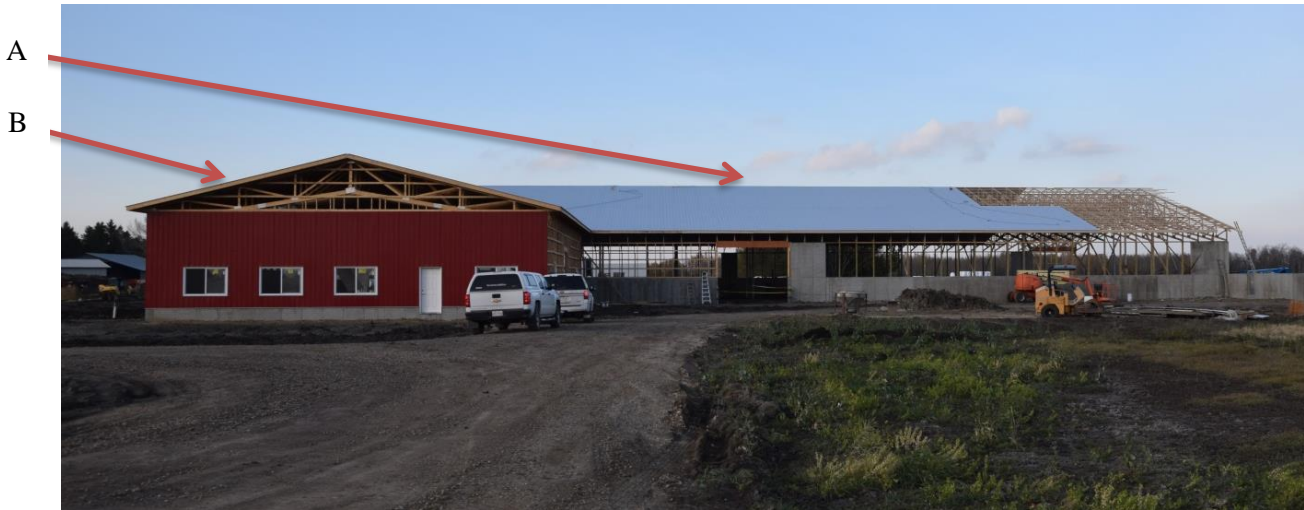
Figure 1. Kozak Holsteins Ltd. dairy barn and milking parlour looking north.

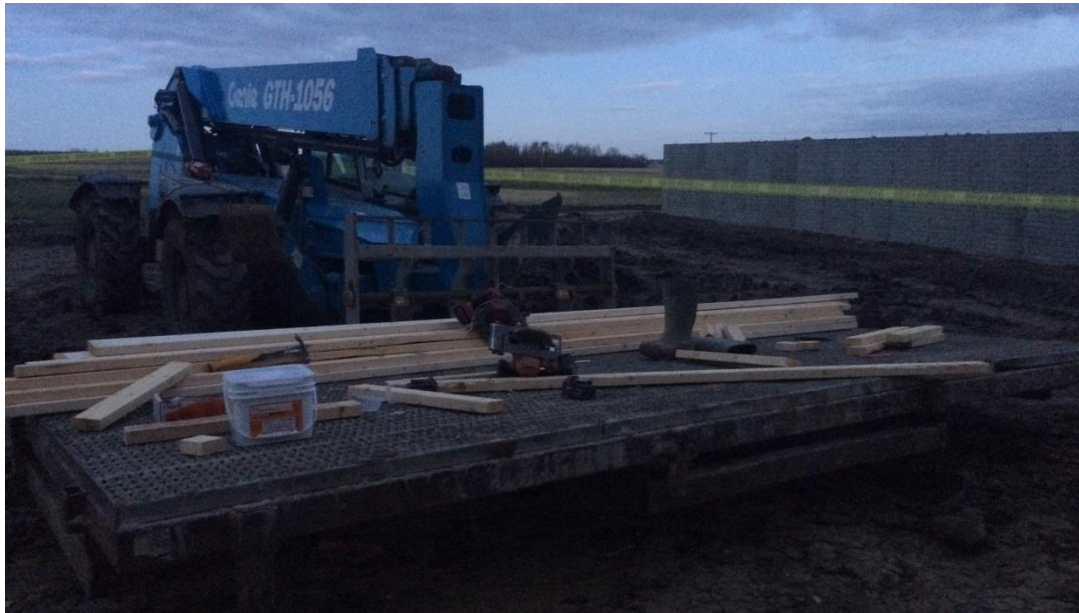
Figure 8. Genie telehandler work platform with tools and materials used to install fascia board on dairy barn.
