**WORKER CRUSHED BETWEEN LOADERS**

Type of Incident: Fatality

Date of Incident: June 13, 2009

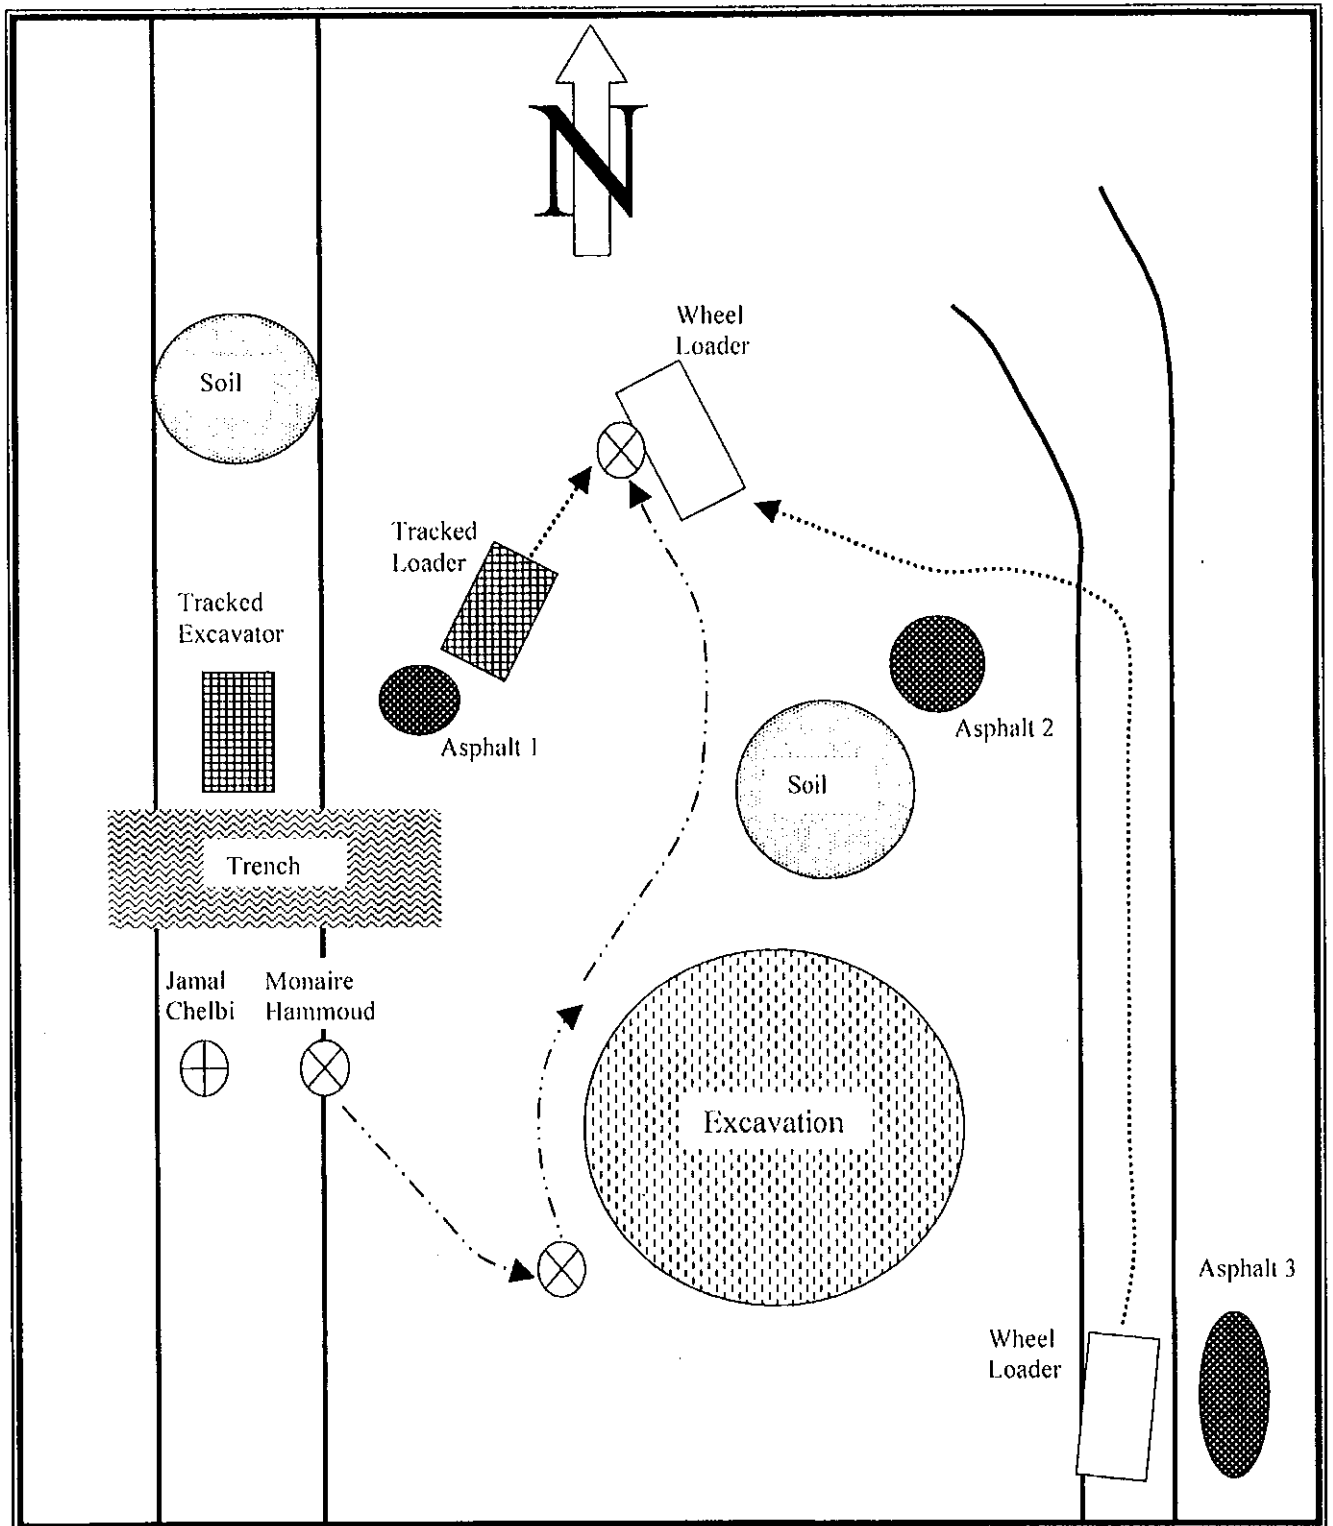
Sketch of the site - not to scale

- 6.1 On June 13, 2009 at approximately 9:00 a.m., the tracked excavator operator ( ) positioned the tracked excavator on the asphalt surface of the 52 Street SE. He scooped up previously cut asphalt and deposited it on the side of the road (Asphalt 1 on the Sketch). After removing asphalt, he began scooping up soil and depositing it on the asphalt surface behind him.

- 6.2 The tracked loader operator ( ) was in the process of picking up the deposited asphalt (Asphalt 1 on the Sketch) and moving to another location (Asphalt 2 in the Sketch). The tracked loader operator ( ) backed away from the asphalt pile whenever the tracked excavator operator ( ) rotated the excavator bucket to unload the excavated material.

- 6.3 The wheel loader operator ( ) was moving the asphalt deposited by the tracked loader (Asphalt 2 in the Sketch) to another location (Asphalt 3 on the Sketch).

- 6.5 At approximately 10:00 a.m., the pipe layer ( ) saw that the wheel loader was near the third asphalt pile (Asphalt 3 on the Sketch) and walked towards the wheel loader waving his arms to get the attention of the operator ( ). The operator ( ) did not notice the pipe layer ( ) and started moving the wheel loader towards the second asphalt pile (Asphalt 2 on the Sketch).

- 6.6 The pipe layer ( ) walked back towards the second asphalt pile (Asphalt 2 on the Sketch). When the wheel loader was near the second asphalt pile, the operator ( ) noticed the pipe layer ( ). The pipe layer ( ) signaled the wheel loader operator ( ) to bring the wheel loader towards him.

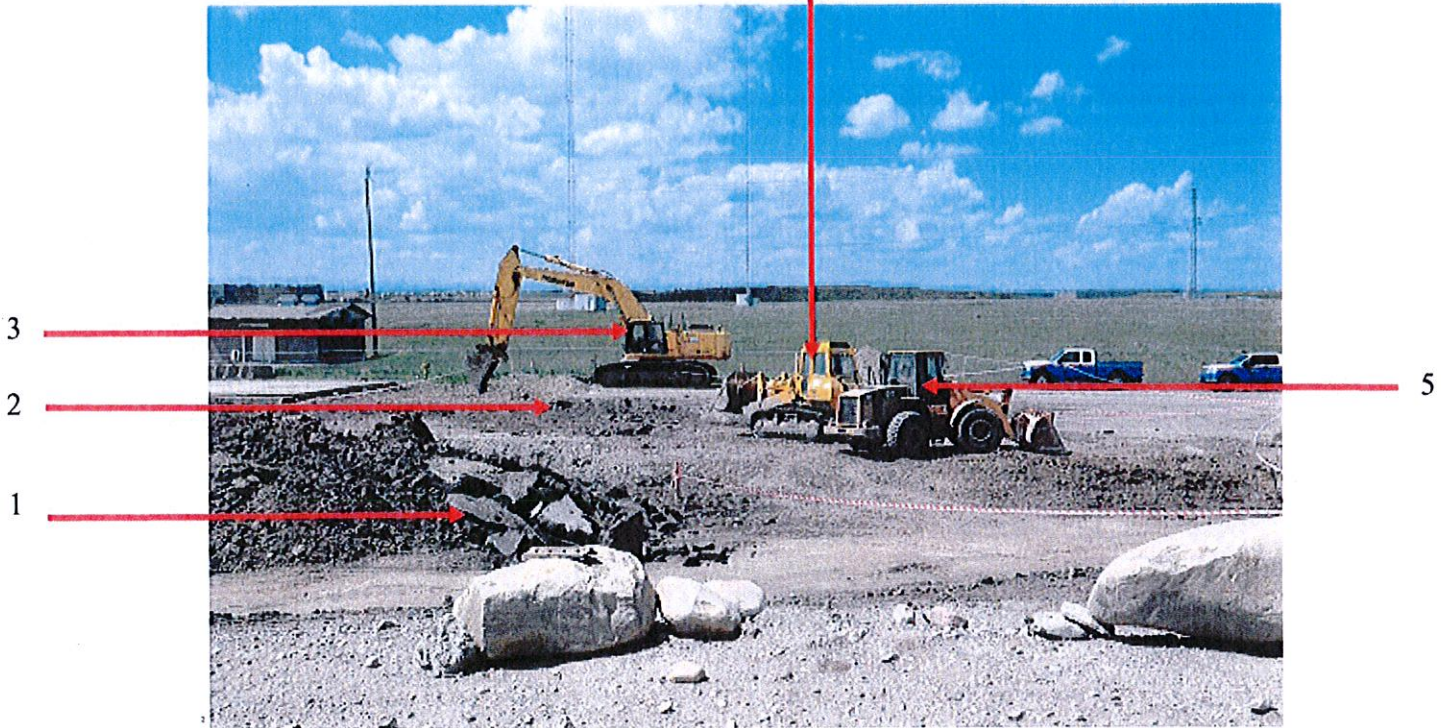
Photograph 1: Shows view of the site of incident.

- 1 Shows asphalt deposited by the tracked loader (Asphalt 2)
- 2 Shows the location where excavator deposited asphalt (Asphalt 1)
- 3 Shows the tracked excavator
- 4 Shows the tracked loader
- 5 Shows the wheel loader

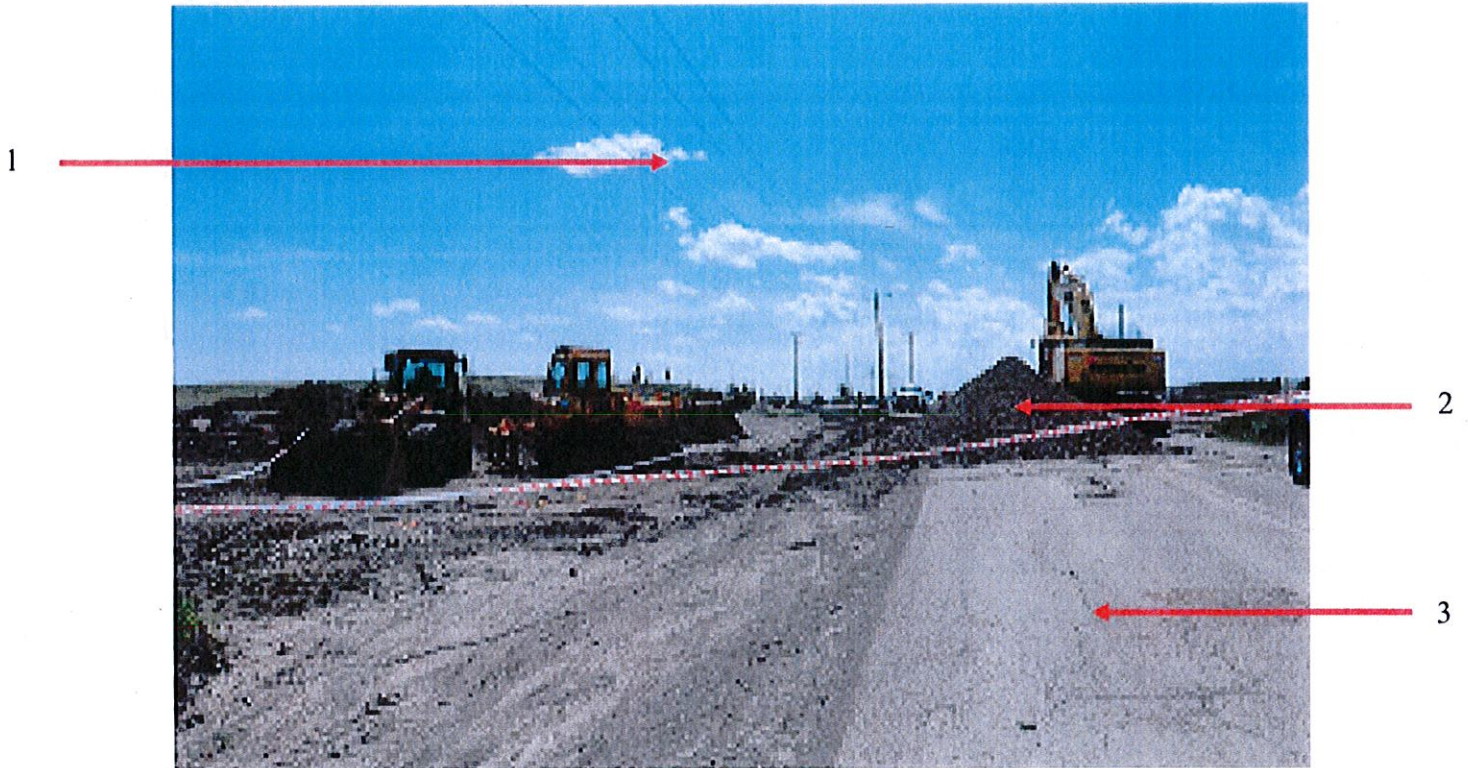
Photograph 2: Shows the view of the site of incident.

- 1 Shows the overhead power lines
- 2 Shows the pile of soil deposited by the tracked excavator
- 3 Shows 52 Street SE, Calgary

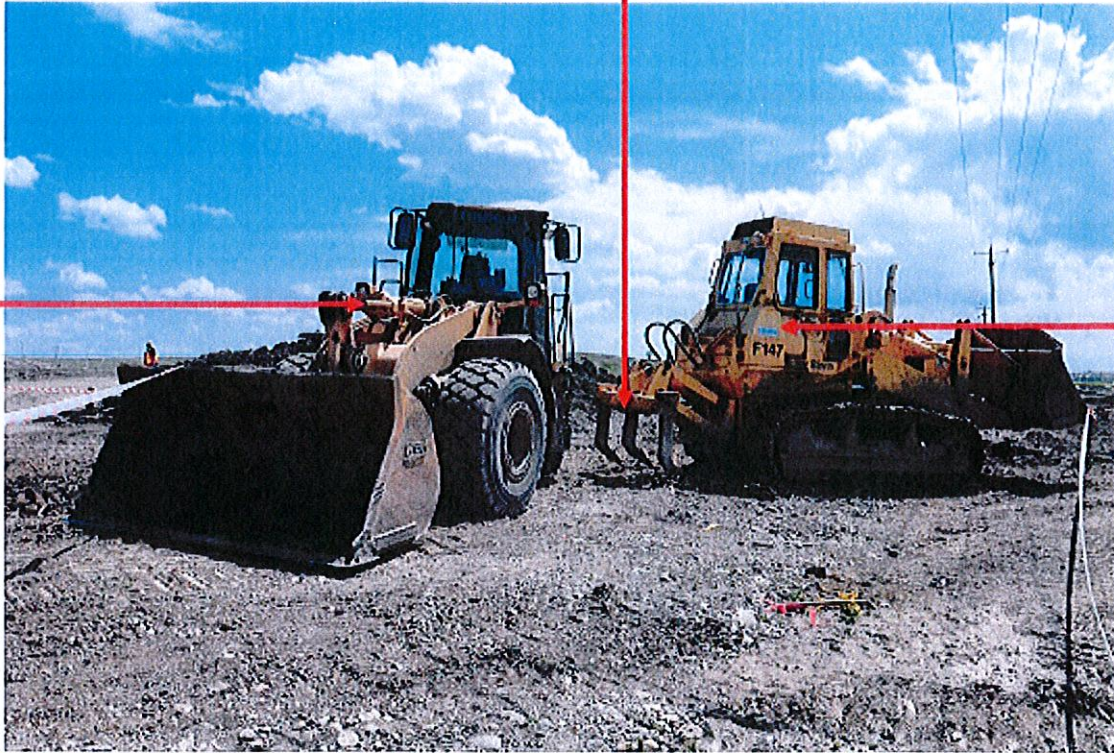
- 5.1.1 The tracked loader involved in the incident was 2003 Komatsu, D 75S – 5 Dozer Shovel, unit # 147 with the serial number 166632. A ripper was attached to the back of the loader (Refer to Attachment C - Photographs 3 and 4).
- 5.1.2 The second wheel loader involved in the incident was a 2002 Caterpillar, 950 G Series II, unit # F 127 with a serial number 15731.
- 5.1.3 At the time of the incident, a 600 Komatsu tracked excavator was also on the 52 Street SE.

Photograph 3: Close up view of the two loaders involved in the incident.

- 1 Shows the wheel loader
- 2 Shows the ripper attached to the back of the tracked loader
- 3 Shows the tracked loader

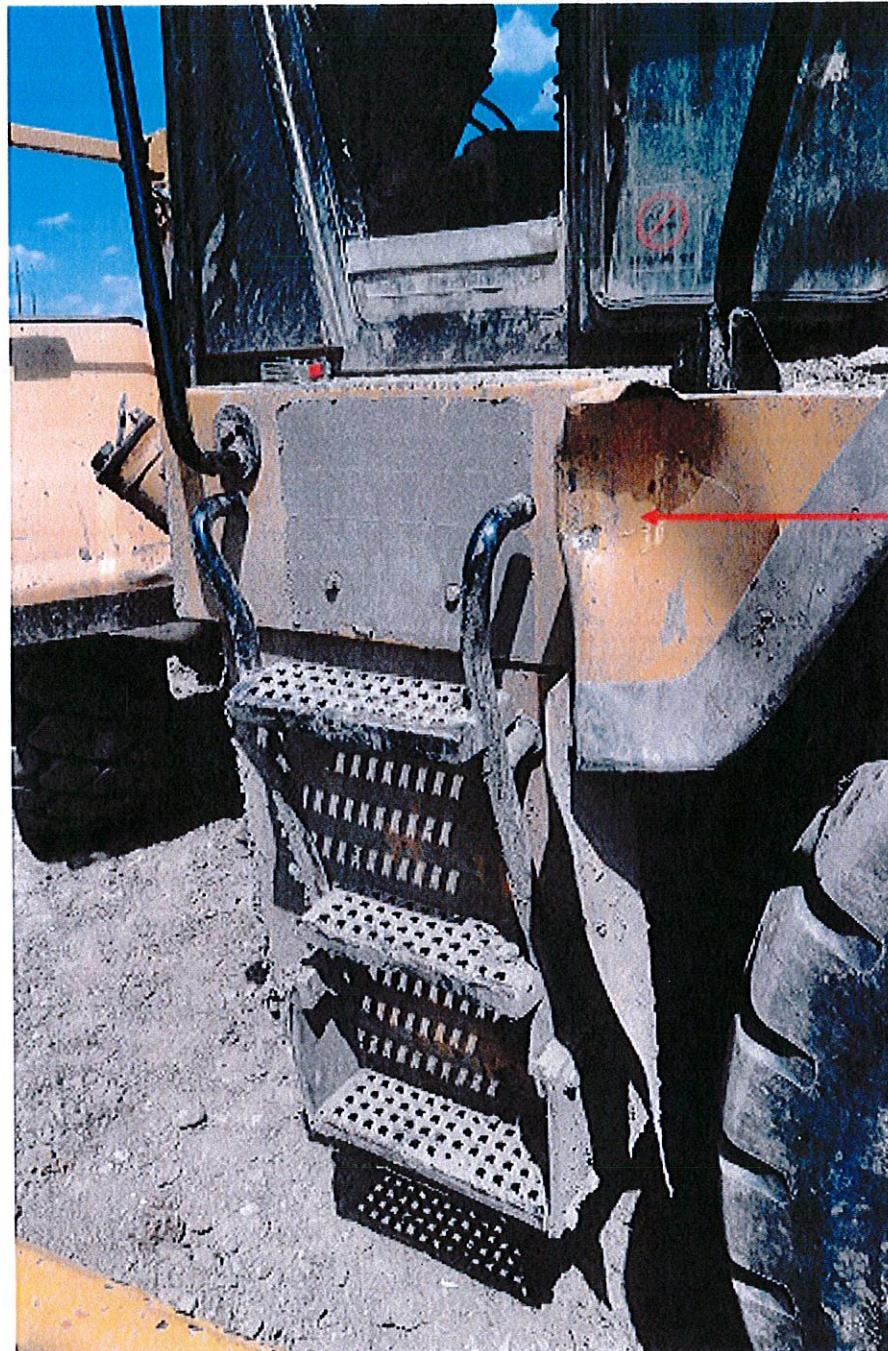
- 6.8 The tracked loader operator ( ), backed his tracked loader up and struck the access ladder area of the wheel loader. The pipe layer ( ) was crushed between the two machines. The tracked loader operator ( ) immediately moved his machine forward and the pipe layer ( ) fell to the ground.

- 7.1.1 The pipe layer [redacted] was crushed between the tracked loader and the wheel loader when the tracked loader operator ([redacted]) backed up his machine.

Photograph 4: Shows the side and ladder area of the wheel loader where the tracked loader backed into it

Arrows shows the dent caused by the collision
