**Worker Crushed by Equipment**

Type of Incident: Fatality

Date of Incident: September 27, 2011

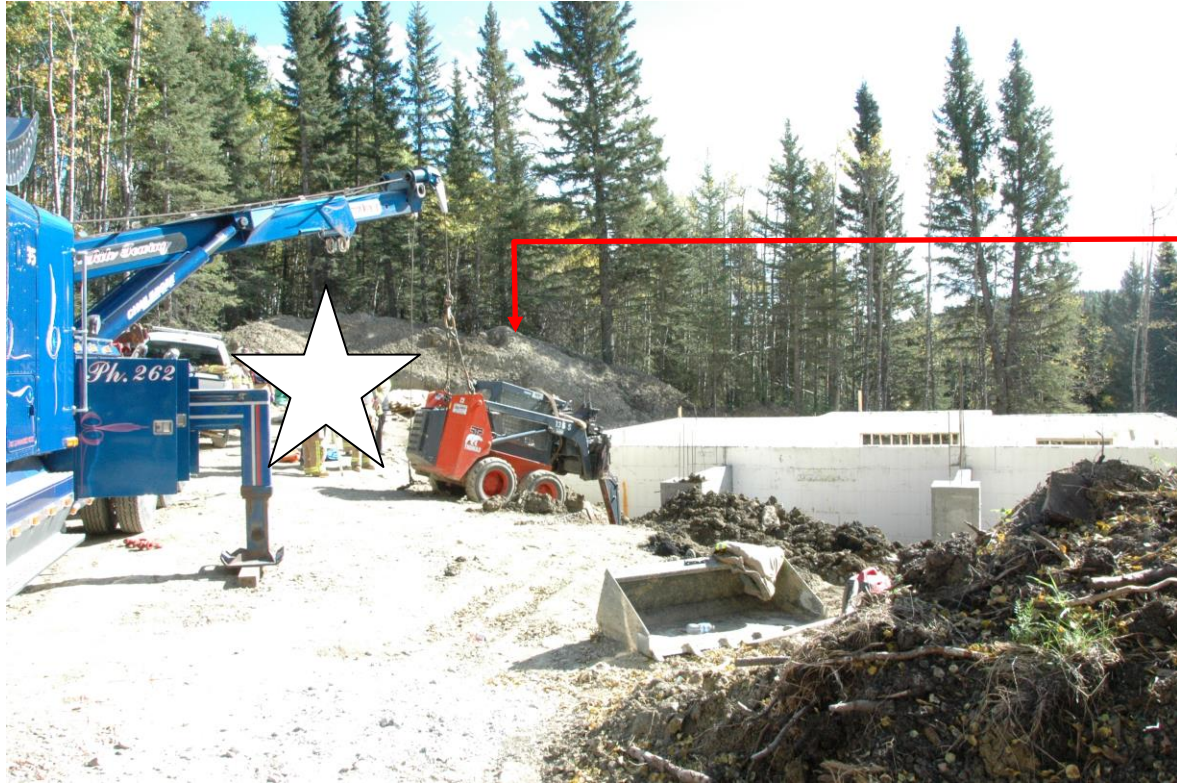
- 4.1 The incident occurred at a residential construction site located at \*\*\*\*\* \*\*\*, W, Millarville, Alberta, see Attachment A – Map, Attachment B – Photograph 1.

**Photograph 1** – Shows the incident scene looking south/southeast.

1. Shows the skid steer involved in the incident.

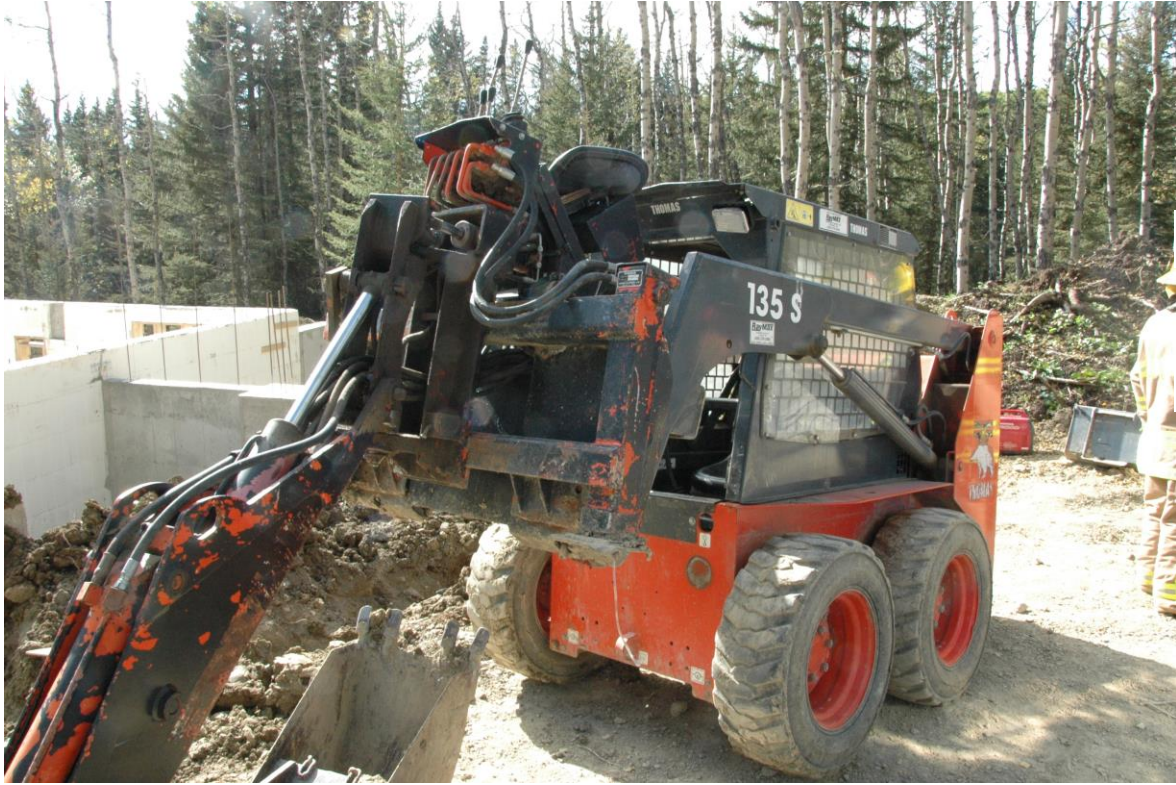
- 5.1.1 1999 Thomas Equipment Skid Steer Loader Model A902/T135S, S/N \*\*\*\*\* (Skid Steer). See Attachment B – Photograph 2. The skid steer was owned by Trendsetter.
- 5.1.2 Thomas Backhoe Attachment Model BH108704, S/N \*\*\*\*\* (Backhoe) When the backhoe attachment is in use, the operator sits on a seat that is outside of the skid steer cab. See Attachment B – Photograph 3. The backhoe attachment was owned by Trendsetter.

**Photograph 2** – Shows the backhoe attachment and skid steer.

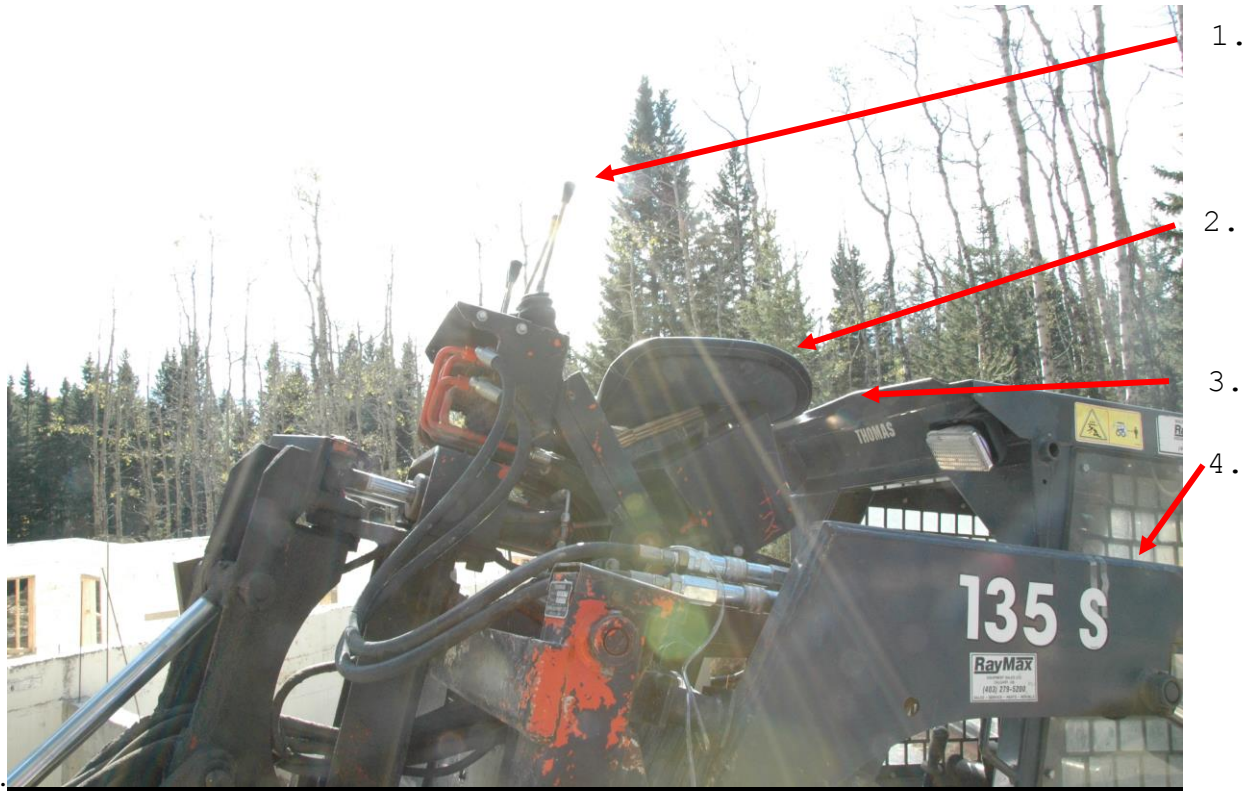
**Photograph 3** – Shows backhoe controls, seat and top of skid steer cab.

1. Shows the backhoe controls.
2. Shows the backhoe seat.
3. Shows the roof of the skid steer cab.
4. Shows the left lift arm.

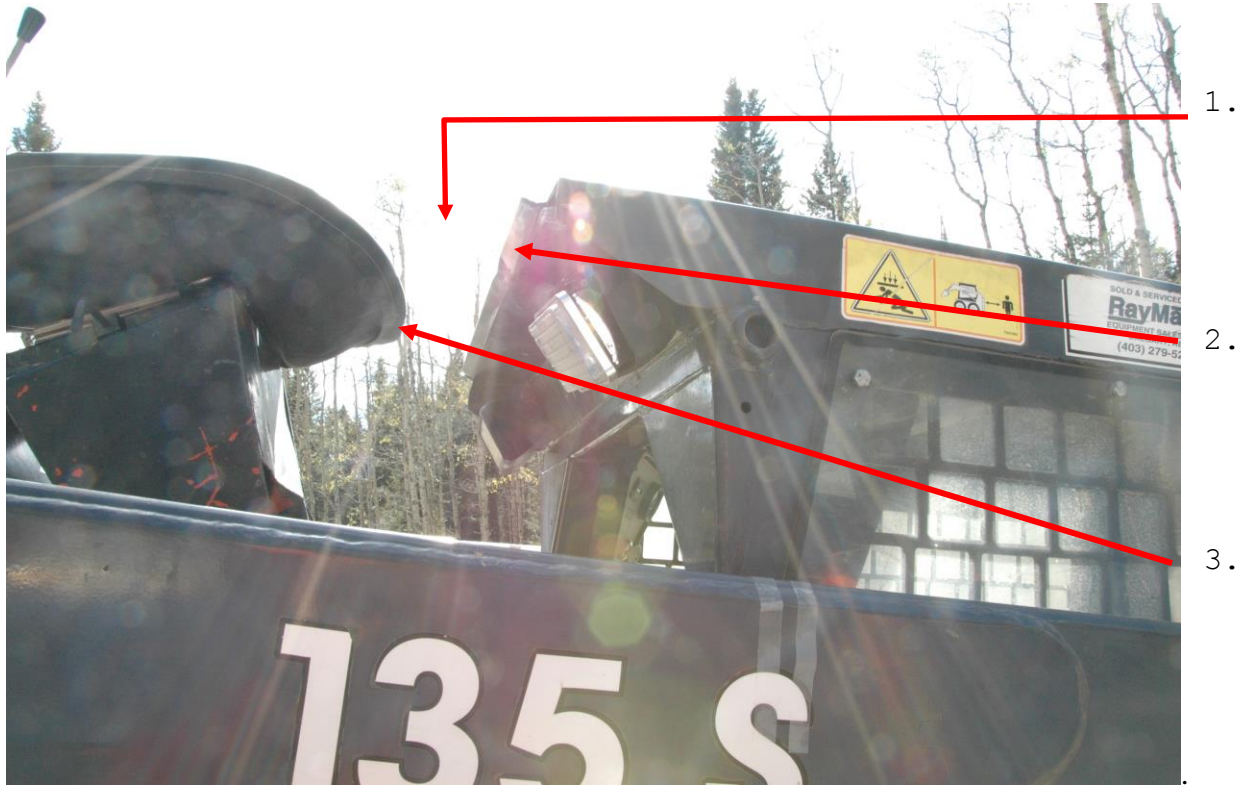
- 6.6 At approximately 11:15 a.m., Workers 2 and 3 (\*\*\*\*\* and \*\*\*\*\* heard Worker 1 (\*\*\*\*\* make a loud, distressed noise. Workers 2 and 3 (\*\*\*\*\* and \*\*\*\*\* ran to the skid steer and found Worker 1 (\*\*\*\*\* with his head and upper torso pinned between the seat of the backhoe attachment and the cab of the skid steer, with his right foot on the backhoe attachment plate and his left foot inside the cab. See Attachment B – Photograph 4.

- 7.1.1 The worker received critical injuries when he was pinned between the roof of the skid steer cab and the backhoe seat.

**Photograph 4** – Shows the approximate location of the worker.

1. Shows the approximate location where the worker became pinned.
2. Shows the roof of the skid steer cab.
3. Shows the backhoe seat.

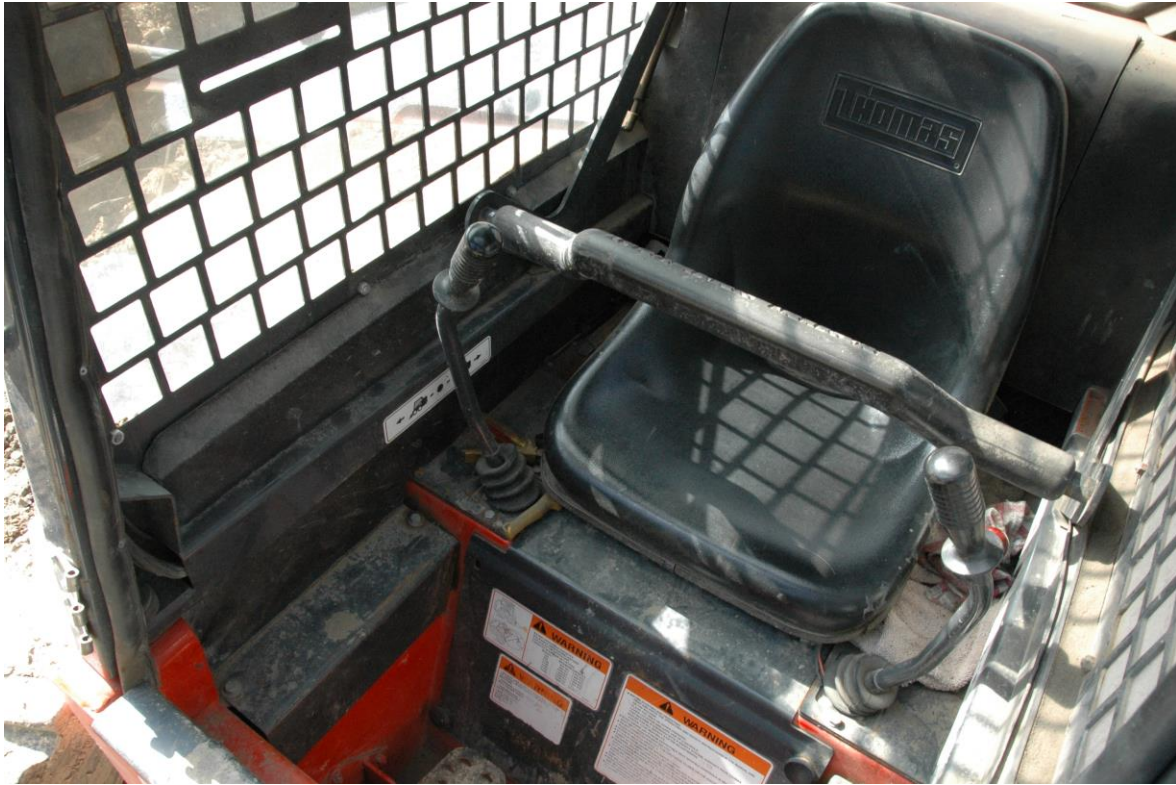
- 5.2.4 The skid steer was facing approximately South perpendicular to a shallow trench with the bucket and dipper arm on the ground. The skid steer was facing downwards approximately 20 degrees.
- 5.2.5 The safety bar in the skid steer was in the down position. When in the down position, the safety bar releases the parking brake and the hydraulic controls of the lift and tilt circuits.

**Photograph 5** – Shows the seat bar in the down position.
