RECAPP Facility Evaluation Report

St. Joseph's General Hospital

B1175A
Vegreville

Evaluation Company: PBK Architects
Evaluation Date: October 26 2011
Evaluator Name: Len O'Connor

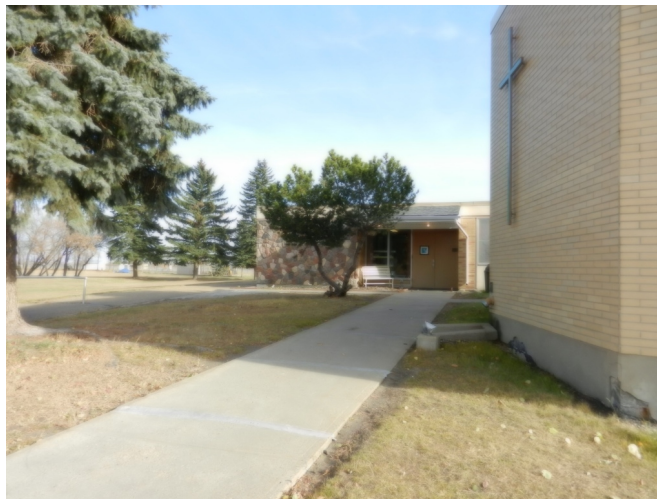
B1175A_DSCN4961.JPG

Site Summary: This building site has both hard and soft landscaping, The hard surfaces include concrete sidewalks, and gravel and asphalt paved parking and roadway areas. The soft areas are covered with grass, landscaping beds and shale transition areas. There are mature trees, and shrubs.
