**CONSTRUCTION FOREMAN KILLED
IN MOTOR VEHICLE COLLISION**

Type of Incident: Fatality

Date of Incident: July 21, 2010

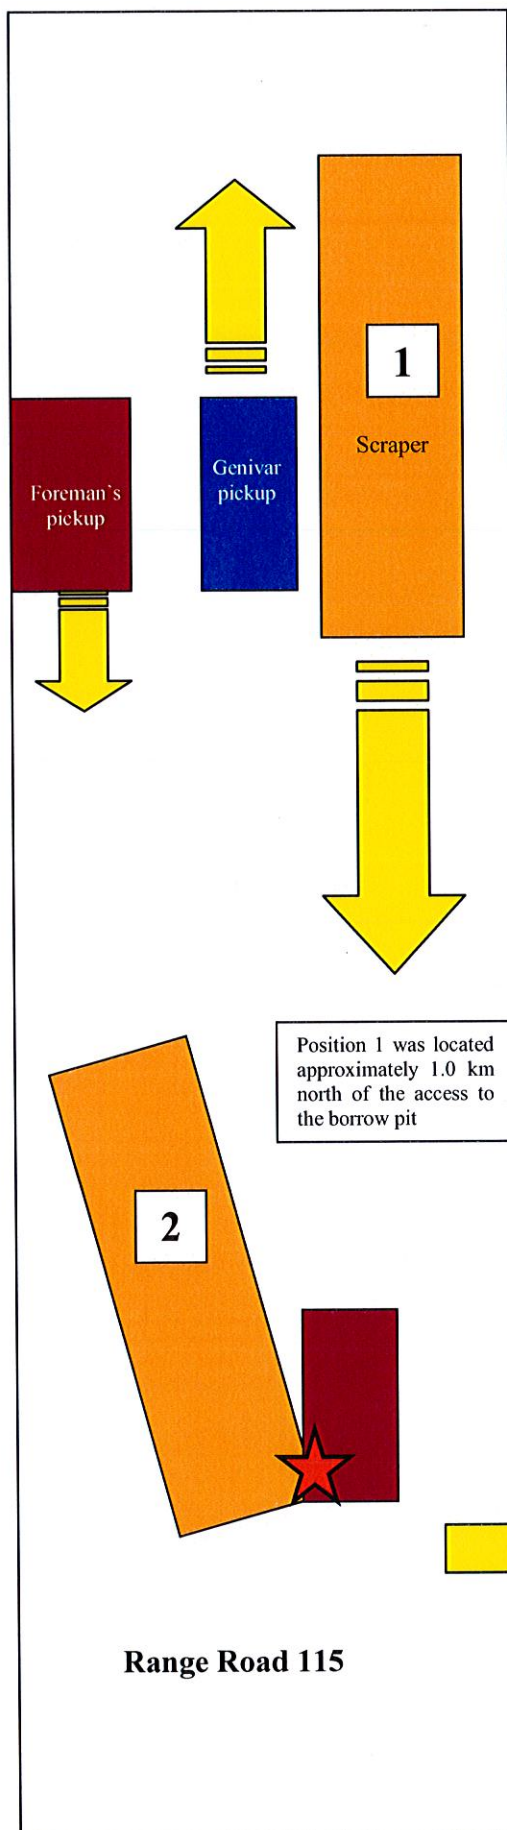
Diagram 1

- 6.3 The Project Manager () and the Foreman () had a brief discussion while they were both sitting in their parked pickup trucks. The Foreman () mentioned that clay material was needed for a culvert installation. They observed the Equipment Operator () drive by with the scraper heading south on Range Road 115. The Project Manager () said the Foreman () mentioned that the Equipment Operator was going to get another load of clay material from borrow pit # 2. Approximately 10 seconds after the scraper went by, the Driver () and the Foreman () continued travelling south on Range Road 115 and the Project Manager () proceeded north (Attachment B, Diagram 1).

This shows the approximate position of the equipment and pickups involved in this incident. The scraper is identified in orange and position 1 shows the scraper traveling south approximately 1.0 km past the two pickups shown in maroon and blue.

As the Equipment Operator () was in the process of turning the scraper left into the borrow pit access (position 2), the maroon pickup owned by the Foreman () and driven by the Driver () tried to pass the scraper (position 2) and collided with it.

The yellow arrows show the direction of travel. The red star shows the area of impact on the passenger side of the maroon pickup where the Foreman () had been sitting.

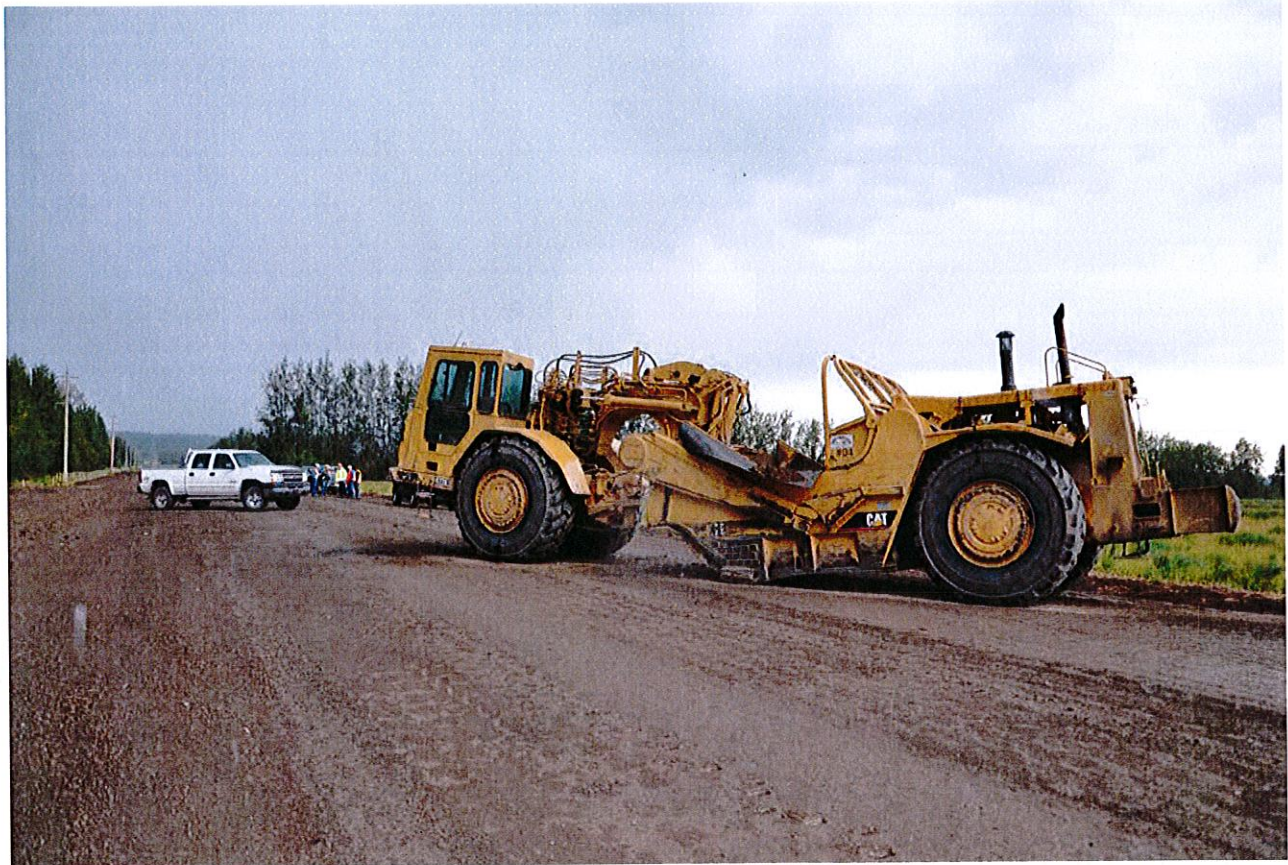
Photograph 1

5.1.1 Wheel Tractor-Scraper (Attachment C, Photograph 1)

Shows the Caterpillar wheel tractor-scraper owned by Ken Wilson Contracting Ltd. and operated by 754421 Alberta Ltd.

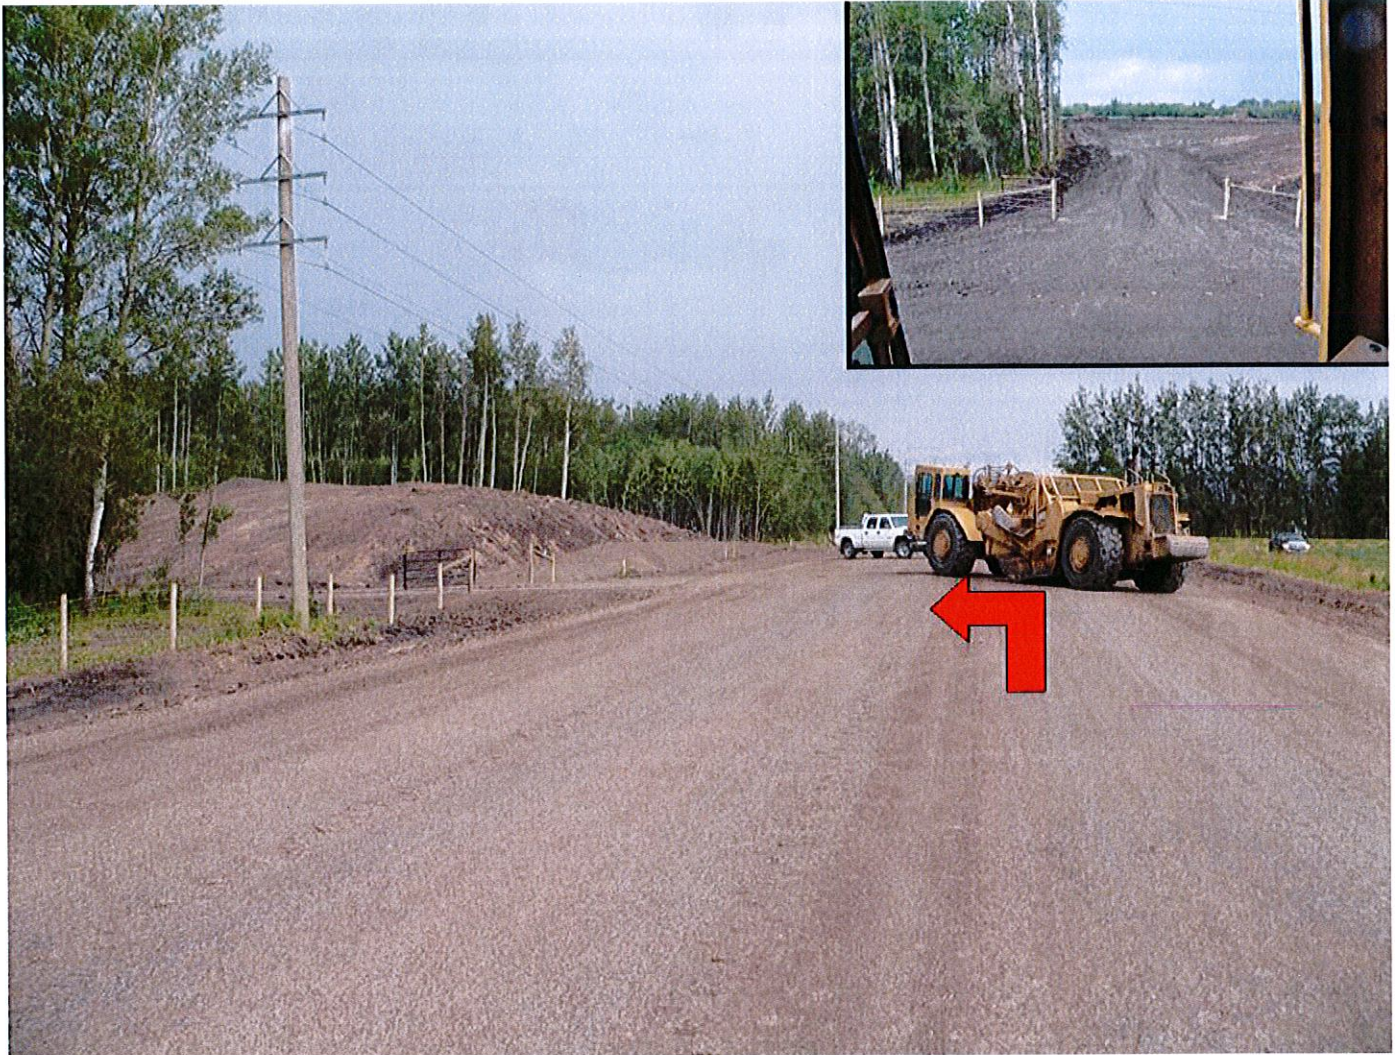
Photograph 2

- 6.4 As the Equipment Operator () approached the access to the borrow pit he started to slow down to make the left hand turn into the borrow site. Just before the Equipment Operator () was about to make the left hand turn, he checked over his right shoulder and did not see any vehicles behind him (Attachment C, Photograph 2).

Shows Range Road 115 looking south. The red arrow shows where the access road to the borrow pit was located and where the Equipment Operator was turning. The insert in the top right hand corner shows the east view from the operator's seat in the scraper looking into the borrow pit area.

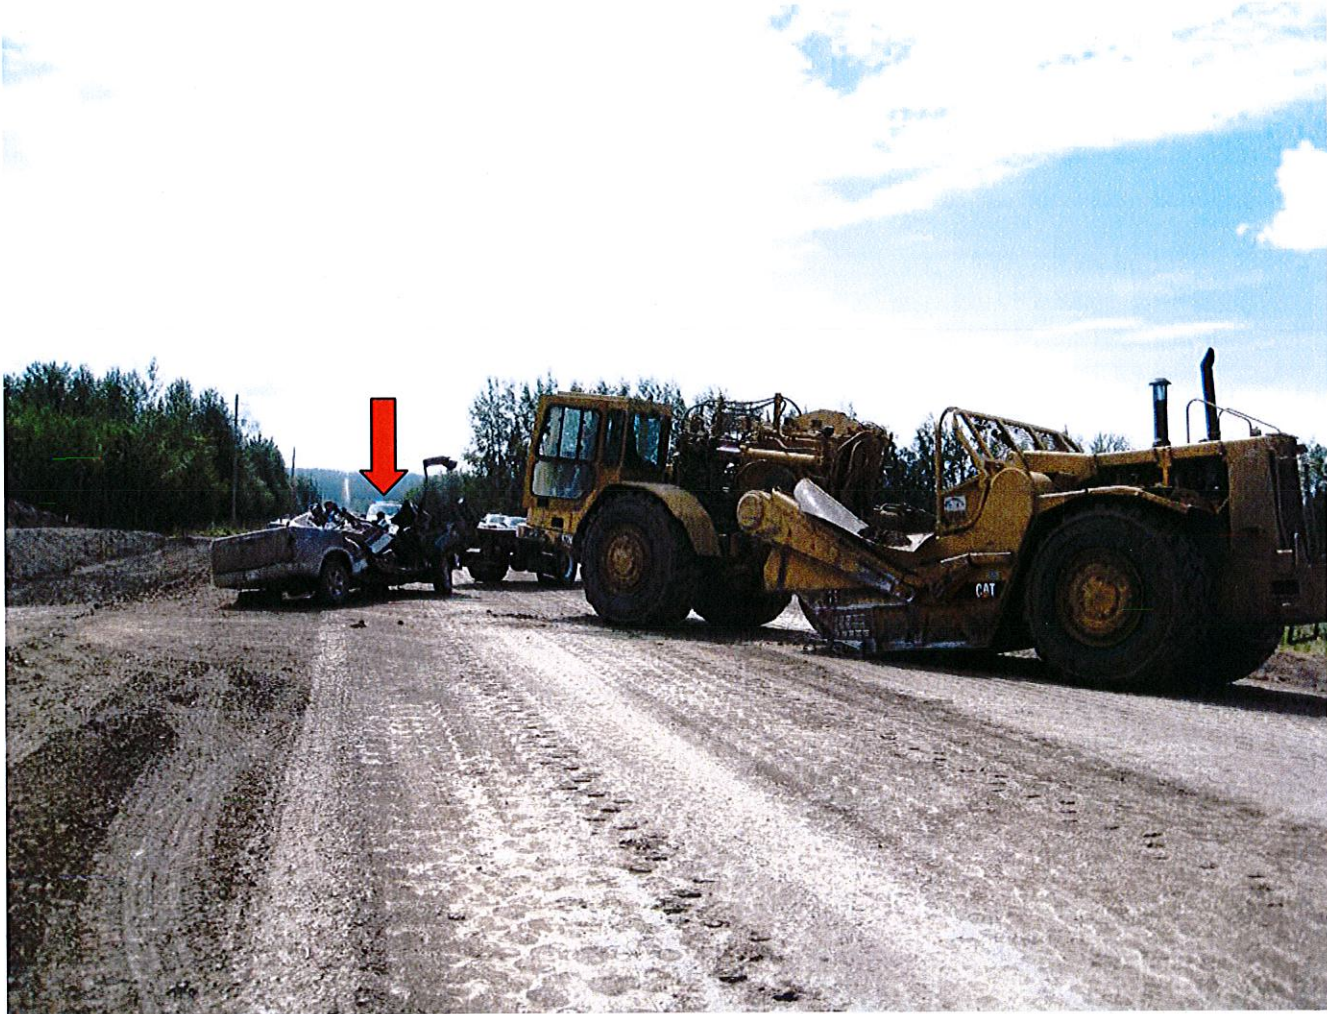
- 6.6 The Foreman's () pickup was crushed under the front left side of the scraper and the Foreman () was trapped inside the pickup on the passenger side. The Equipment Operator () backed the scraper off the pickup truck and radioed for help (Attachment C, Photograph 3).
- 6.7 Emergency Services arrived at the scene of the incident and extracted the Foreman () from the pickup. The Driver () was not seriously injured and refused to seek medical treatment. The Foreman () succumbed to his injuries later that day in hospital.

Photograph 3
Shows the Foreman's _____ truck after it had collided with the front left side of the scraper.
The area of impact was directly to the passenger side of the pickup truck.

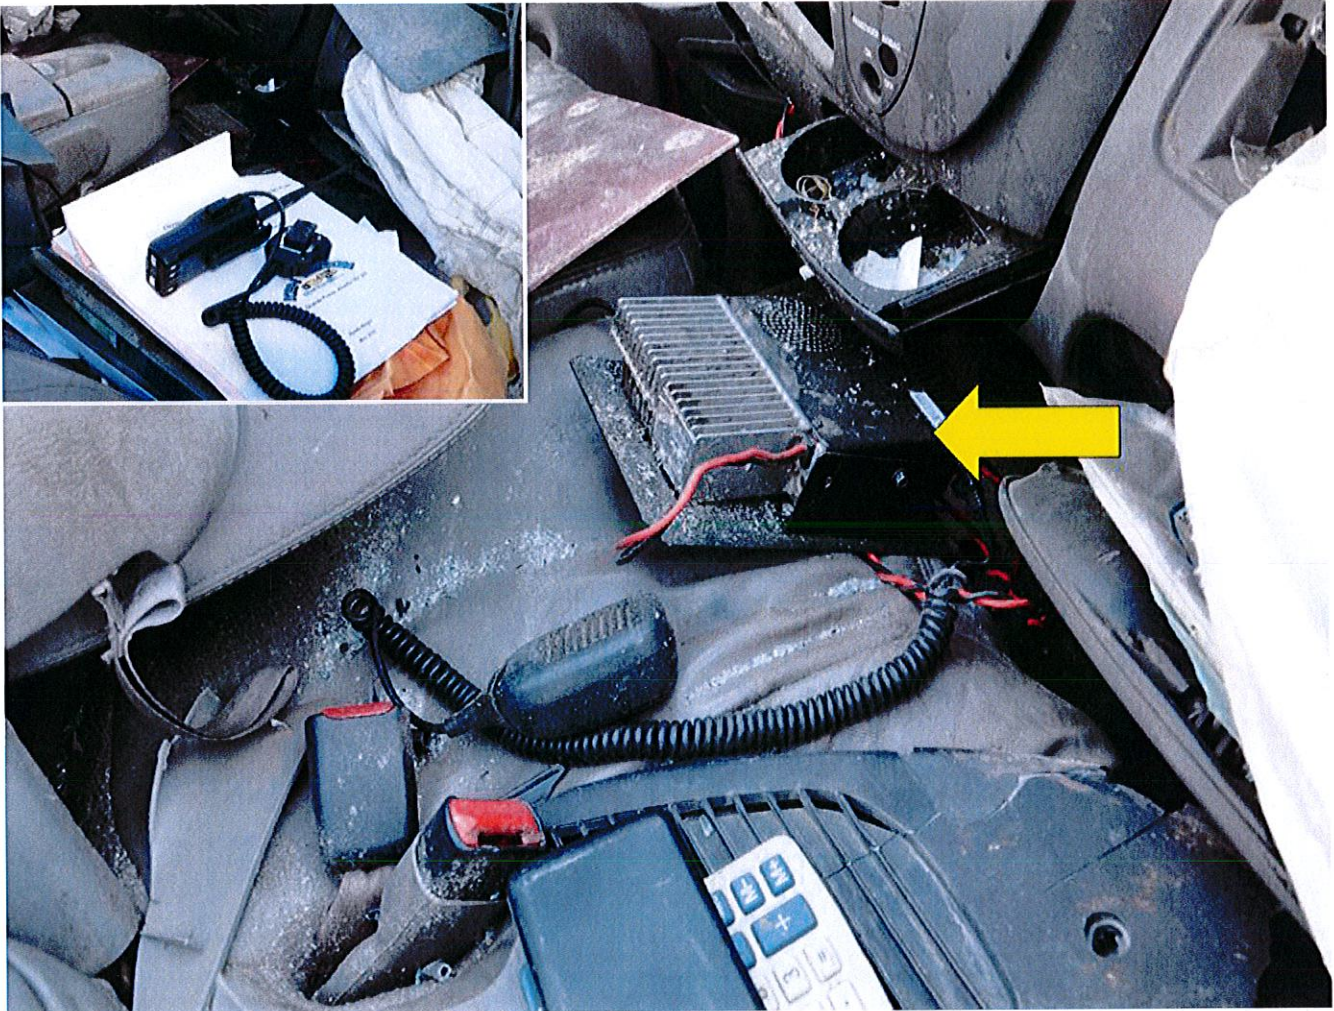
Photograph 4

- 7.2.1 Neither the Driver () or the Foreman () used the two-way radio to inform the Equipment Operator (Ingham Harding) their intention to pass the scraper (Attachment C, Photograph 4).

Shows the two-way mounted radio inside the Foreman's () pickup. The insert in the top left shows a handheld two-way radio that was also found inside the Foreman's pickup.

- 8.2.2 Ken Wilson Contracting Ltd. amended the protocol on the use of radios to include light vehicles and the safety rules of the road were reviewed with all crews. At the request of N.P.A. Ltd. operating as Wapiti Gravel Suppliers, Ken Wilson Contracting Ltd. positioned flag persons where there was heavy equipment crossing, exiting or entering the roadway. The scraper was inspected and repaired as required.
