**FLOORHAND STRUCK BY ROTATING
DRILLING EQUIPMENT**

Type of Incident: Fatality

Date of Incident: December 12, 2010

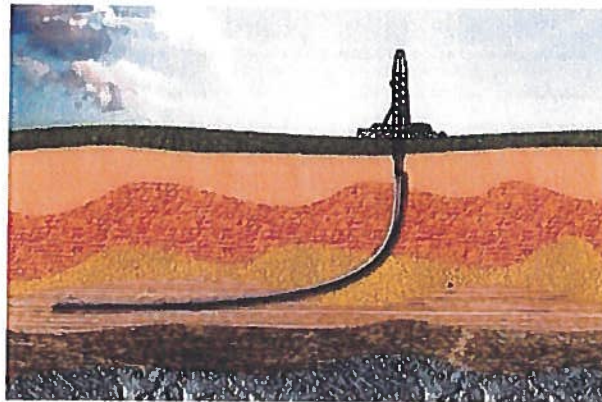
Diagram 1 – Directional or Slant Drilling

5.1.1.2 Conventional drilling rigs were traditionally used for drilling vertical bore holes. With modifications to the bottom hole assembly, conventional drilling rigs have been adapted to drill directional well bores (Attachment B, Diagram 1). Downhole mud motors with a bent housing use hydraulic power from the circulating drilling mud to rotate the drill bit without having to rotate the entire drill string from the surface. This process is known as slide drilling and causes the bit to drill at an angle off the vertical. Once the desired angle is achieved, then the entire drill string is rotated from surface and the drill bit drills straight by conventional drilling means.

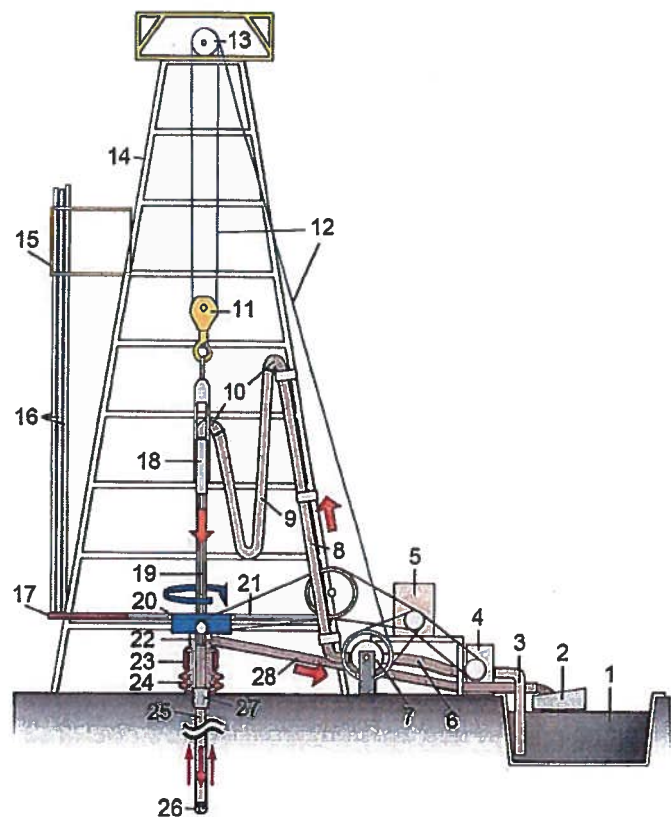
Diagram 2 – Conventional Rotary Drilling Rig Components

5.1.1.3 Part of the mechanical drilling process with a conventional drilling rig is accomplished by a rotating system that is made up of the following equipment: rotary table, kelly drive, swivel and drill string (Attachment B, Diagram 2). The rotary table provides the initial rotational movement which is transmitted to the square or hexagonal shaped kelly drive. The kelly drive then transmits the rotation to the drill string as it is attached to it by a threaded connection. The swivel allows the kelly drive and drill string to rotate without rotating the hook or other equipment. This process transmits the rotation to a drill bit which bores the hole.

- 7.2.3 The Driller [REDACTED], missed a step in the tripping out process by not disengaging the rotary table brake to release the trapped torque in the drill string. There was no means on the control panel to warn the Driller [REDACTED] that there was trapped torque in the drill string. The Pason digital screen would not have shown any torque at the time the Driller [REDACTED] engaged the hoisting clutch since the torque reading would have cleared to zero when Driller [REDACTED] stopped the rotation of the rotary table (Attachment B, Diagram 2).

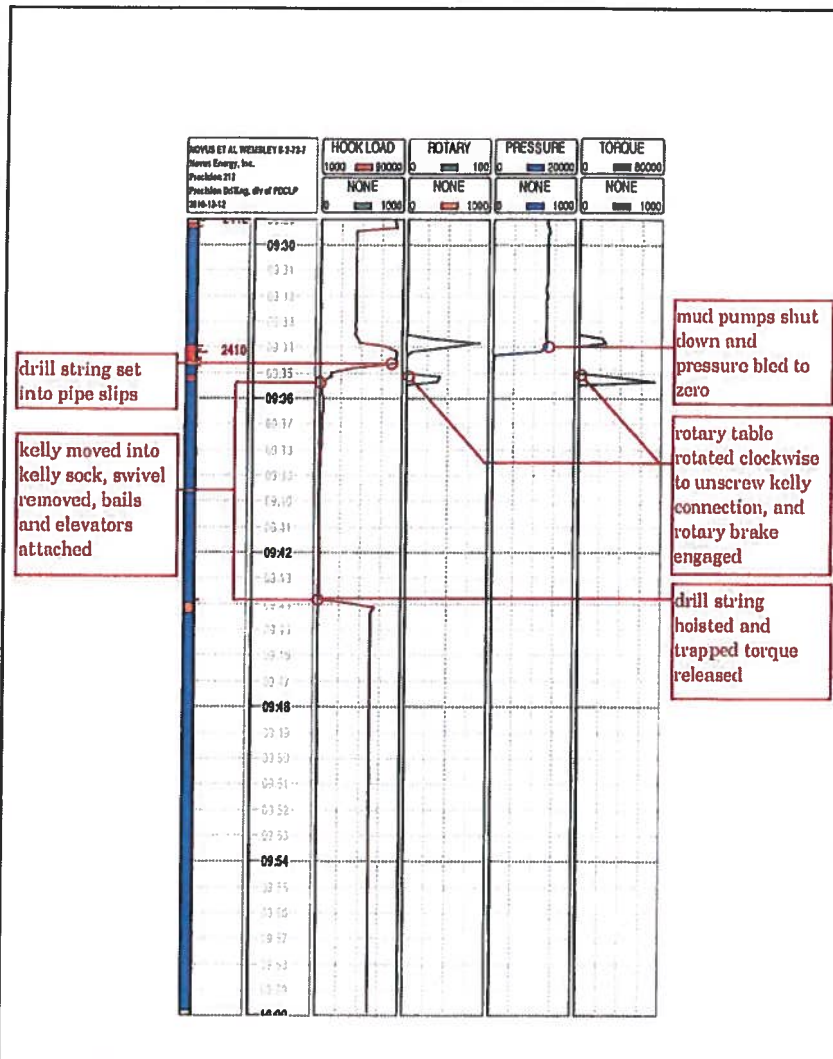
Diagram 3

Shows the Pason data extracted from the Novus Energy Inc.'s drilling operations around the time of the incident. The data shows that the Driller engaged the rotary table to unscrew the pipe from the kelly sub at 9:35 a.m. At that time, the torque reading peaked at 73,075 ft-lbs., then cleared to zero once the rotary table brake was engaged just before 9:36 a.m. At 9:44 a.m., the Driller engaged the hoisting clutch, lifted the pipe and the trapped torque was released from the drill string.

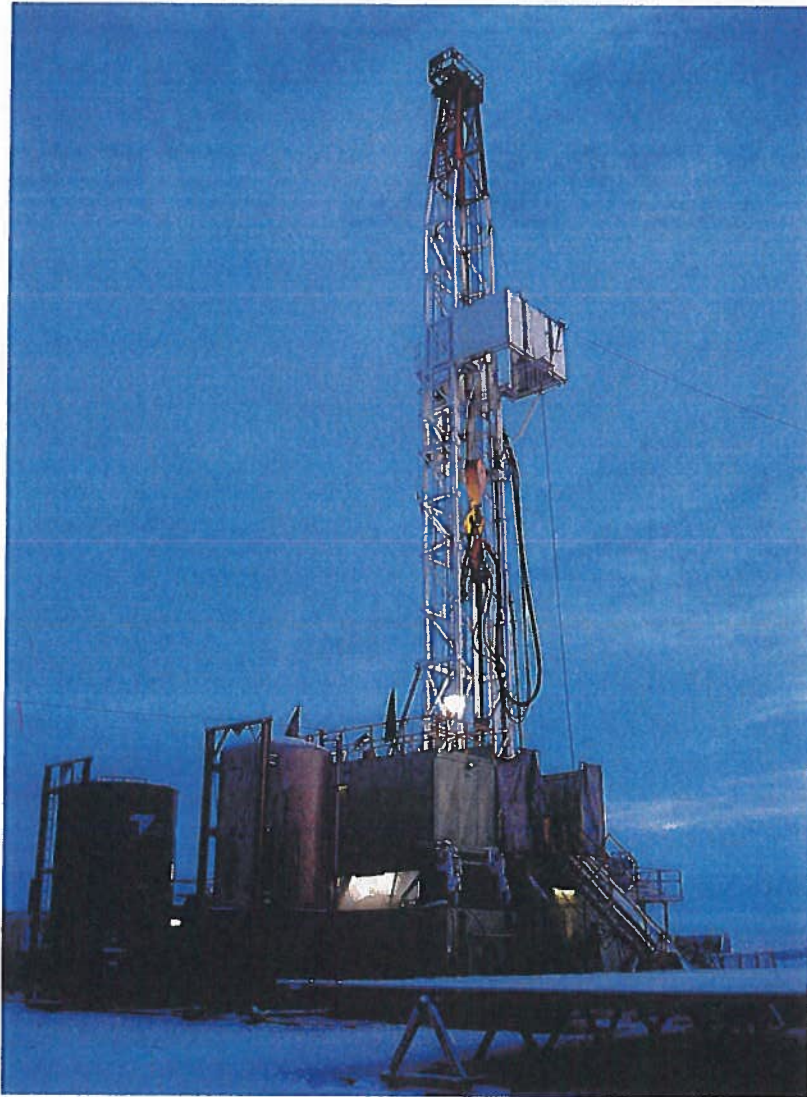
5.1.1 Double Telescopic Drilling Rig 212 (Attachment C, Photograph 1)

Photograph 1
Shows Precision Drilling Corporation's double telescopic conventional drilling rig # 212. This photograph was provided by Precision Drilling Corporation and was taken on Dec. 13, 2010.

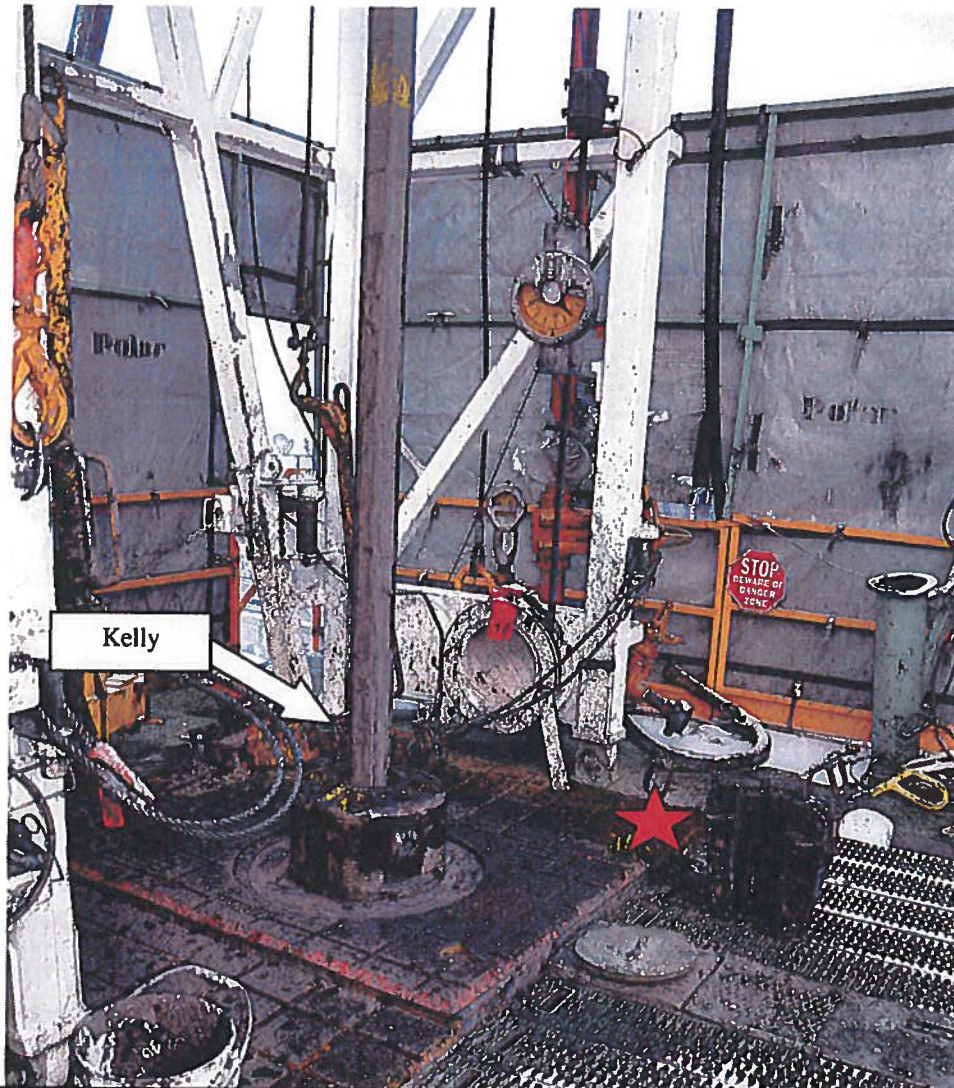
Photograph 2

- 5.2.1 Occupational Health and Safety (OHS) Investigators arrived on the Novus Energy Inc. work site at 1:00 p.m. on Dec. 12, 2010.
- 5.2.2 Precision Drilling Corporation's Rig Manager [REDACTED] informed OHS Investigators that following the incident, the well had to be secured and the immediate scene was disturbed to protect workers and the well. To do this, the drilling crew put the kelly back onto the drill string and secured the well (Attachment C, Photograph 2).

Shows the scene of the incident observed by Occupational Health and Safety Investigators upon arrival at the worksite on Dec. 12, 2010. The area shown is the rig floor on Precision Drilling Corporation's drilling rig #212. The Kelly had been placed back onto the drill string to secure the well. The red star shows where the Floorhand [REDACTED] was located immediately following the incident.

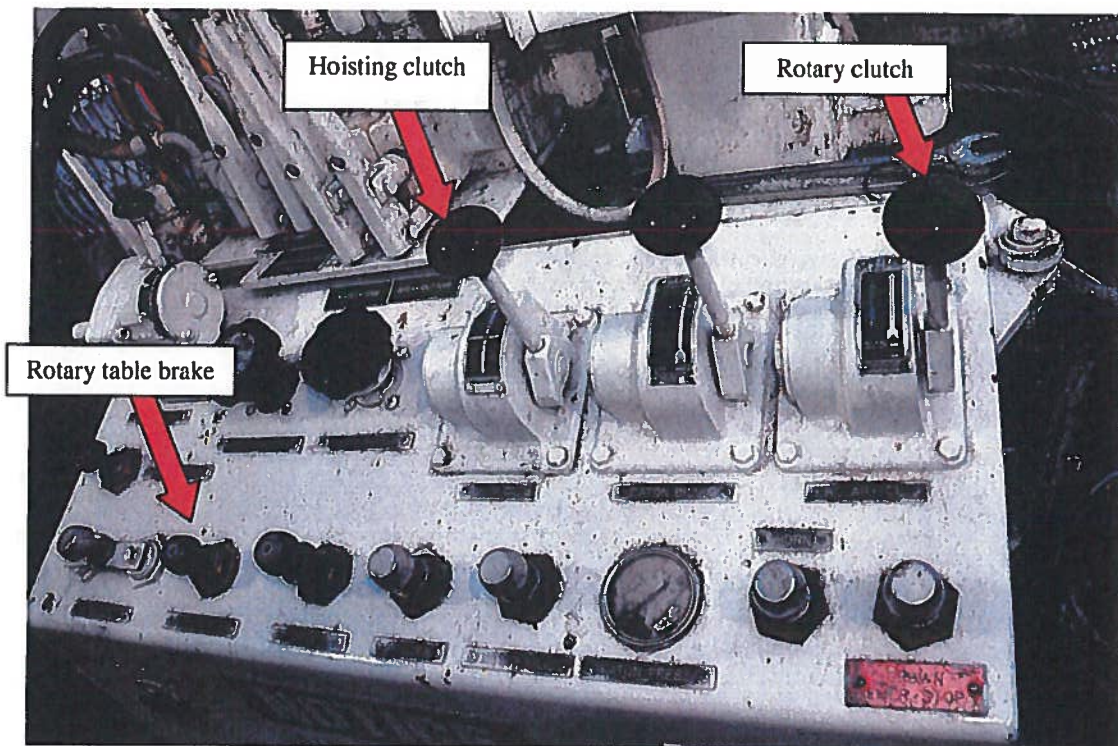
Photograph 3

- 5.2.3 The driller's control panel was examined. The control for the rotary table brake, hoisting clutch and rotary clutch were identified. (Attachment C, Photograph 3).

Shows the driller's consol on Precision Drilling Corporation's rig #212. The rotary clutch controls the rotation of the rotary table. The rotary table brake, when engaged, locks the rotary table and prevents rotational movement. The hoisting clutch shown above, allows the driller to raise and lower the drill string.

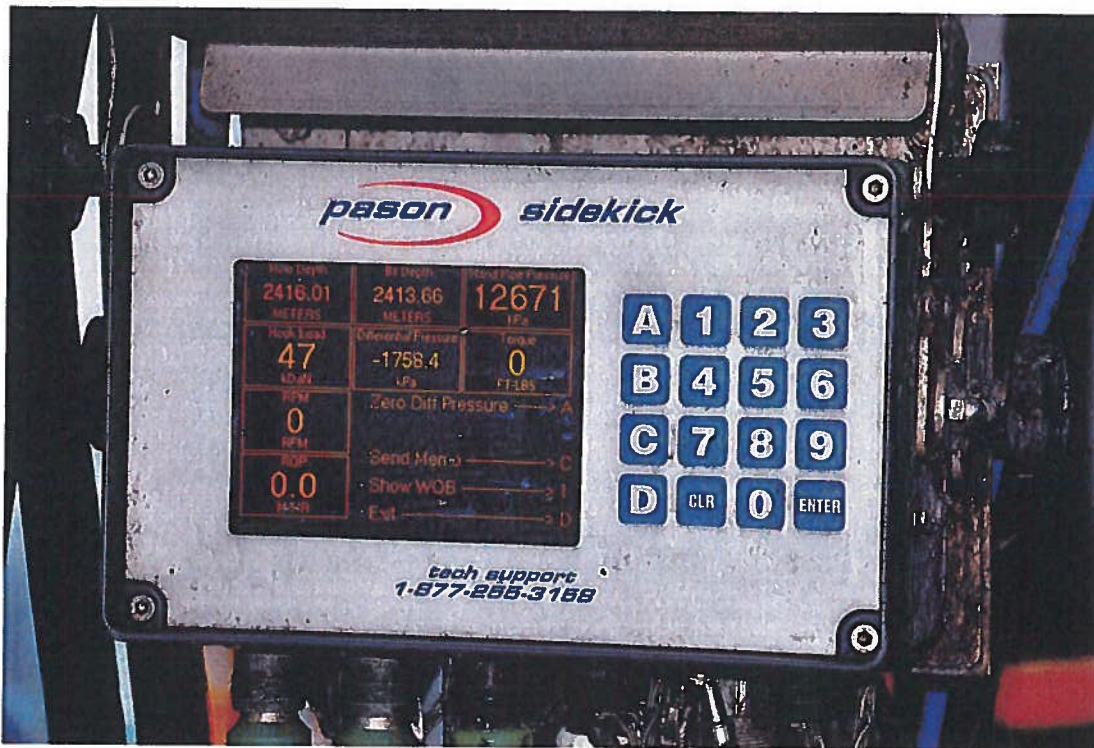
Photograph 4

- 5.2.4 The Pason Sidekick was observed near the driller's consol and indicated the hole depth was 2416 m, the drill bit depth was 2413 m and the torque reading was zero (Attachment C, Photograph 4).

Shows the Pason Sidekick display which was located to the upper left of the driller's consol on Precision Drilling Corporation's rig 212 (See Photograph # 5). The display shown here indicates the drill bit is located 2413 m down hole and the total hole depth is 2416 m. The torque reading displays zero foot-pounds. The torque value is displayed when the driller applies drive to the rotary table. The amount of drive transferred to the drill string is measured as torque in foot-pounds.

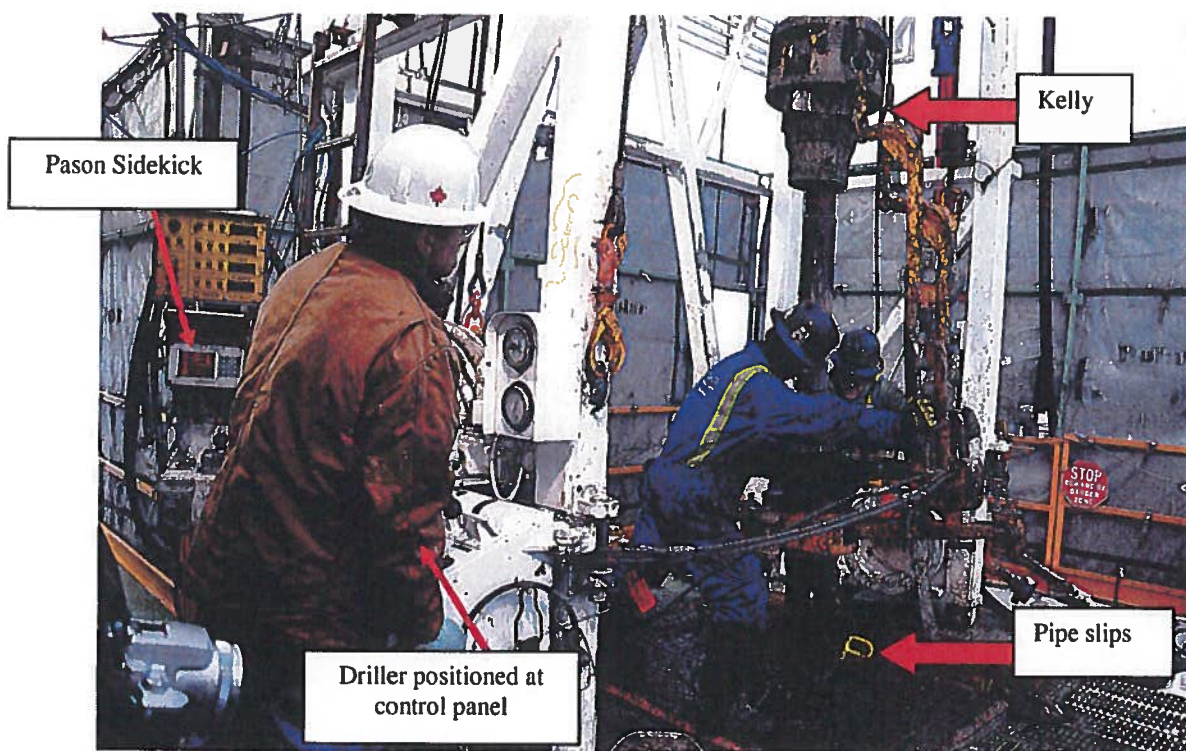
Photograph 5

- 6.4 Floorhand # 1 [REDACTED] and Floorhand #2 [REDACTED] used 2 sets of hydraulic tongs to break the connection between the kelly and the drill pipe assembly (Attachment C, Photograph 5).

Shows a re-enactment of the floorhands using power tongs to break the connection between the Kelly and the drill pipe and location of the Pason Sidekick.

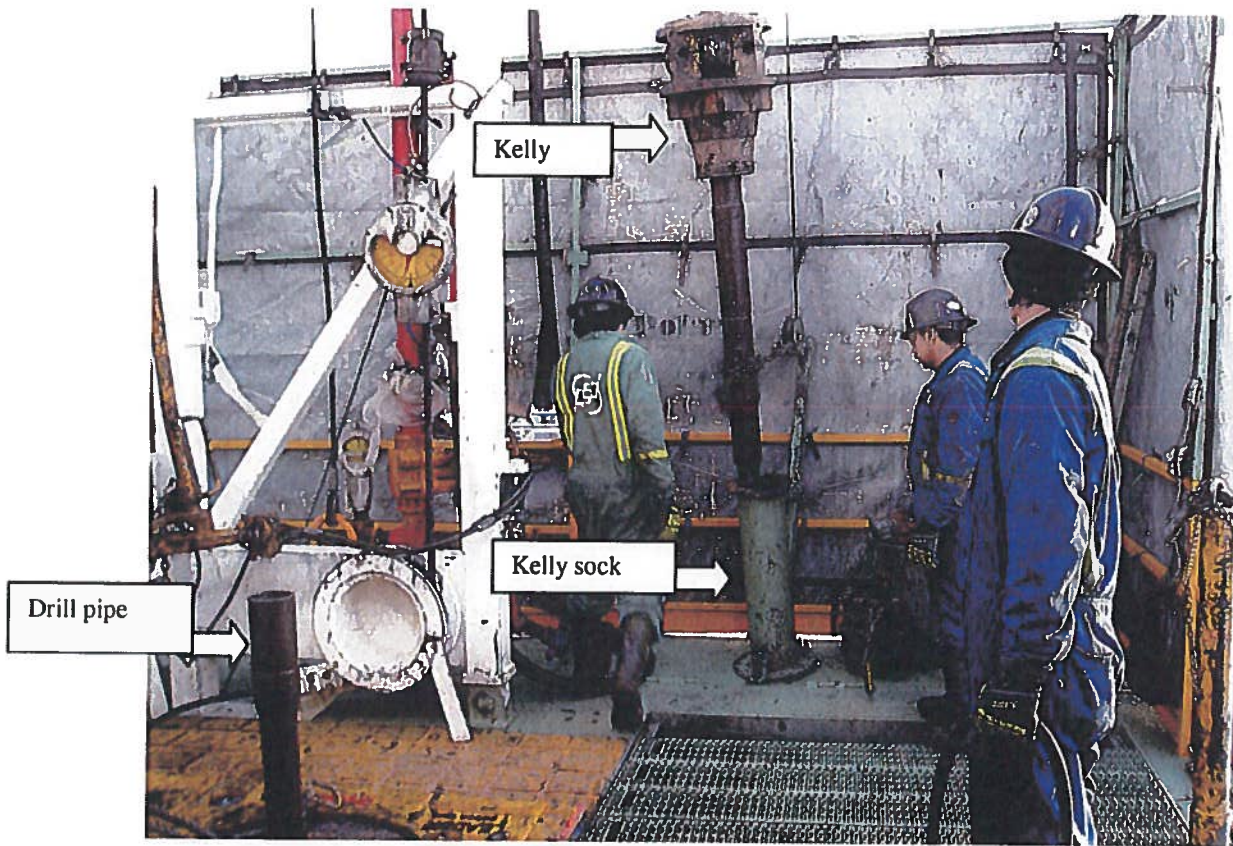
Photograph 6

- 6.6 The kelly was removed and Floorhand # 1 [REDACTED] and Floorhand #2 [REDACTED] guided the kelly into the kelly sock to secure it (Attachment C, Photograph 6). The Driller [REDACTED] lowered the traveling blocks to the rig floor and the Motorman [REDACTED] and Floorhand # 1 [REDACTED] and Floorhand #2 [REDACTED] installed the bails and elevators onto the travelling block and attached the elevators around the drill pipe.

Shows the drill pipe sitting in the slips after the kelly has been removed. The kelly, once removed, is guided over to the kelly sock and secured.

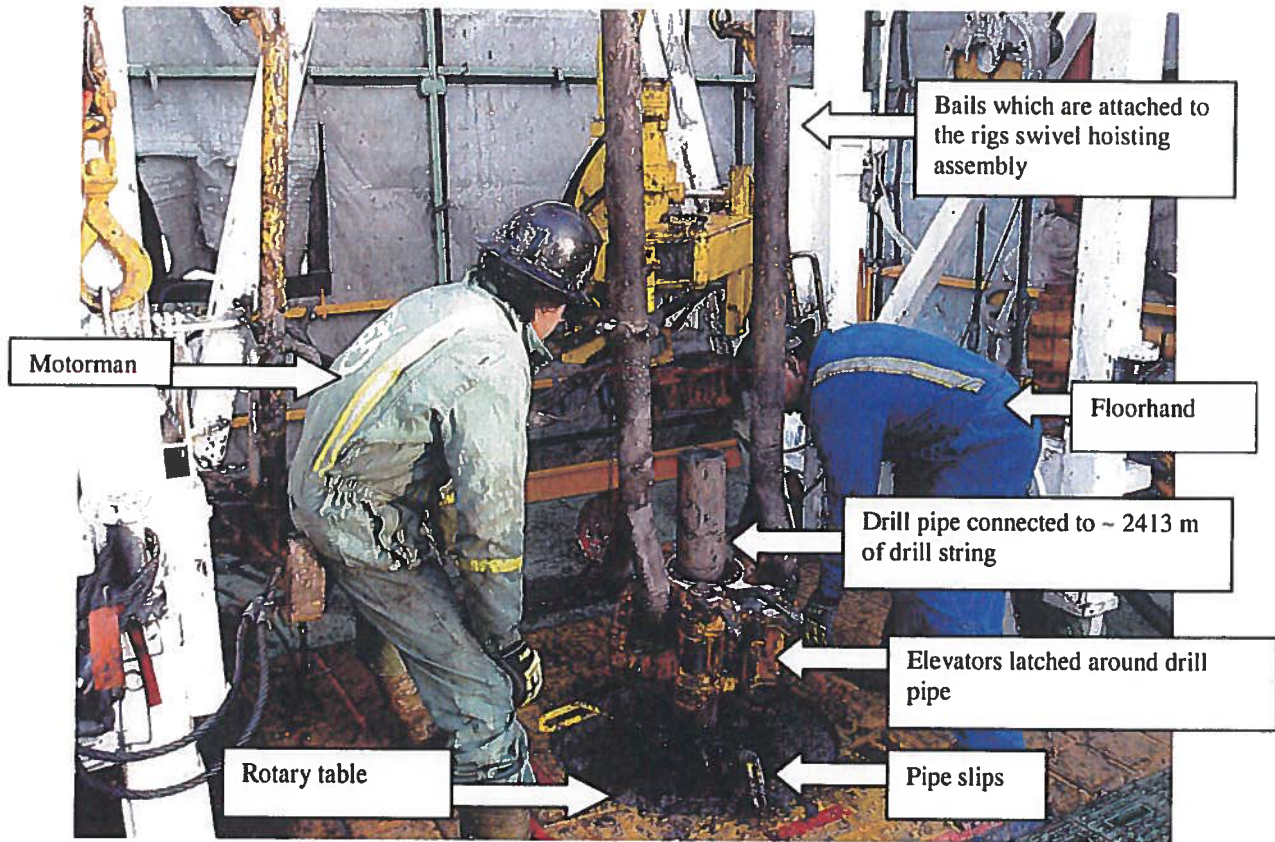
Photograph 7

- 6.7 Floorhand # 1 [REDACTED] and the Motorman [REDACTED] were ready to pull the pipe slips by positioning themselves near the rotary table and were waiting for the Driller [REDACTED] to start hoisting the drill pipe (Attachment C, Photograph 7).

Shows the re-enactment of the Motorman [REDACTED] and the Floorhand [REDACTED] as they prepared to lift the pipe slips. The scene shows the rig's hoisting system latched onto the drill pipe. When the pipe is lifted out of the pipe slips, the weight of the drill string is taken on by the rig's swivel hoisting assembly. Photograph provided by Precision Drilling Corporation.

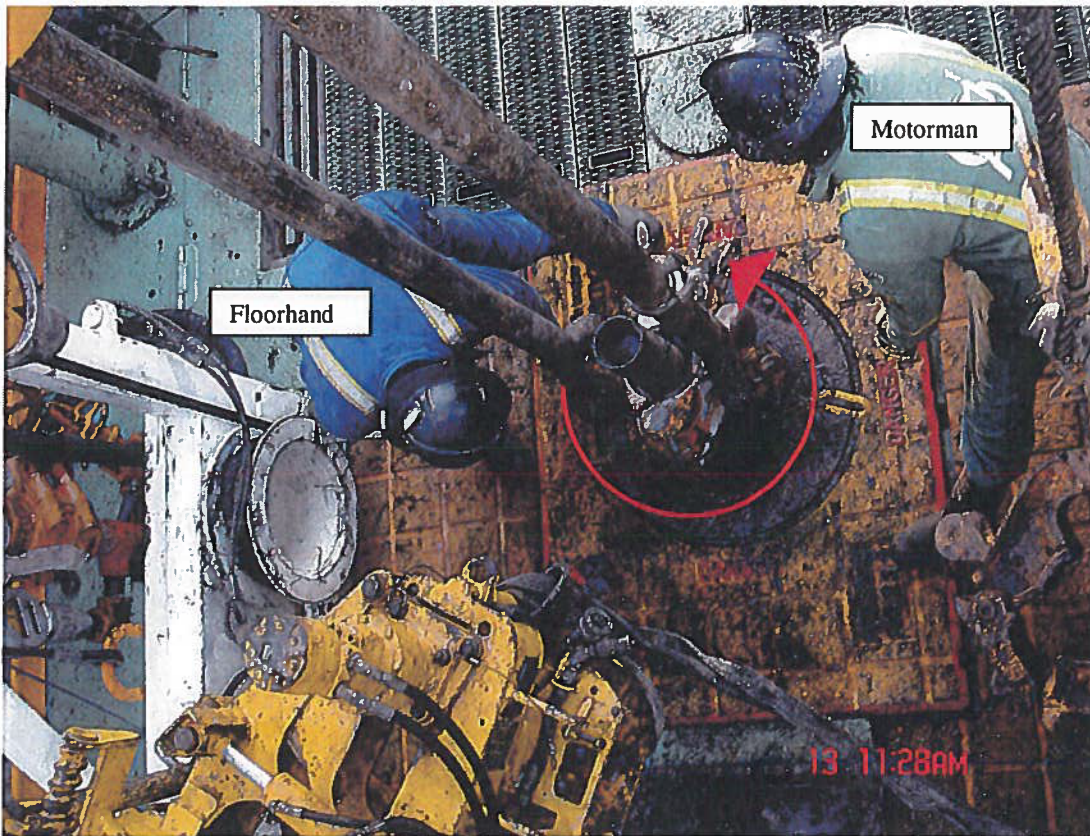
Photograph 8

- 6.8 At 9:44 a.m. the Driller [REDACTED] engaged the hoisting clutch and started to pull the drill pipe up out of the slips. As soon as the Driller [REDACTED] started to hoist the drill pipe, the torque that had been trapped in the drill string, released. When the torque released, the drill pipe and the equipment latched onto it rotated unexpectedly (Attachment C, Photograph 8).

Shows an overhead view of the approximate positions of the Floorhand [REDACTED] and the Motorman [REDACTED] as they were prepared to pull the pipe slips. When the Driller engaged the hoisting clutch and began to lift the pipe, the hoisting assembly attached to the drill pipe rotated and struck the Floorhand.
Photograph provided by Precision Drilling Corporation.
