Investigation Report
Worker Fatally Injured
Thermal Burns from Contact with Hot Water
August 18, 2014

Incident summary

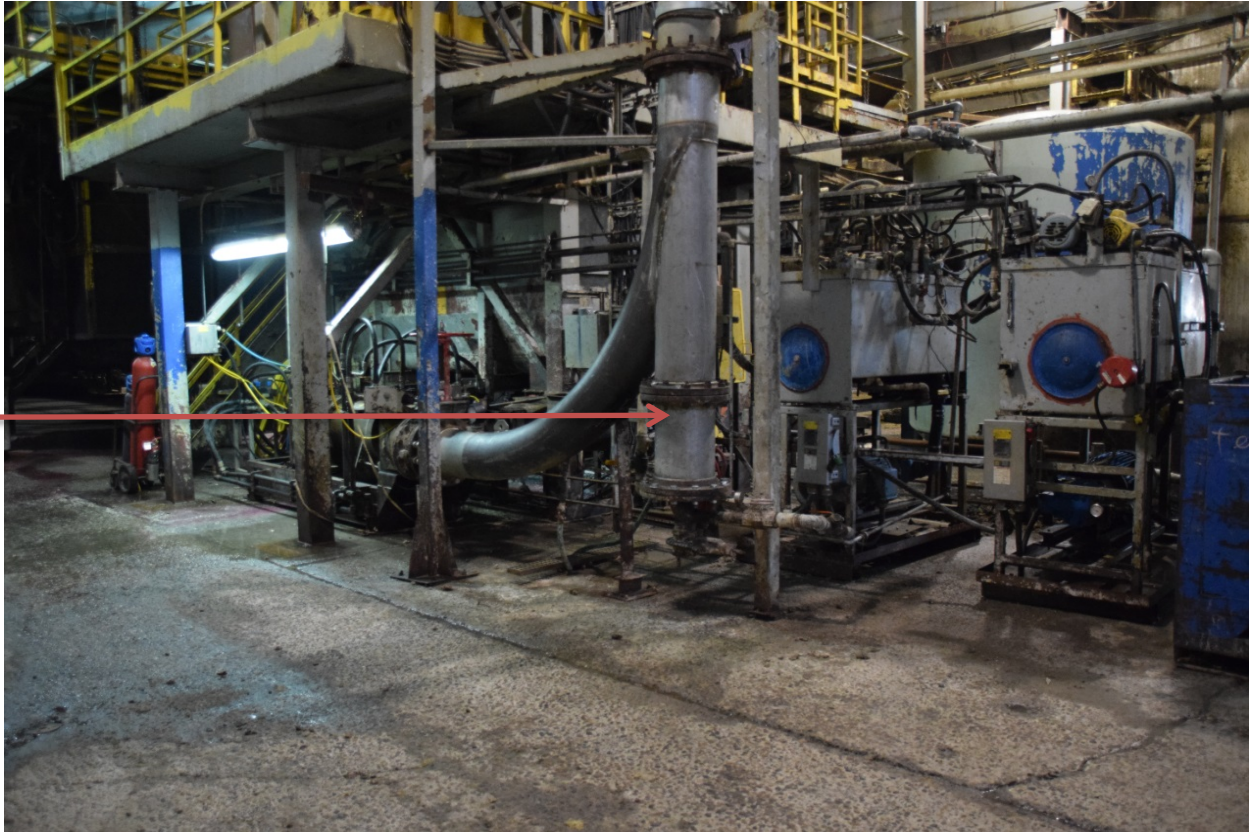
Figure 1. shows the feeder line originated at the raw materials plant. The hydraulic pump could be seen to the right of the feeder line. A rubber pig could be added to the bottom of the pipe to clear blockages. This was the normal process to remove blockages. A. shows where the feeder line began and also where a rubber pig could be added to the feeder line.

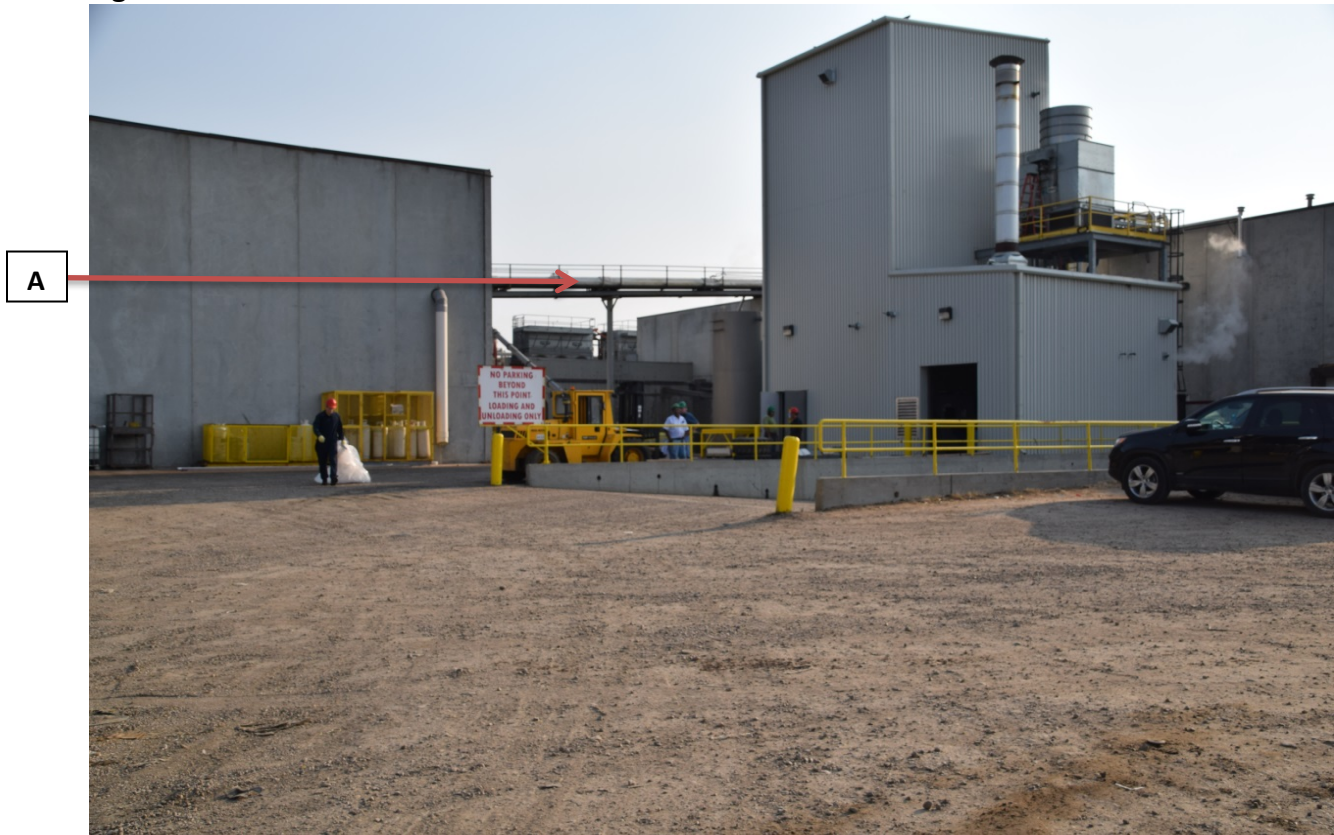
Figure 2.

Figure 2 shows the portion of the feeder line that travelled from the raw materials plant to the rendering plant. The picture shows the downward slope of the feeder line. A. shows the feeder line as it travelled from the raw materials plant towards the rendering plant.

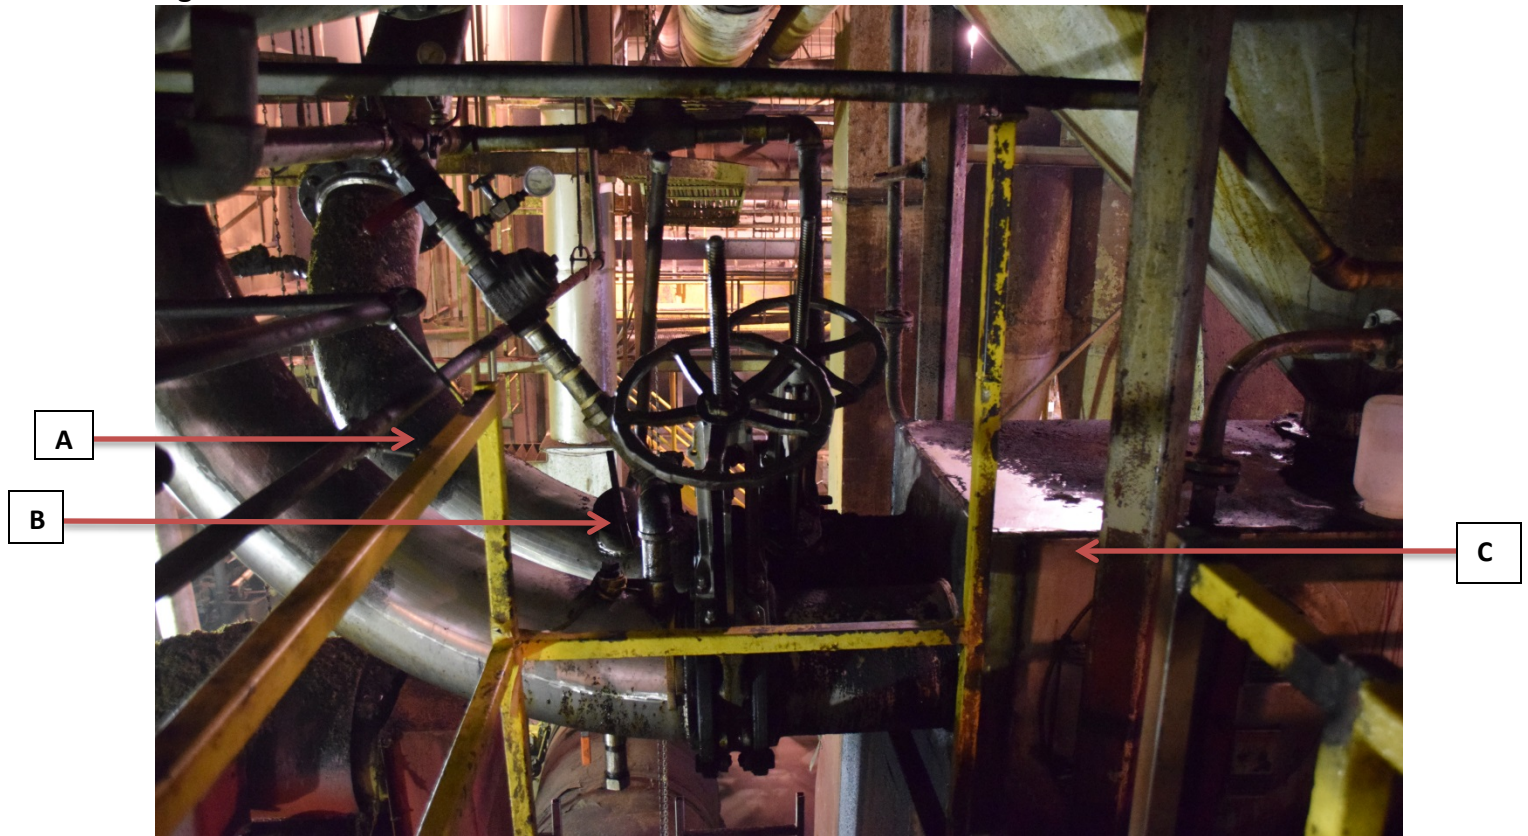
Figure 3.

Figure 3 shows the termination point of the feeder line. The two pipes entered into the cooker at this point and were controlled by multiple valves to determine which feeder line was being used. At the time of the incident, the valve from feeder line 1 to the cooker was closed so as to prevent water from entering the operating cooker. **A.** shows feeder line 1. **B** shows the pipe cap that became dislodged and released the steam heated water and **C** shows where materials entered the cooker.

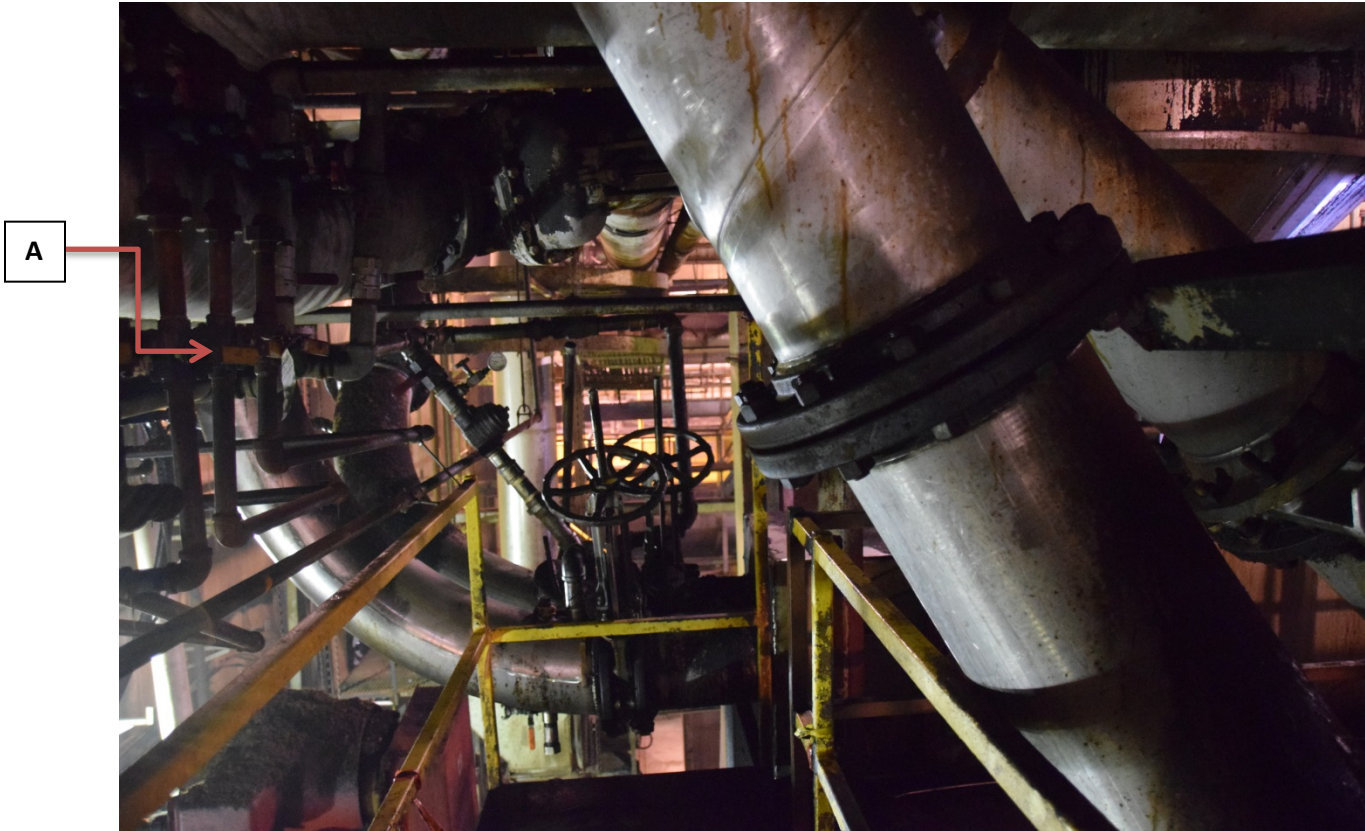
Figure 4.

Figure 4 shows the control points for the air and steam. The rendering supervisor was standing on the mezzanine level operating these controls during the flushing operation. **A** shows the location of the steam and air controls for the feeder lines.

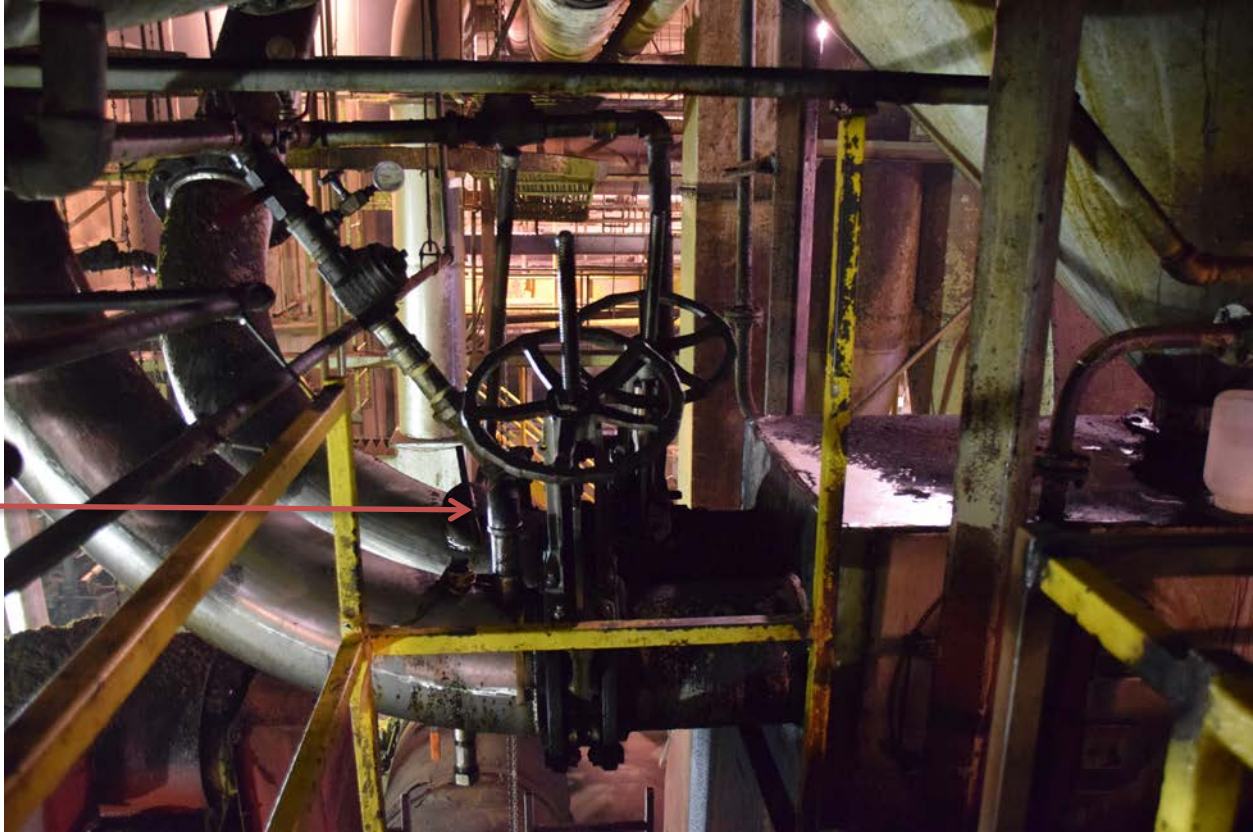
Figure 5.

The relief cap was a 15.25 cm cast iron cap threaded onto an opening in the pipe that was installed so that workers could access that section of the pipe in case of freezing. (See Figures 5 and 6).

Figure 5 shows the access cap that was removed or dislodged leading to the release of hot water and steam that contacted the worker during the flushing of the line. This picture was taken from the mezzanine platform where the rendering supervisor was located. The cap opening where the water came from is pointing towards the mezzanine platform. A. shows where the pipe cap was located on the feeder line.

The rendering superintendent heard a pop, which was later identified as the cap dislodging from the feeder line. The rendering supervisor had been contacted by the steam heated water in the feeder line.

The cap was not a design element of the initial installation. Although it wasn't clear when the cap was installed, it was noted that it was prior to the acquisition of the facility by JBS Foods. The cap was added to the system to deal with freezing concerns that were occurring in the feeder lines. After the incident, the cap was welded on to the opening so that it could never again be removed and/or dislodged.

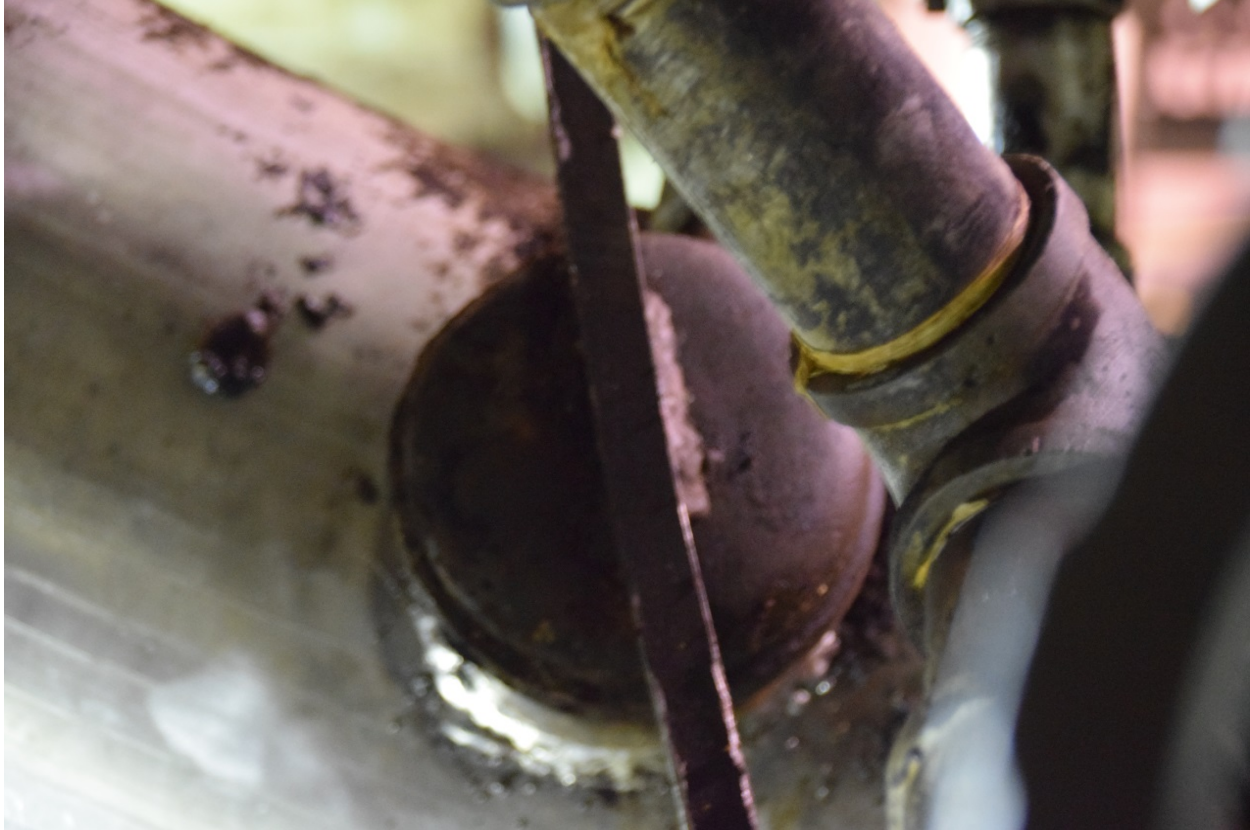
Figure 6.

Figure 6 shows a close up of the pipe cap attached to feeder line 1.

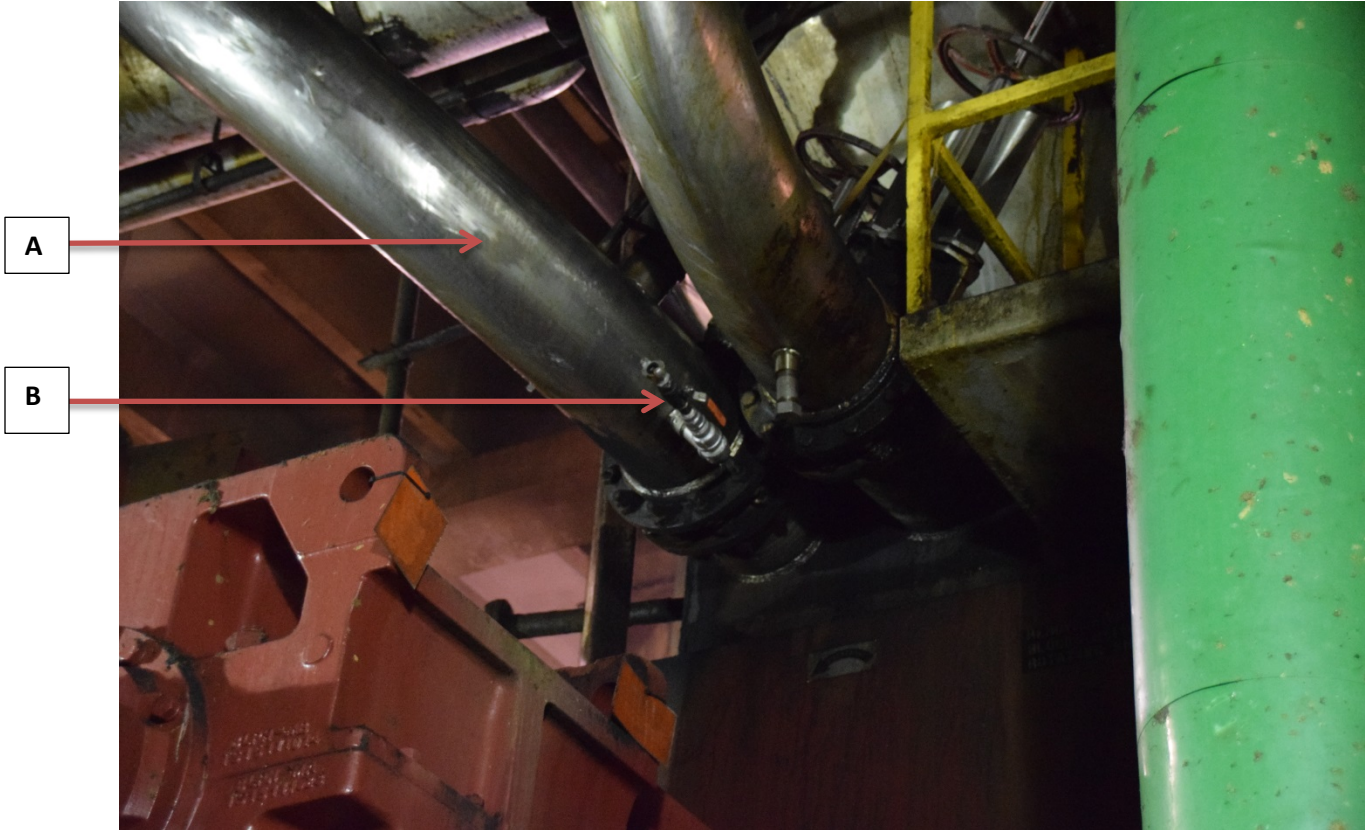
Figure 7.

The water line consisted of a ball valve with a chicago fitting so that a standard hose could be attached directly to the feeder line from the facility water lines (See Figures 7 and 8). Once the hose was removed, it was also to be used as a means to drain the line. Previous to the day of the incident, there were no means to add water directly to the feeder line. On the day of the incident, the rendering supervisor tasked rendering maintenance personnel to install the equipment necessary to add water to the feed line.

*Figure 7. shows the view of the water drain line from the floor approximately where the rendering superintendent was standing at the time of the incident. **A** shows the feeder line with a view from the floor. **B** shows the connection added to the feeder line so that water could be added to the pipe.*

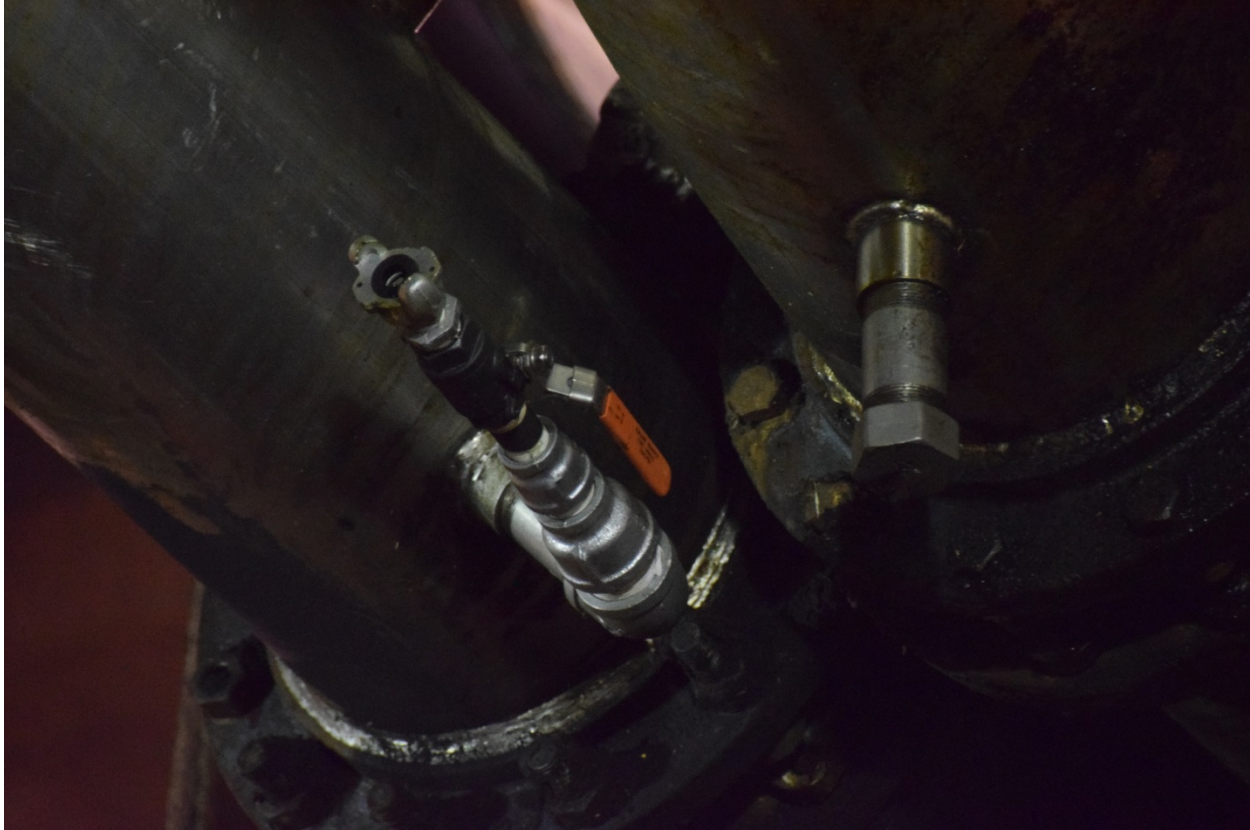
Figure 8. shows a close up of the water line connection and planned drainage point for the water that was added to the feed line. Once the hose was removed, the water was to drain to the floor of the rendering plant.

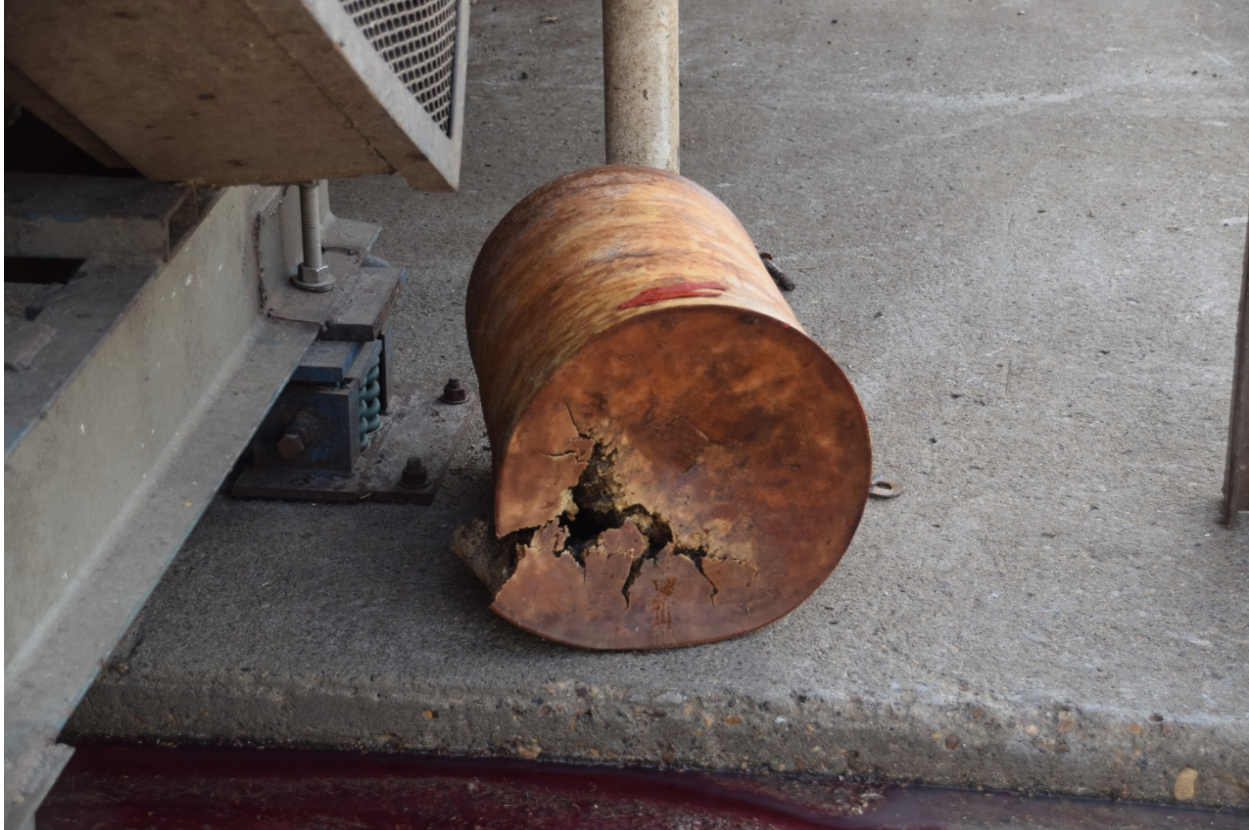
Figure 9.

Approximately two weeks prior to the incident, a blockage was detected in feeder line 1. Blockages in the pipe were detected in the control room as less product fed into the cooker and pumps began to struggle to move product. On August 8, 2014, a rubber pig was added to the pipe to clear out any blockages (See Figure 9). The pig arrived at the cooker and rendering operations, in consultation with maintenance, determined the blockage to be cleared.

Figure 9 shows an example of a rubber pig that was sent through the feeder lines to determine if there was a blockage.
