Workplace Health and Safety Fatality Report

Driver Fatally Injured by Fall from Truck
Date of Incident: March 5, 2007
Type of Incident: Fatality

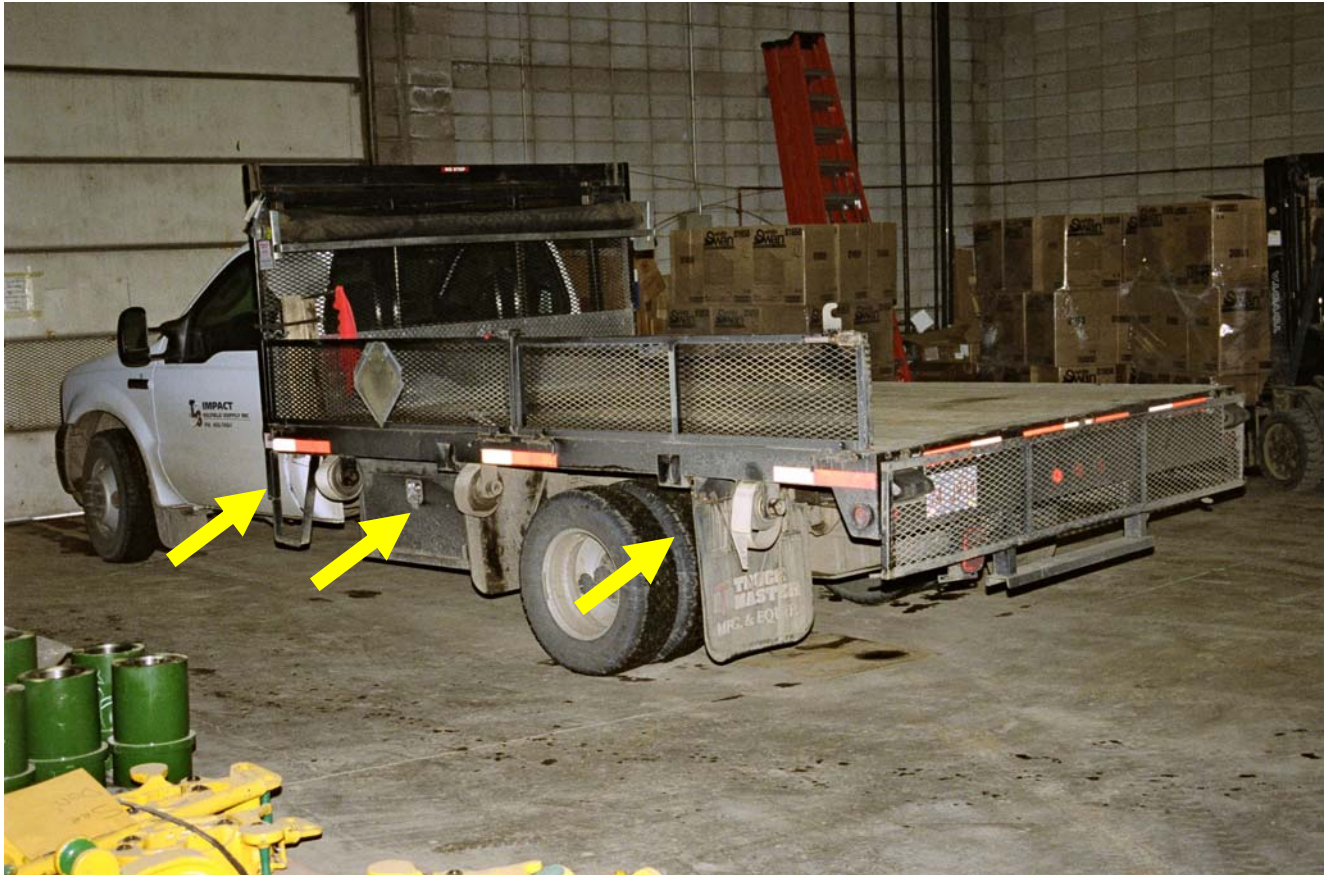
- 6.3 After the first two pallets had been loaded the Driver commenced placing his straps to secure the load. The truck was fitted with three straps on the driver's side. The straps were pulled out and thrown over the load, to be fastened on the passenger side. The loads, consisting of industrial paper product, were soft and could be deformed by the straps. In order to prevent deformation of the load, pieces of 2x4 lumber were placed onto the top edges of the palletted loads where the straps contacted the loads. The Driver commenced placing the front strap over the two side-by-side pallets that had been placed against the truck cab. (Attachment "A", Photographs #1, #2, #4)

Photograph #1 Shows the flatbed truck in the Cando Oilfield Supply & Rentals Ltd. loading bay at 2104-8 Street, Nisku, Alberta. Arrows indicate the load securing strap reels fitted to the driver's side of the truck.

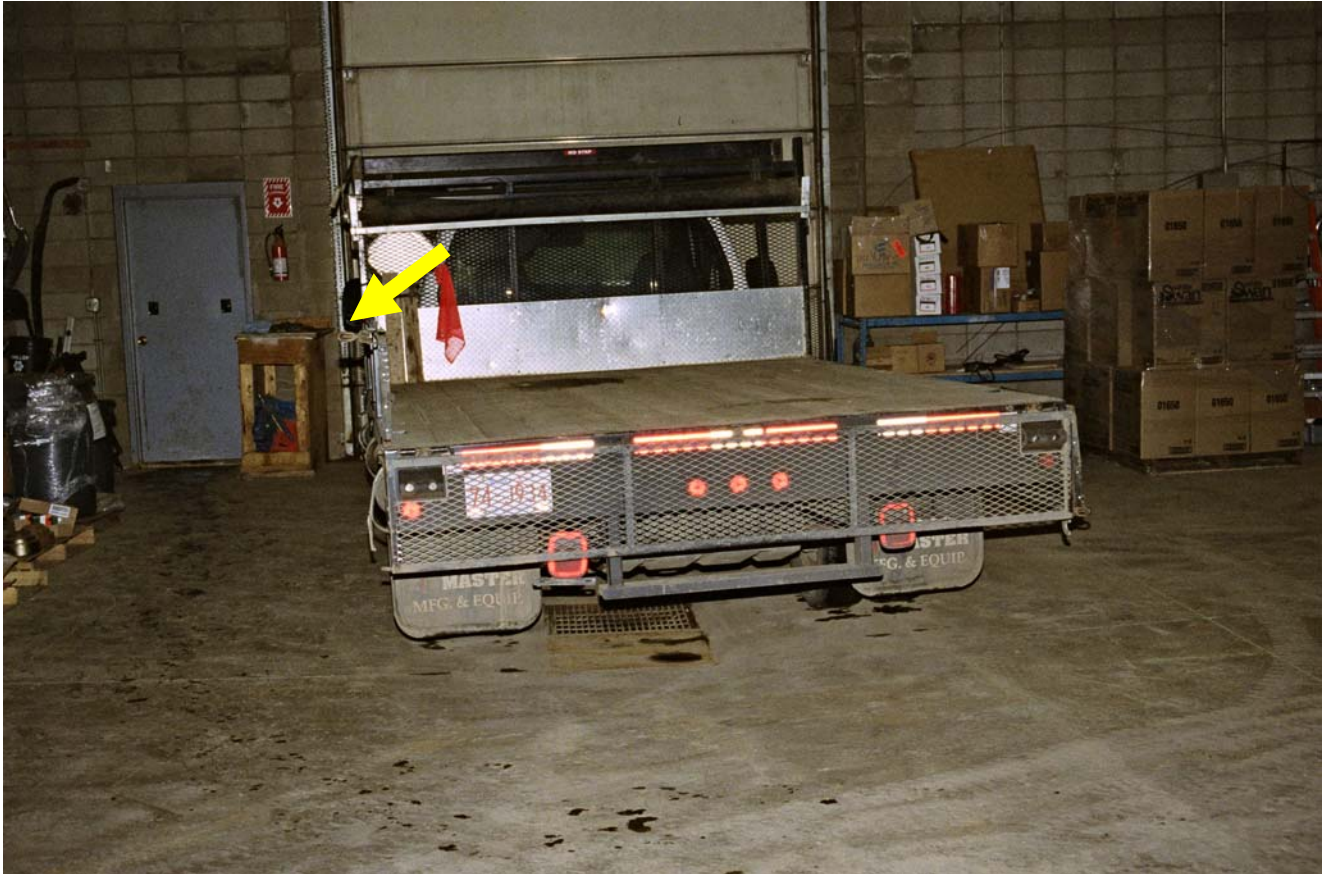
Photograph #2 Shows the flatbed fitted to the truck. Arrow shows pieces of 2x4 used to prevent load straps from deforming the load.

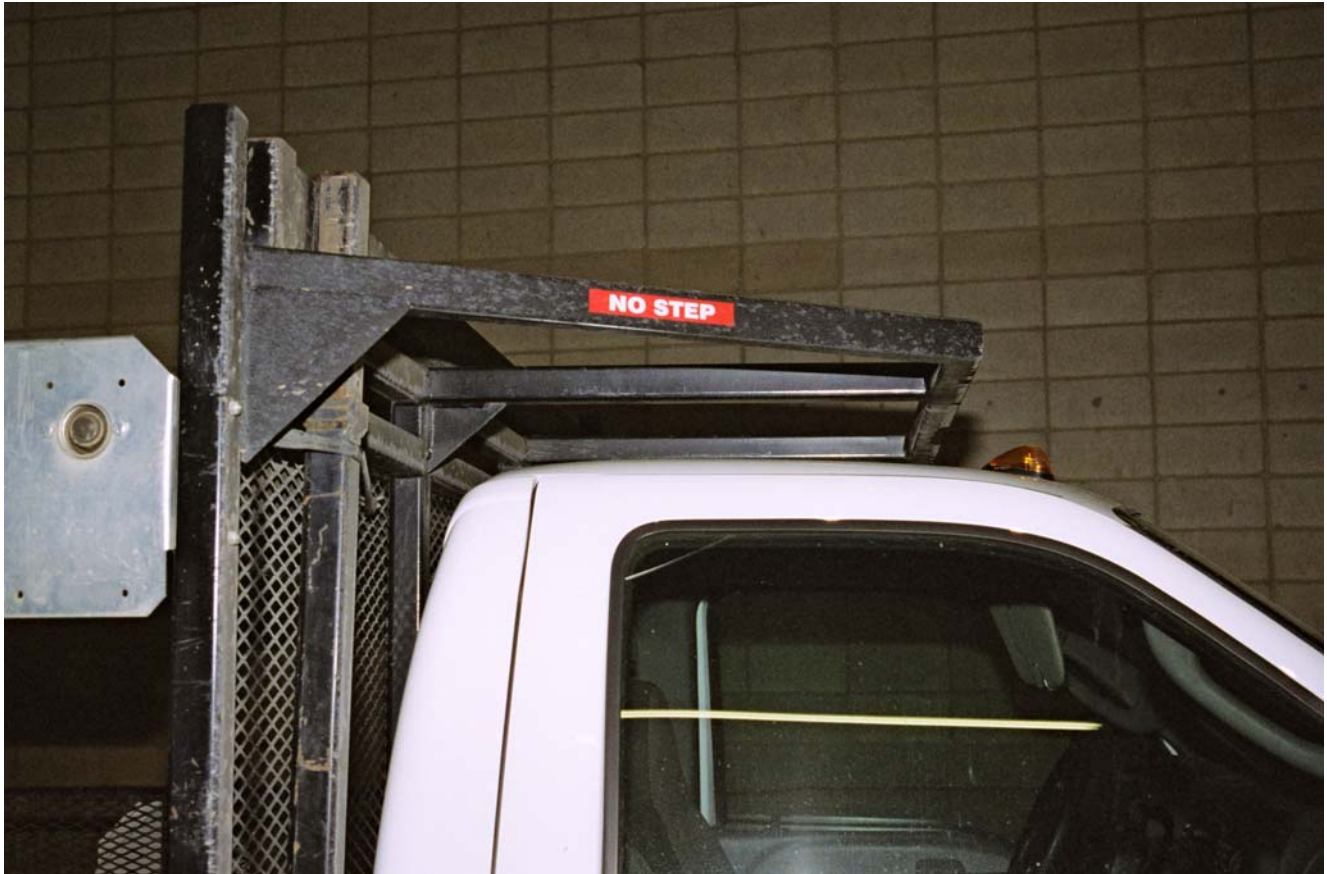
- 6.4 Another driver, Driver 2, who was waiting his turn to load, went to assist the Driver to place his straps. When Driver 2 reached the truck he observed that the Driver had already placed the first strap, the strap closest to the cab, over the load. Driver 2 commenced pulling out and straightening the second strap on the driver's side of the truck. Driver 2 did not see the location of the Driver until he observed the Driver's head appearing over the load, at the front of the truck. It was apparent to Driver 2 that the Driver was standing on the roof of the cab, or on the rack that had been installed over the cab. (Attachment "A", Photograph #3)

- 7.2.3 The rack fitted over the cab was clearly marked “NO STEP”. (Attachment “A”, Photograph #3)

Photograph #3 Shows the rack fitted over the truck cab. "No Step" signs on the rack are clearly visible.

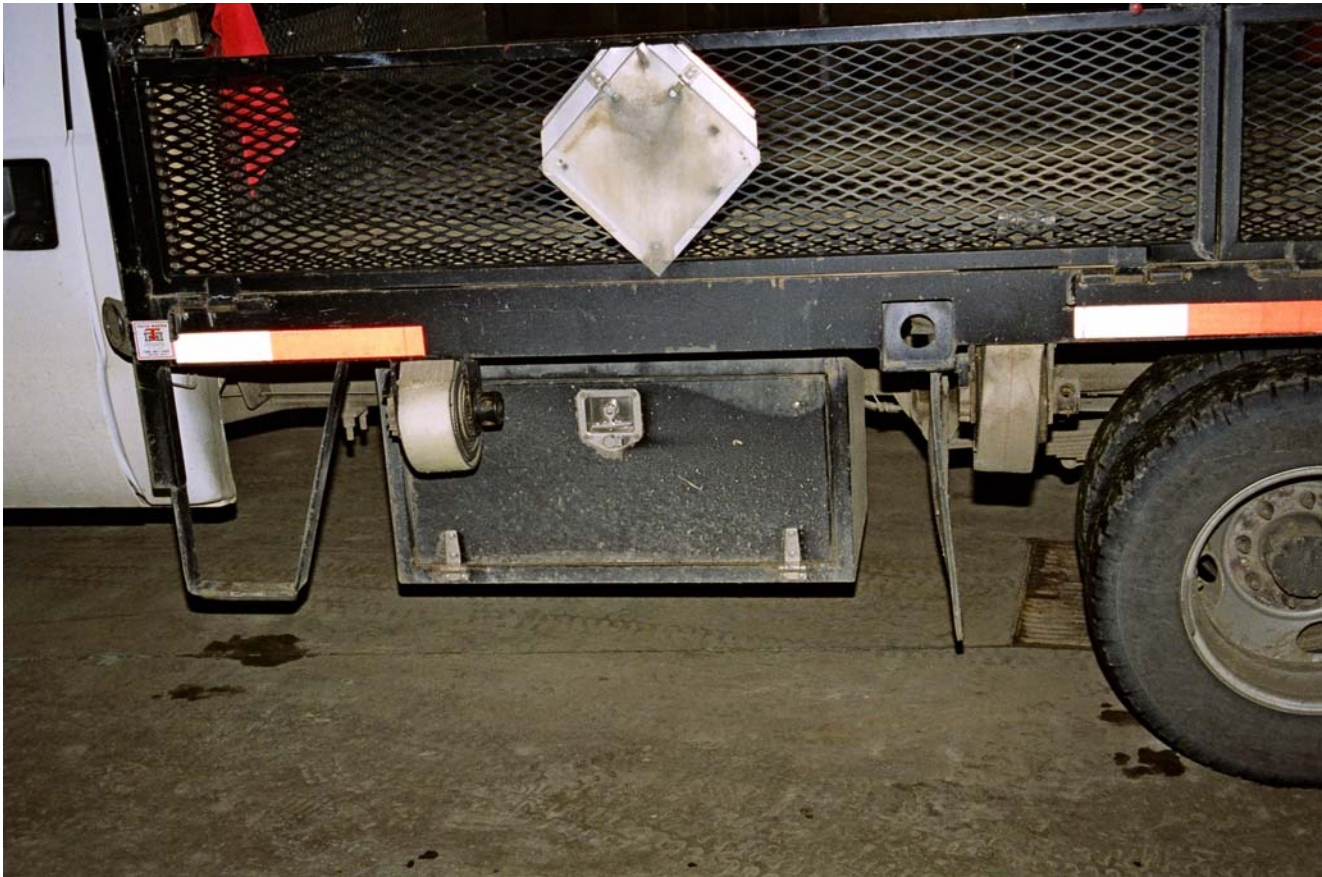
Photograph #4 Shows a close-up view of the two front load securing strap reels on the driver's side of the truck.

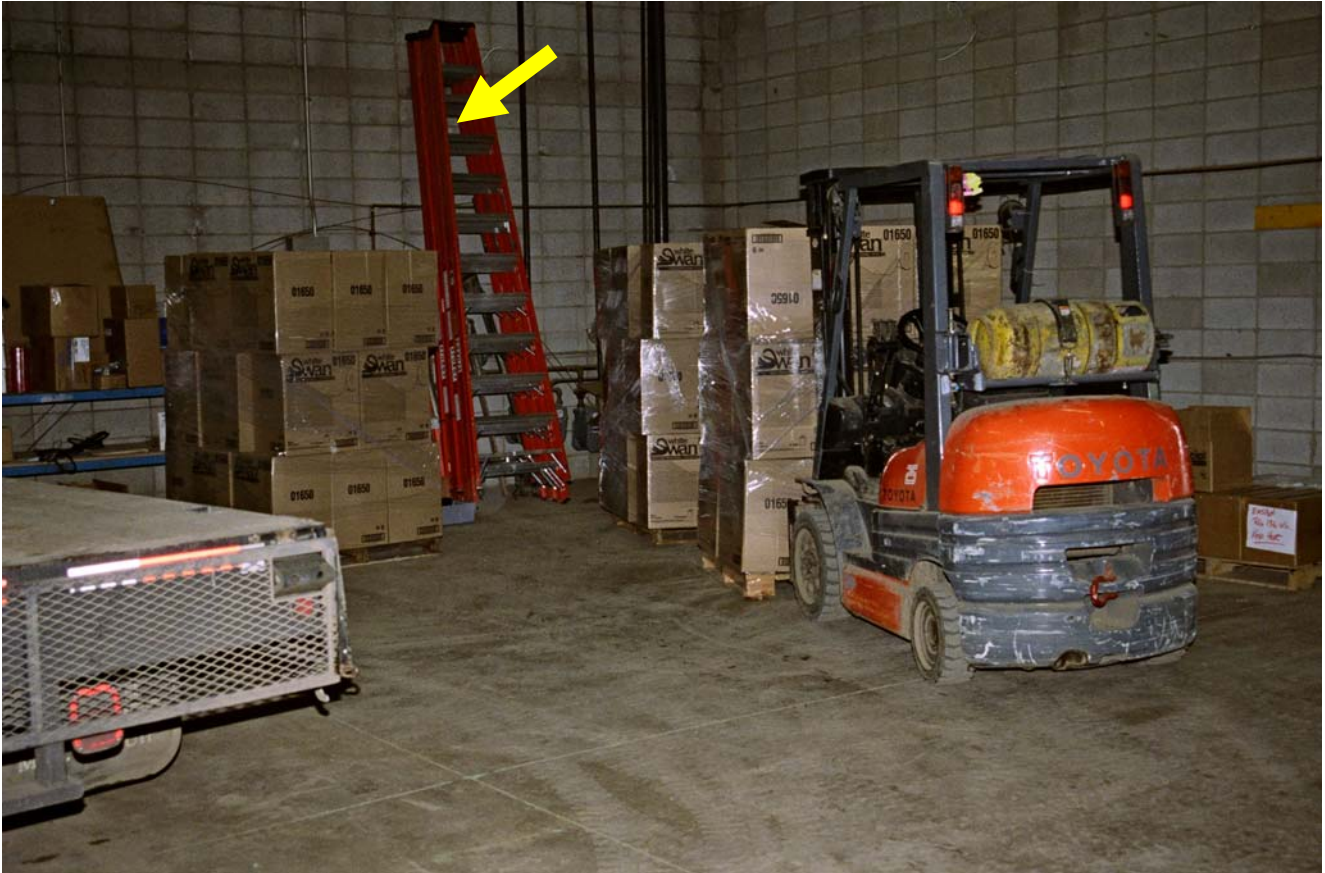
- 7.2.1 It was not established why the Driver had climbed onto the roof of the cab. It is probable that he did so in order to adjust the position of the securing straps or to place pieces of 2x4 lumber onto the sides of the load.
- 7.2.2 It was not necessary for the Driver to climb onto the roof of the cab. Access to the load could have been achieved by standing on the flatbed of the truck. Stepladders were also readily accessible in the loading bay. (Attachment "A", Photograph #5)

Photograph #5 Shows the fork lift and pallets of industrial paper similar to those that were being loaded onto the truck at the time of the incident. Arrow indicates stepladders stored in the shop and readily available.
