Investigation Report
Worker Struck by Object
November 20, 2013

Final Report

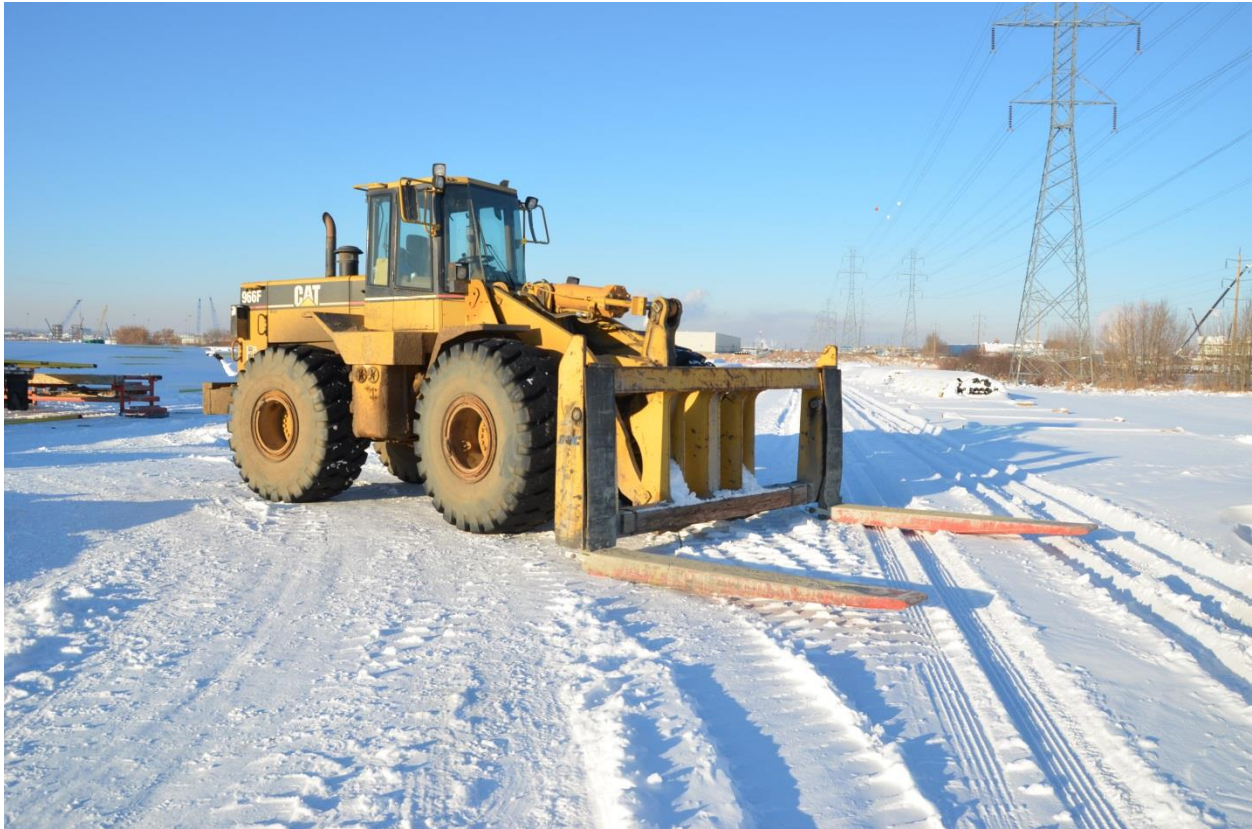
Figure 1. Photo (looking north) identifying the replacement loader.

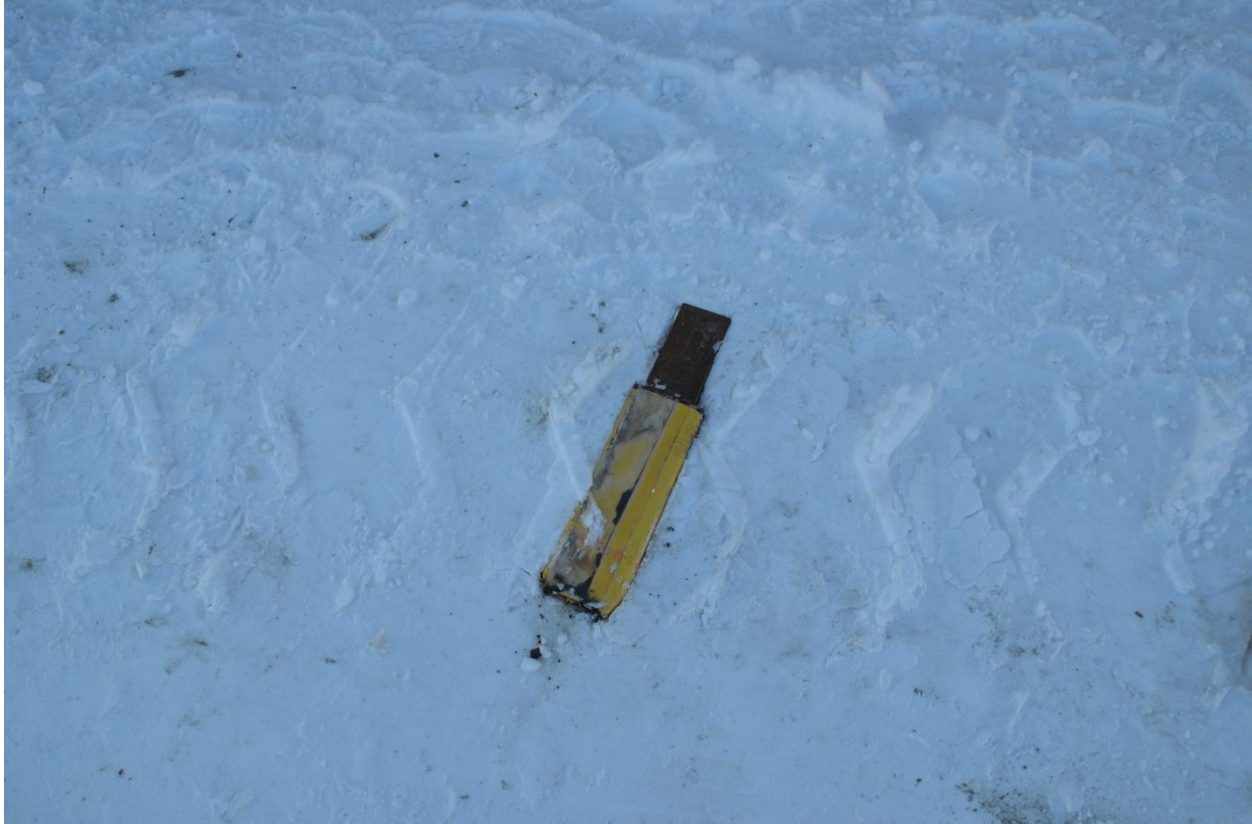
Figure 4. Photo identifying a deck pin.
