RECAPP Facility Evaluation Report

Consort Hospital and Care Centre

B1013A
Consort

Evaluation Details	
Evaluation Company:	Sherry Turpin - Architect
Evaluation Date:	June 16 2009
Evaluator Name:	Len O'Connor

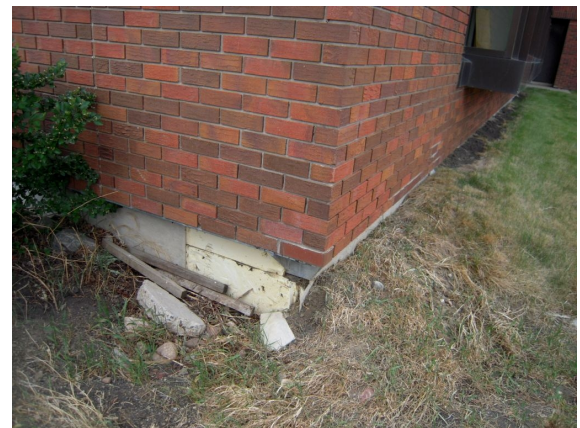
Protection board at grade, 6 mm asbestos board, requires repairs to various locations at building perimeter. Rigid insulation is exposed.

Deterioration of rigid insulation.

Damaged asbestos board

Excavate to expose panel, remove all asbestos board under abatement and replace with cement board panels, replace earth, compact, and repair landscape areas.

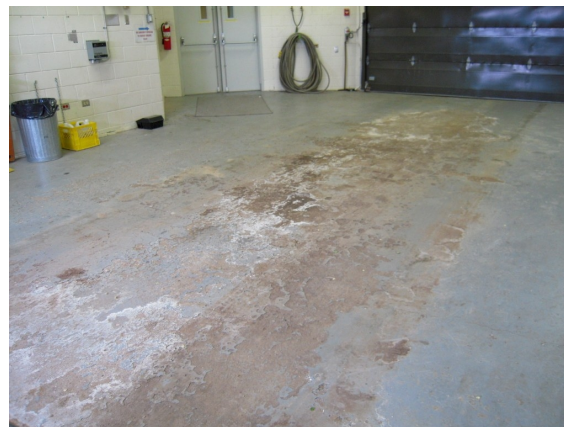
Ambulance Bay: Surface coating is worn off. The concrete surface is pitted due to salt deposits. There is no floor drain nor trench drain.

Ambulance bay floor.
