Asset Assessment Report

La Crete Continuing Care Centre B1106A

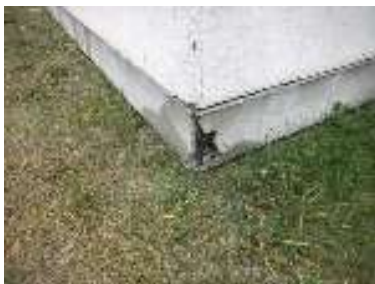
Lower sill section of exterior wall on older section of building has stucco portions missing exposing the wood.

Remove and replace stucco on lower sill section approx 8" width and the entire perimeter of building (94 m)

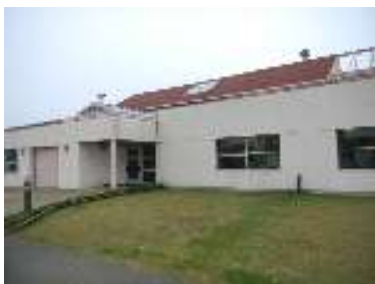
<u>Details</u>	<u>Values</u>
Condition Rating	2 - Poor
Year Installed	1989
Theoretical Design Life	15
ACL	ACL 1

Sand and paint wood flashing.

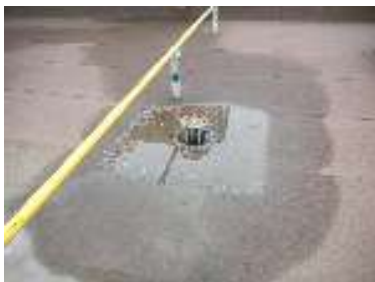
<u>Details</u>		<u>Values</u>
Short Title		Repair Roof Drains (16)
Cost		\$40,000.00
Start Year		2012
Impact		Significant
Probability		Imminent
Budget Type		Unspecified
Event Status		Not Approved
<u>Narratives</u>		
Concern		
		Roof drains are slightly raised causing water to pool adjacent roof drain.
Recommendation		
		Reconstruct and lower roof drain to allow proper drainage.
