**WORKER CRUSHED BY VEHICLE CHASSIS**

Type of Incident: Fatality

Date of Incident: February 17, 2012

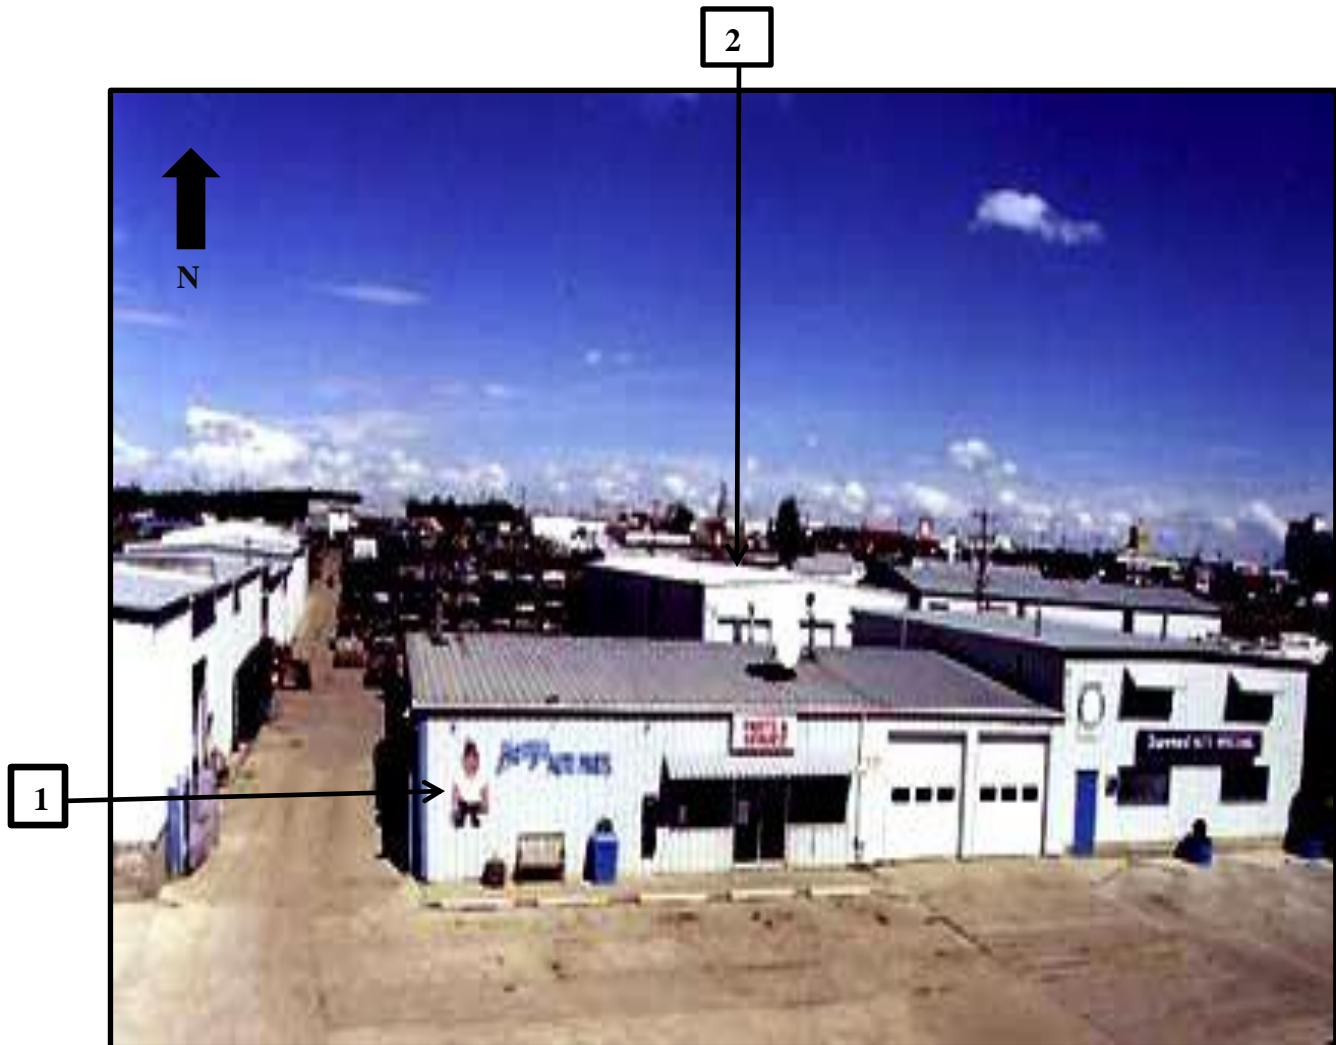
Photograph # 1

5.1.1.1 The incident occurred in the west bay of a 3 bay dismantling building. The dismantling building was located directly north of the main office building. (Attachment C, Photograph # 1)

1. Shows the Maxi Service Ltd. O/A Harry's Auto Wrecking main office building with the parts and service departments.
2. Shows the west bay of the dismantling shop where the incident occurred.

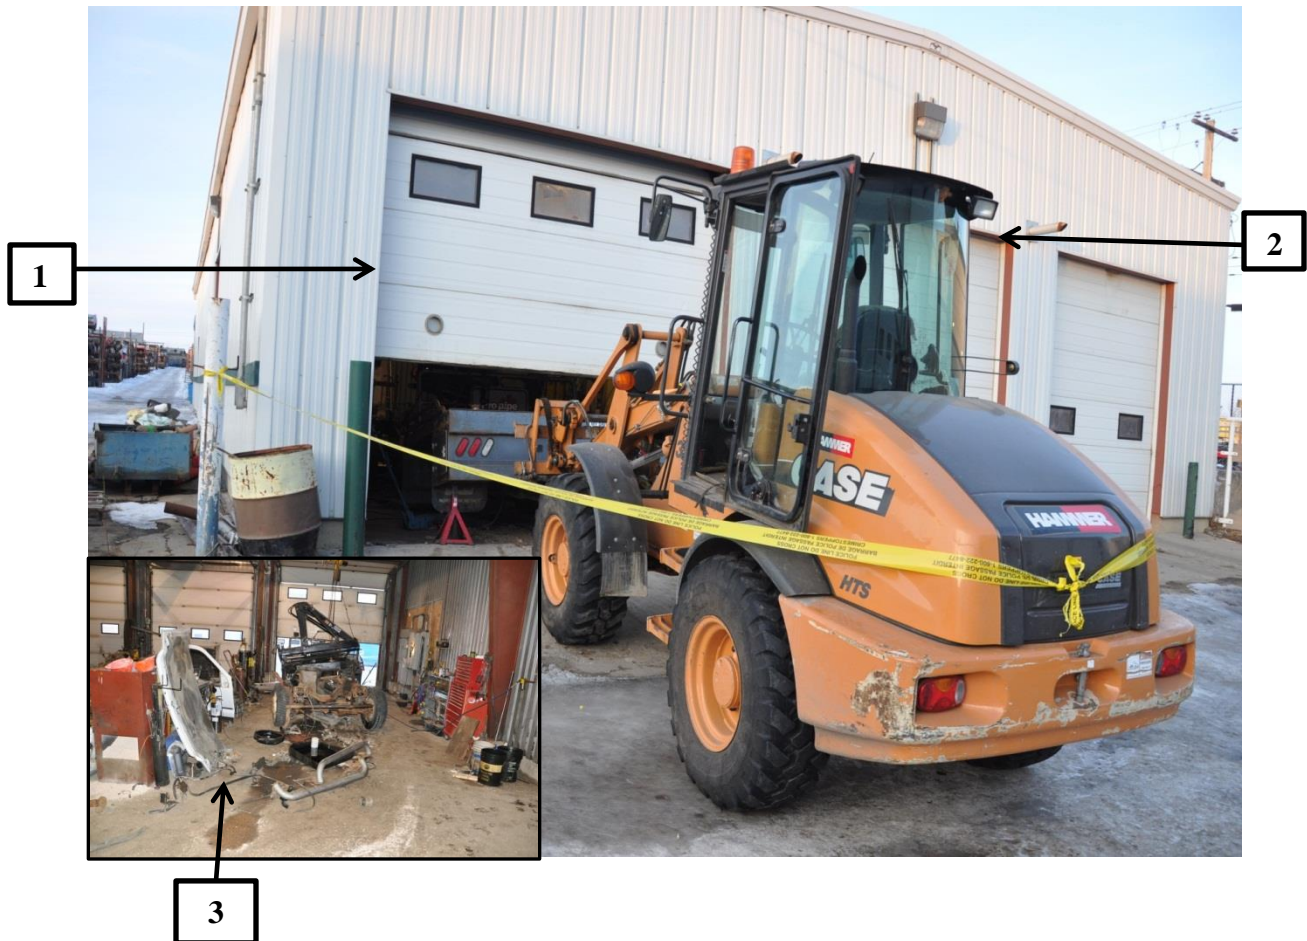
Photograph # 2

5.1.1.2 Dismantler (\*\*\*\*\* \*\*\*) was assigned the west bay in the dismantling building to conduct dismantling activities. (Attachment C, Photograph # 2)

1. Shows the west bay in which the Dismantler (\*\*\*\*\* \*\*\*) was working.
2. Shows the loader which was used to provide support to the steel deck during the rescue.
3. The inset photograph shows the interior of the west bay where the incident occurred. The inset photograph was taken facing south and shows the front cab, engine, seats and windows all removed.

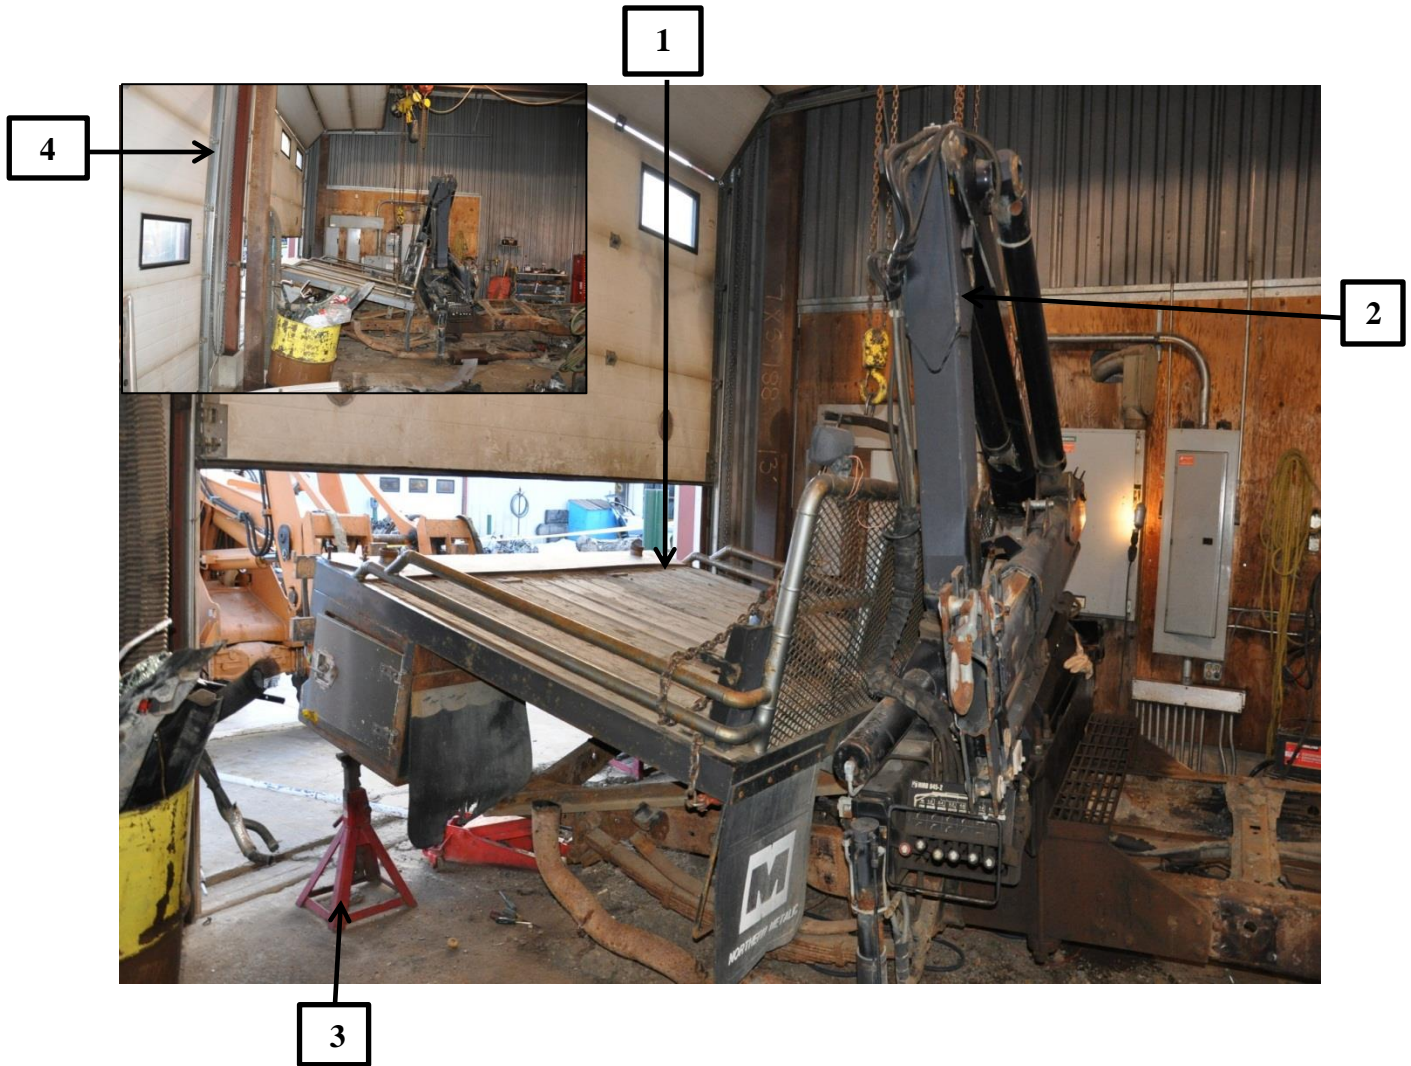
5.1.2.2 The steel deck with bulkhead was bolted (with 8 bolts) to the chassis of the 2001 Ford F-550 truck prior to the incident. (Attachment C, Photograph # 3 and Photograph # 8)

1. Shows the steel deck with bulkhead which was attached to the Ford F-550 vehicle chassis prior to the incident.
2. Shows the HIAB 045-2 truck mounted crane which was attached to the Ford F-550 vehicle chassis.
3. Shows one of the Blackhawk Automotive 10 ton jack stands which was used to support the steel deck.
4. The inset photograph shows a more distant view of the west bay.

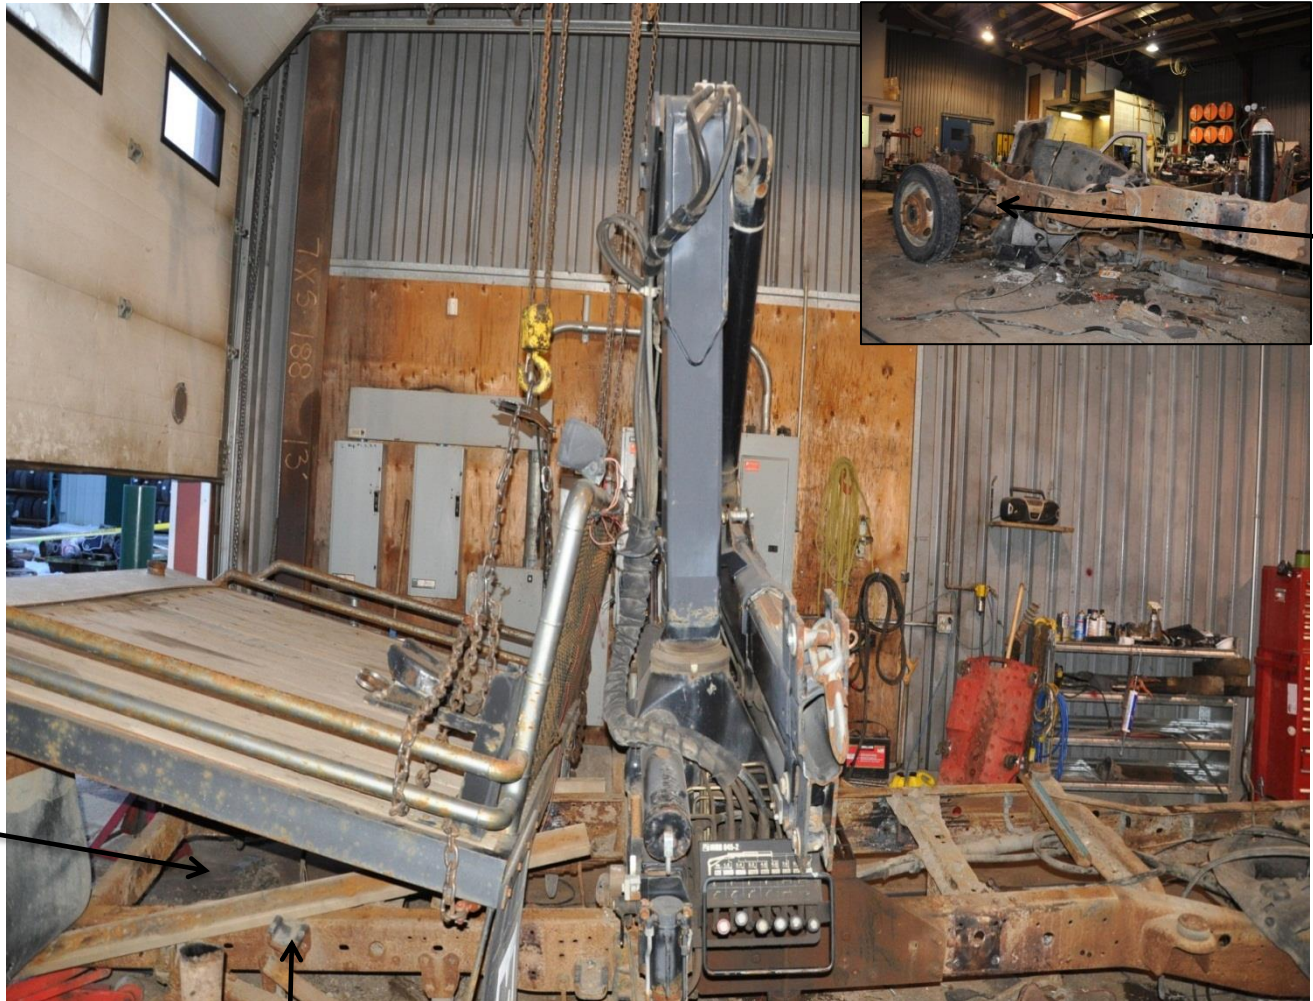
Photograph # 4

5.1.2.3 The chassis of the 2001 Ford F-550 truck was positioned in the west bay of the dismantling building. The front axle and tires were attached to the chassis, the rear axle and tires had been removed. (Attachment C, Photograph # 4)

1. Shows the rear part of the chassis from the Ford F-550 truck.
2. Shows there was no rear axle or rear tire.
3. The inset photograph shows the front part of the chassis from the Ford F-550 truck. It also shows the front axle and tires still attached.

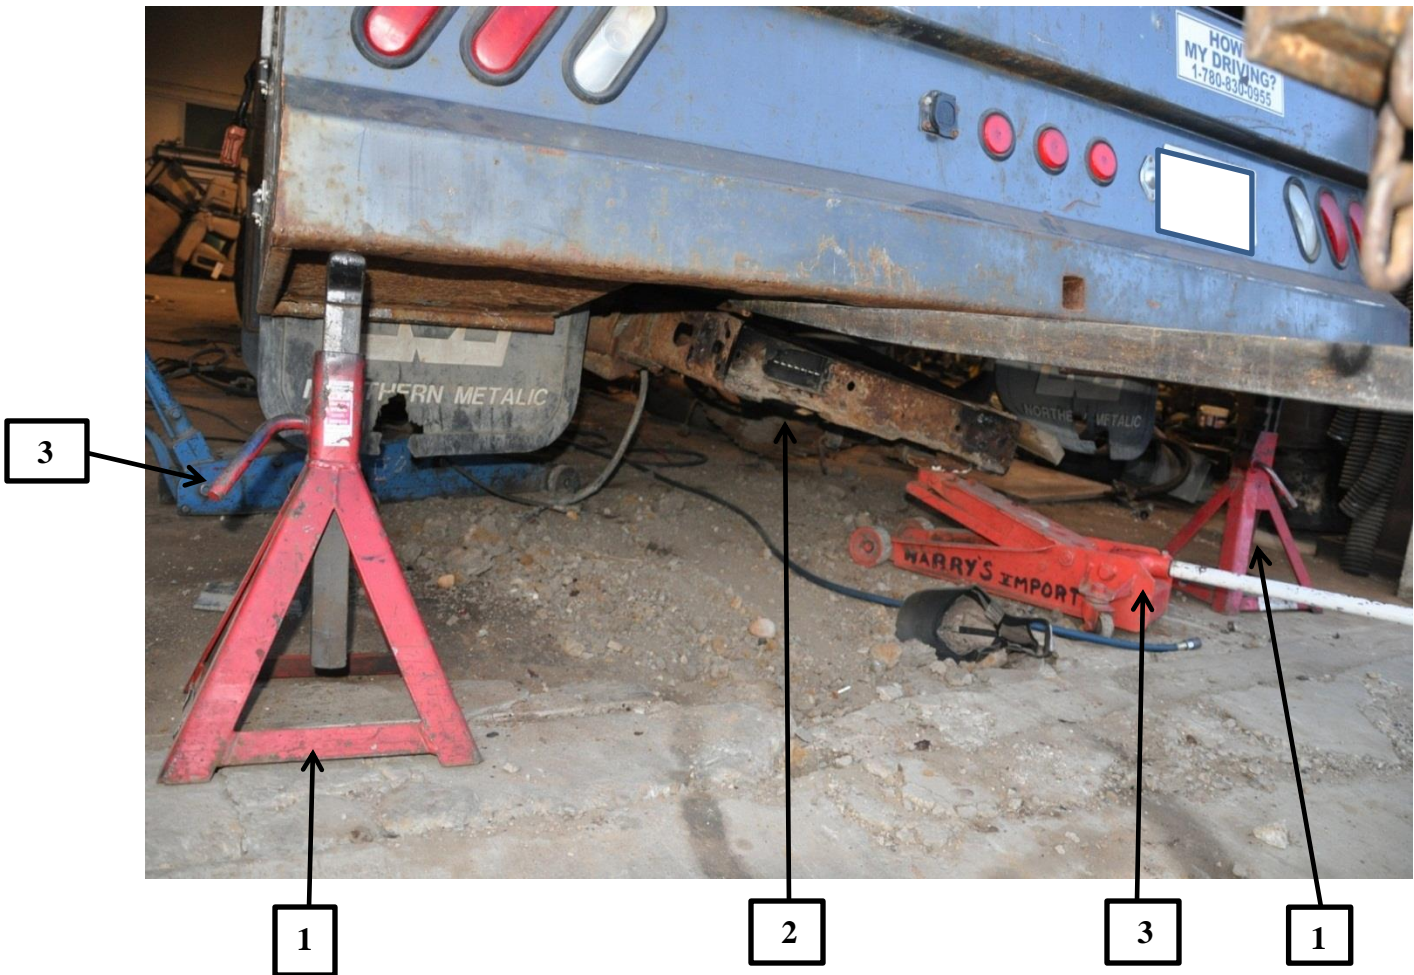
5.1.3.1 The steel deck with bulkhead (which was part of the truck) was supported by two 10 ton Blackhawk Automotive jack stands Model B67312. The jack stands were placed at each rear corner of the steel deck to provide support to the steel deck. (Attachment C, Photograph # 5)

5.2.3 The rear of the chassis was raised up off the shop floor by two floor jacks. The two floor jacks were used at the time of the rescue to lift the chassis off of Dismantler (\*\*\*\*\* \*\*\*\*\*). (Attachment C, Photograph # 5 and Photograph # 7)

1. Shows the 2 Blackhawk Automotive 10 ton jack stands that were placed under each corner of the steel deck to provide support. Dismantler (\*\*\*\*\* \*\*\*) set the jack stands when the Ford F-550 truck was put in the west bay.
2. Shows the chassis of the Ford F-550 truck which fell on Dismantler (\*\*\*\*\* \*\*\*) causing fatal injuries.
3. Shows the two floor jacks which were used during the rescue to lift the chassis off of Dismantler (\*\*\*\*\* \*\*\*)

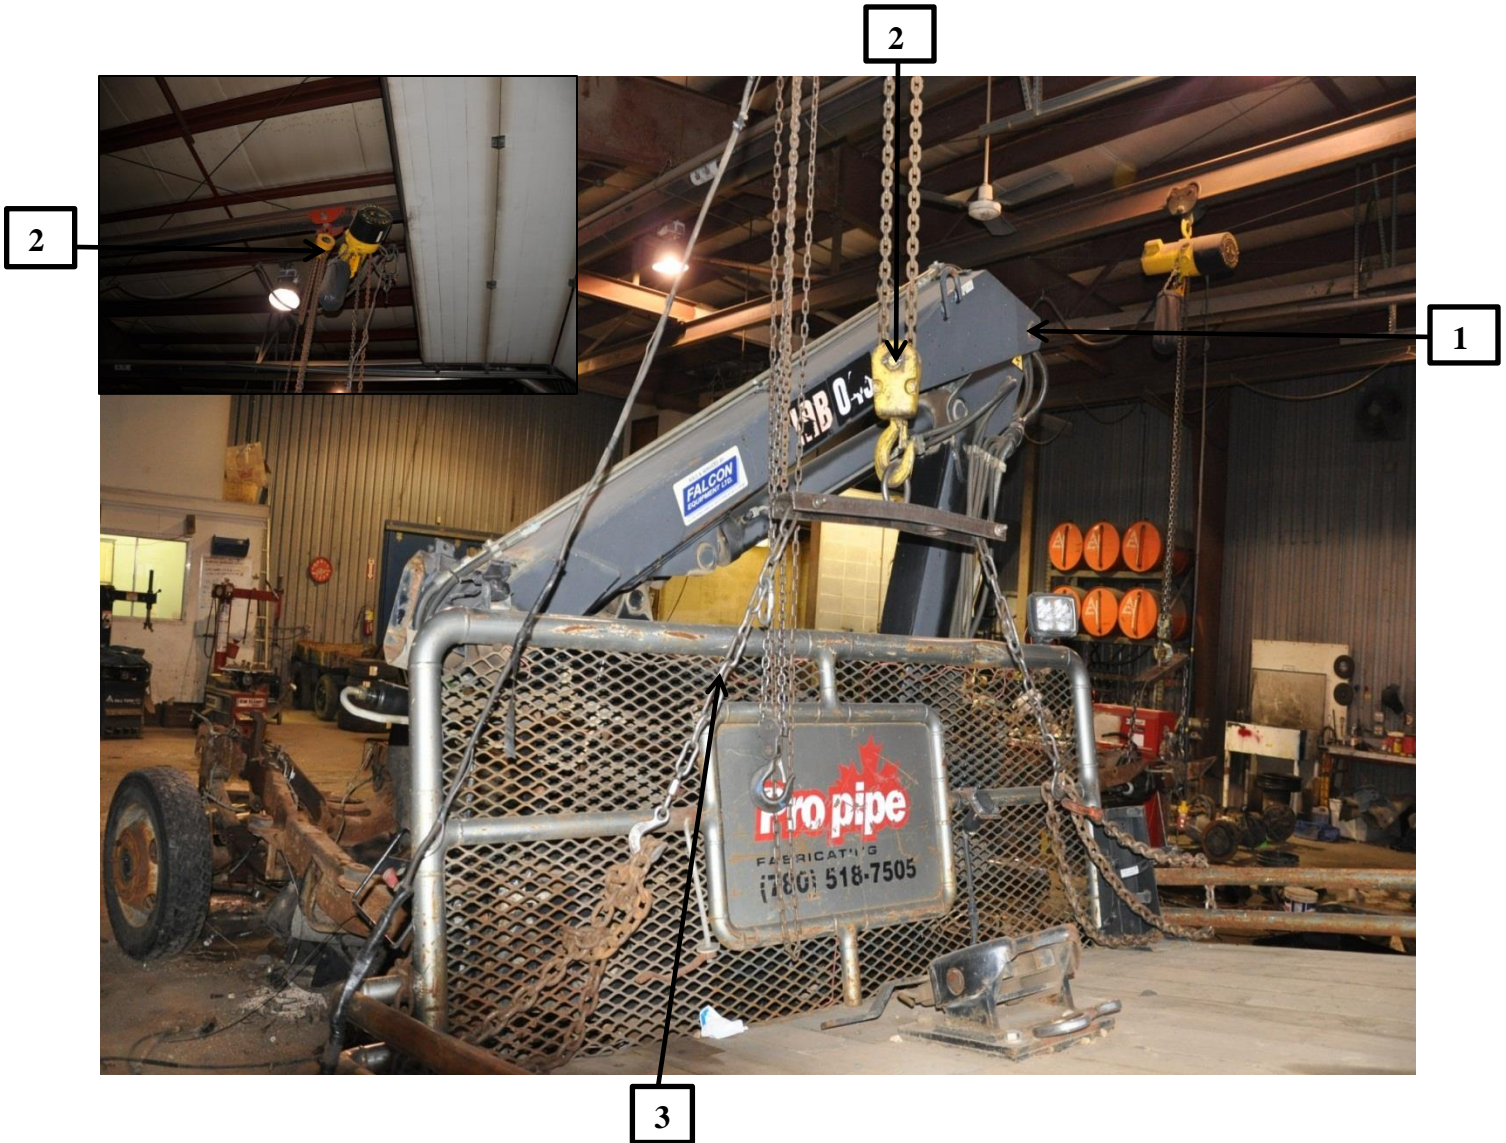
Photograph # 6

5.1.3.2 The Vulcan 2 ton hoist had a homemade spreader bar attached to the hoist hook. The homemade spreader bar had a chain at either end of the spreader bar, and this chain was attached to the side rails of the steel deck to provide support to the steel deck during the dismantling process. (Attachment C, Photograph # 6)

5.1.4.1 The HIAB Model # 045-2 truck mounted crane was attached to the chassis. The HIAB Model # 045-2 truck mounted crane was a “behind the cab mount”. The crane would have added extra weight to the chassis. (Attachment C, Photograph # 6)

1. Shows the HIAB 045-2 truck mounted crane. The crane was a "behind the cab" mount and was attached to the Ford F-550 truck chassis.
2. Shows the Vulcan 2 ton hoist with a homemade spreader bar attached to the 2 ton hoist hook.
3. Shows the chain attached to the homemade spreader bar and wrapped around the steel deck rails.

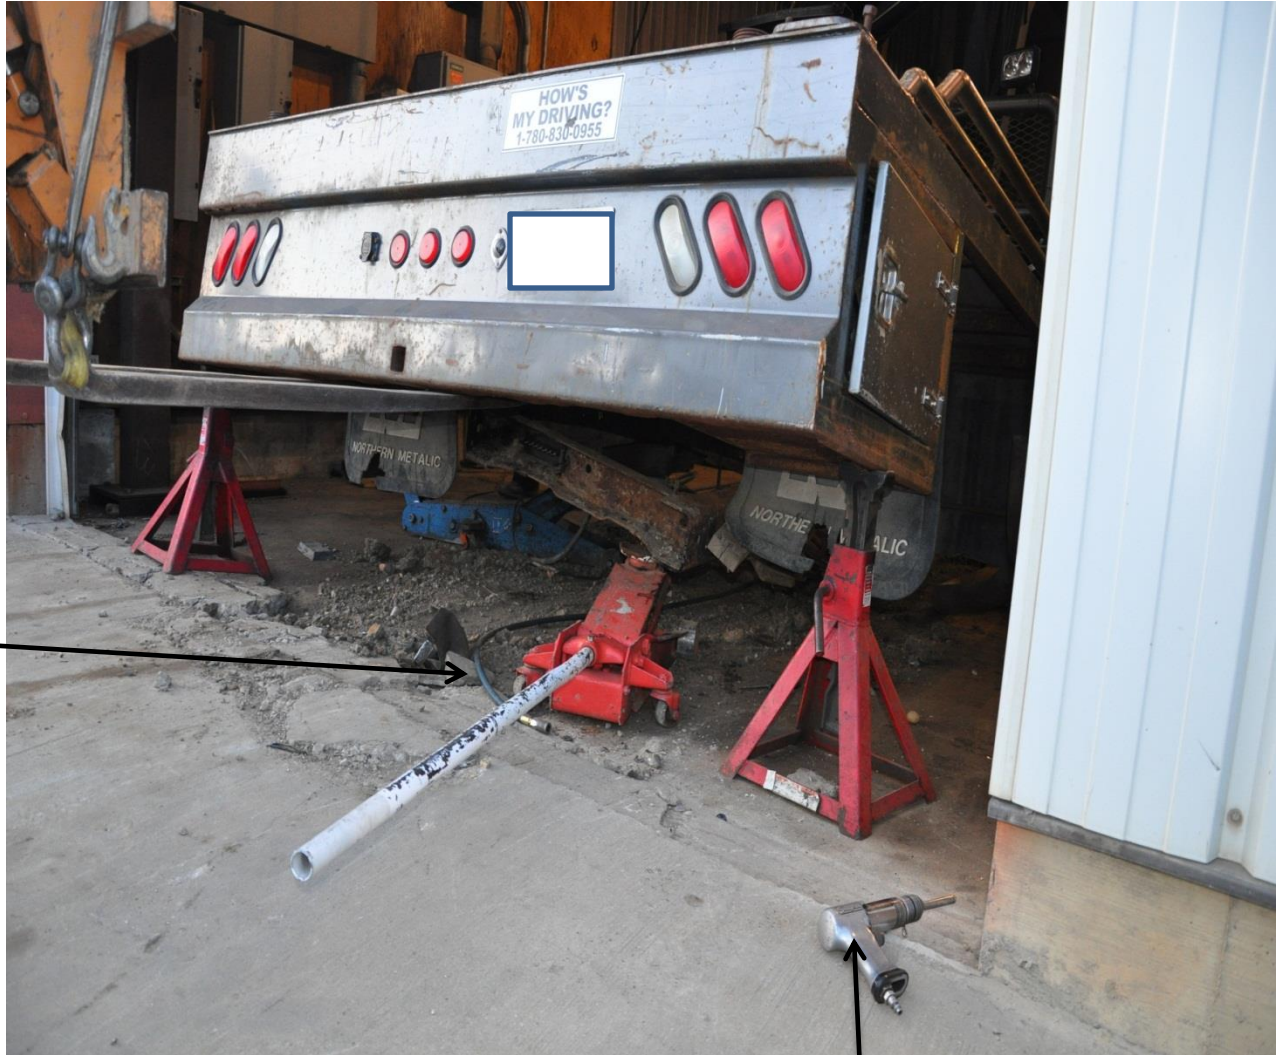
Photograph # 7

5.2.2 There were two Blackhawk Automotive 10 ton jack stands, one under each corner of the steel deck with bulkhead. A front end loader with fork attachment was observed supporting the back end of the steel deck with bulkhead. (Attachment C, Photograph # 7)

5.2.4 An air line was observed underneath the chassis and supported steel deck. An impact gun with a chisel attachment was found at the rear of the supported steel deck. (Attachment C, Photograph # 7)

1. Shows the airline located underneath the truck chassis.
2. Shows the impact gun with chisel attachment.  
Dismantler (\*\*\*\*\* \*\*\*) was using the impact gun with chisel attachment to remove the bolts that attached the steel deck to the truck chassis.  
The photograph also shows the forks of the loader supporting the steel truck deck and the 2 floor jacks used as part of the rescue.

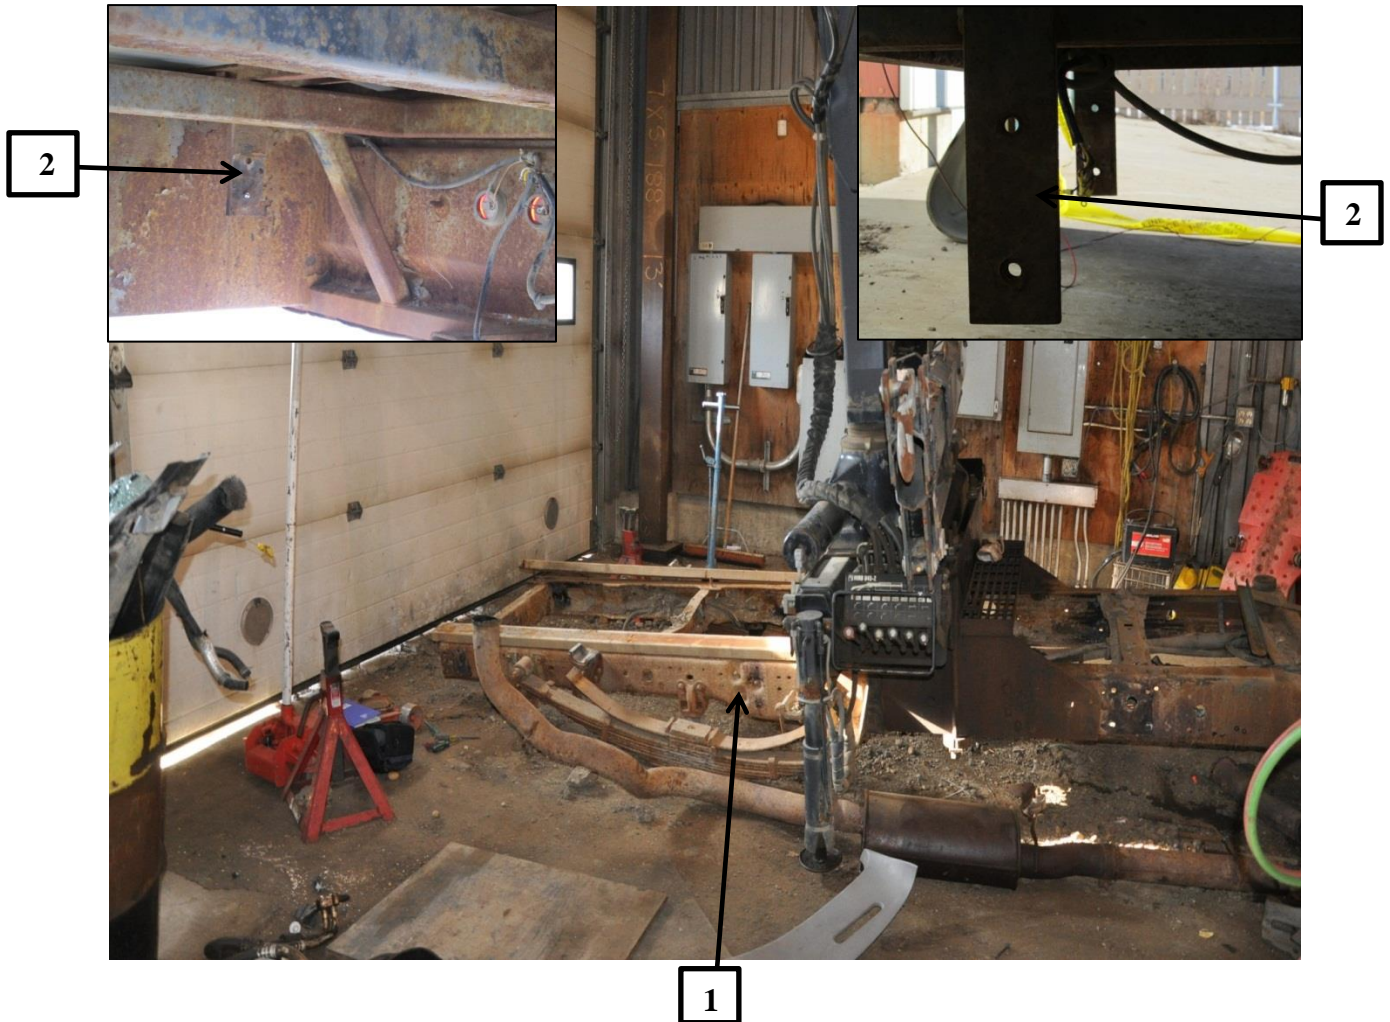
Photograph # 8

- 6.7     The Dismantler (\*\*\*\*\* \*\*\*) was laying on the shop floor underneath the 2001 Ford F-550 truck chassis and steel deck and was using an air chisel working at removing the bolts that attached the steel deck to the chassis. (Attachment C, Photograph # 8)

1. Shows where the steel truck deck was bolted onto the Ford F-550 truck chassis.
2. The inset photographs show the underside of the steel truck deck that was bolted to the truck chassis.

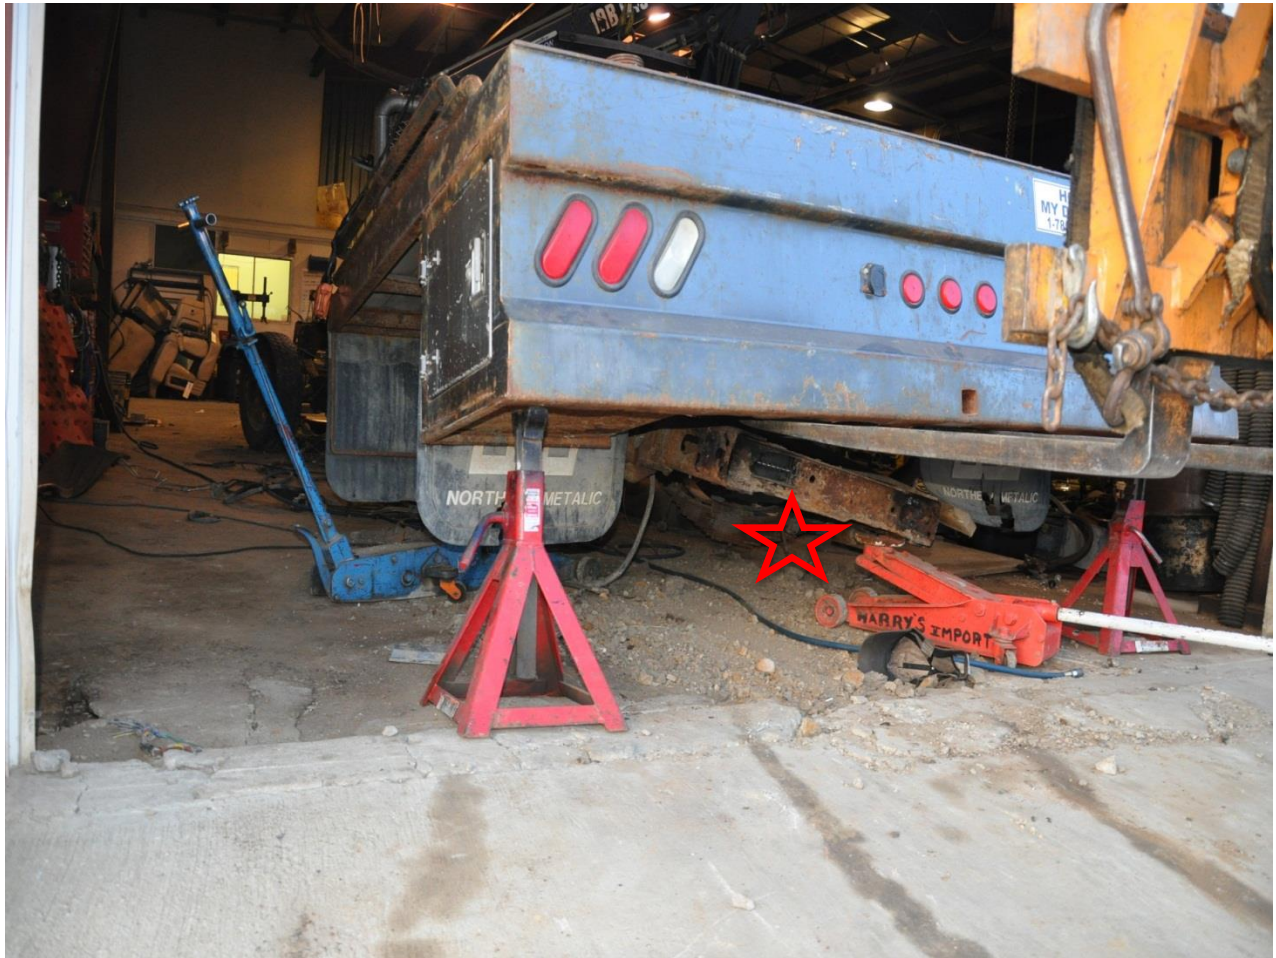
Photograph # 9

The red star shows the approximate location Dismantler (\*\*\*\*\* \*\*\*) was pinned when the Ford F-550 truck chassis fell.
