Investigation Report
Worker fatally injured in farm tractor rollover
May 20, 2019

Report No-F-OHS-171334
March 2021
Page 1 of 9

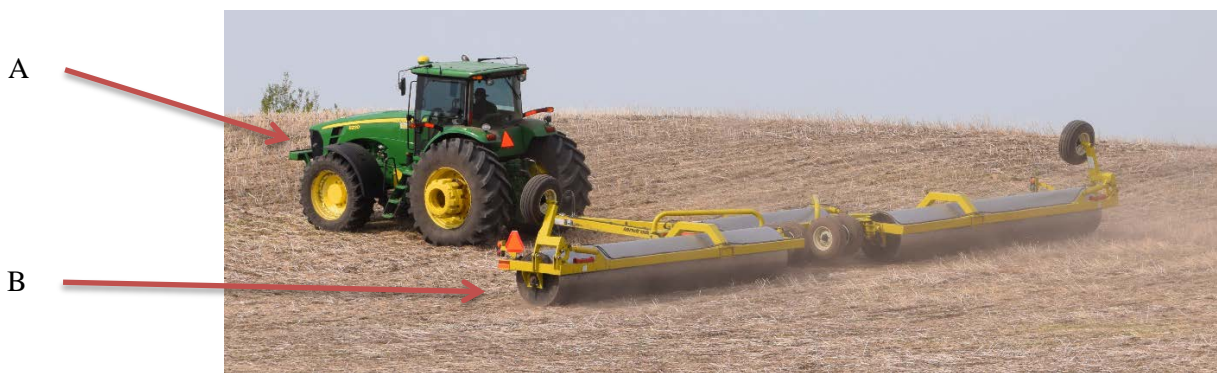
Figure 2. Similar tractor and land roller working at incident site. Photo shows land roller in deployed configuration

- A. Tractor
- B. Land roller

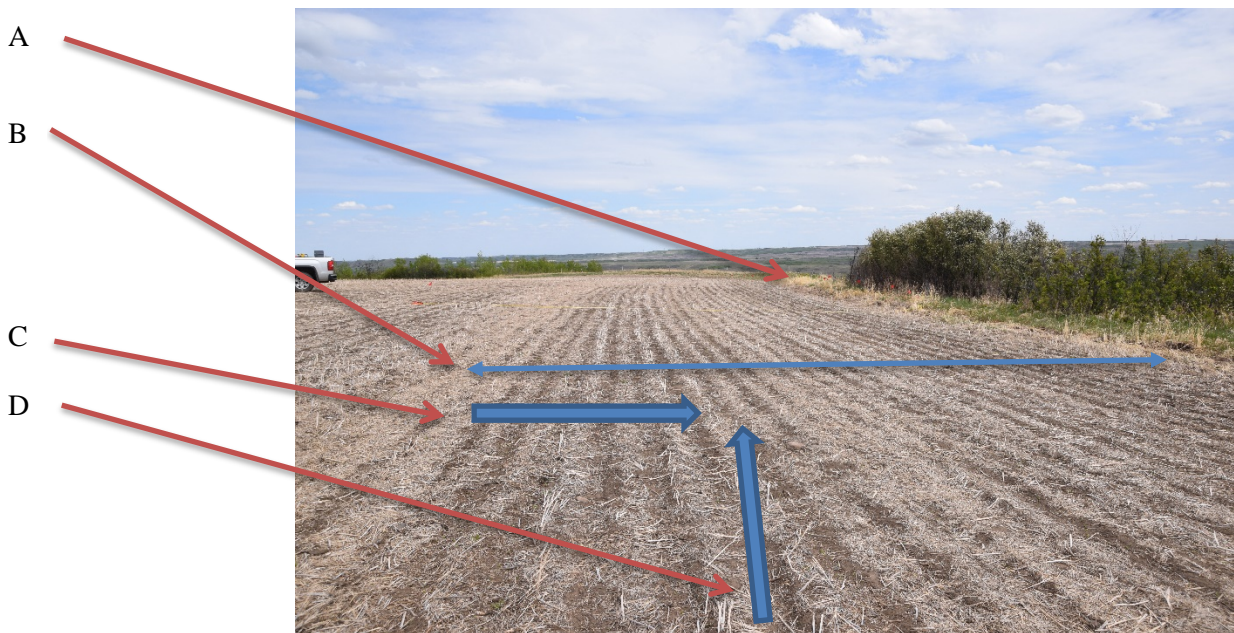
Figure 3. Pea field looking north

Farm hand 1 began a second pass within the set perimeter which placed the tractor and land roller approximately 15 m from the edge of the pea field (Figure 3B). The pea field sloped approximately 4° downwards in the direction of travel and approximately 2° towards the right edge of the field. (Figure 3C and 3D)

- A. Location where tractor and land roller went over edge
- B. Width of land roller path (approximately 15 m) for first pass
- C. Direction of slope to right side of tractor and land roller
- D. Direction of slope in travel path of tractor and land roller

Tire tracks indicated that the tractor gradually travelled across the first pass area until the roller on the right side of the land roller tipped over the edge (Figure 3A). The weight of the roller pulled the tractor further to the right until the tractor and land roller went over the edge and overturned multiple times. Farm hand 1 was ejected from the tractor cab. The tractor and land roller were located approximately 91 m from the edge of the pea field at the bottom of the gully. (Figure 4 and Figure 5)

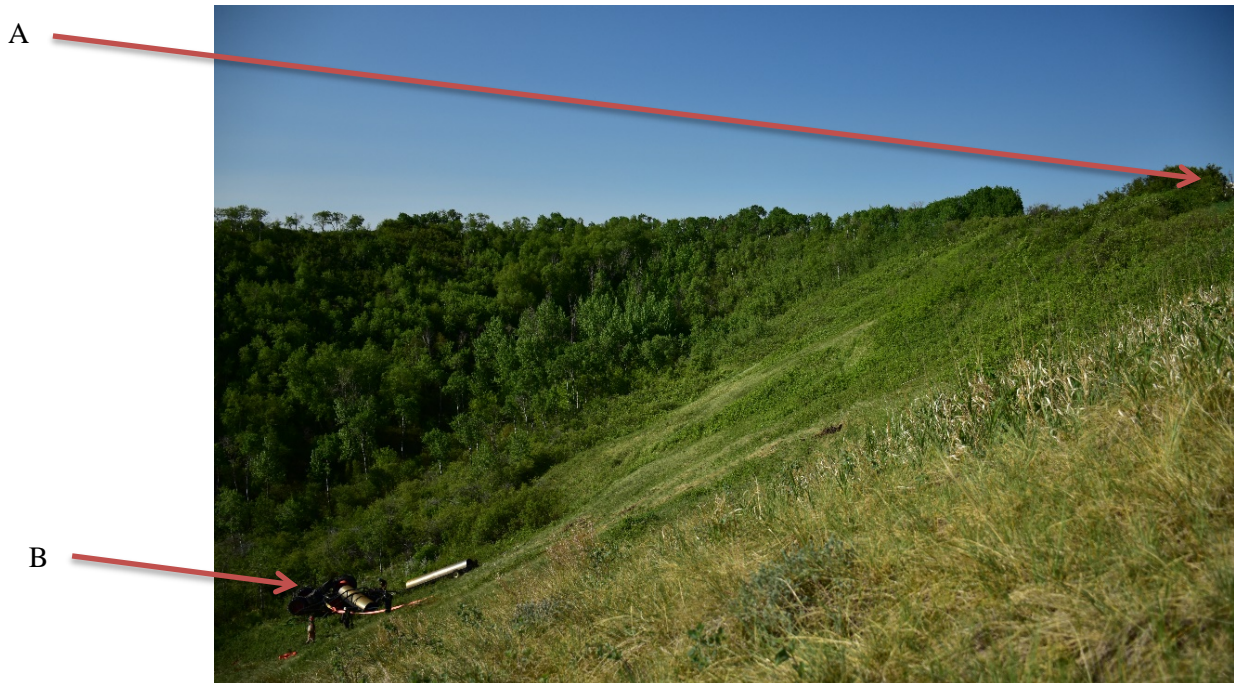
Figure 4. Gully showing slope and final resting place of tractor and land roller

- A. Location where tractor and land roller went over edge*
- B. Location of resting place of tractor and land roller*

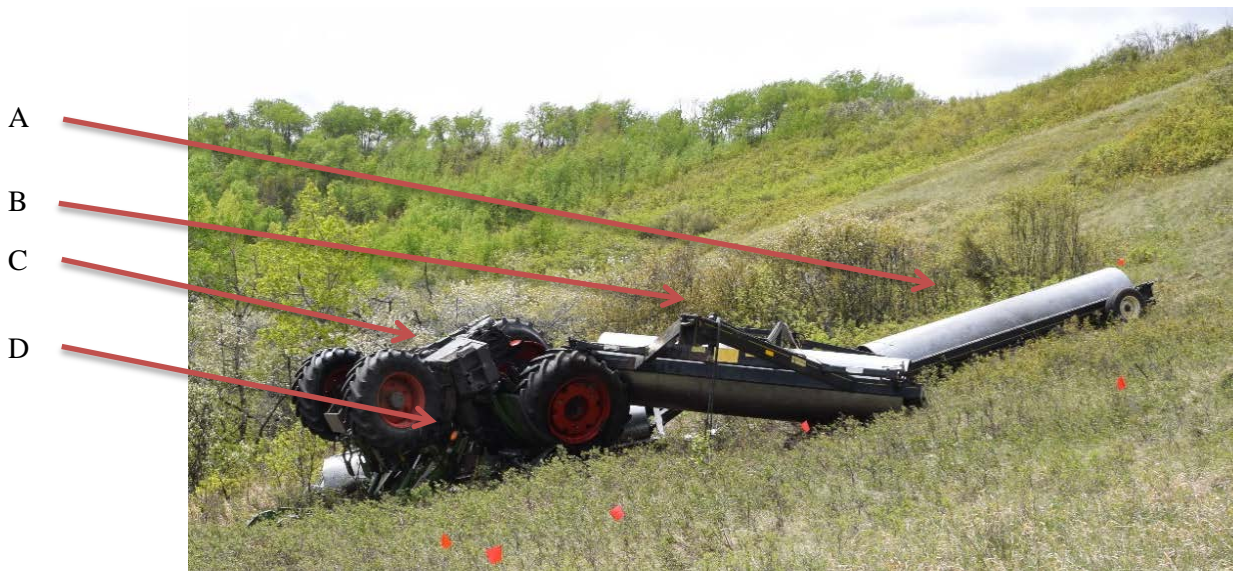
Figure 5. Tractor and land roller

- A. Right roller
- B. Centre roller
- C. Tractor
- D. Left roller
