RECAPP Facility Evaluation Report

Aspen Regional Health Authority

Elk Point Health Centre

B1044A

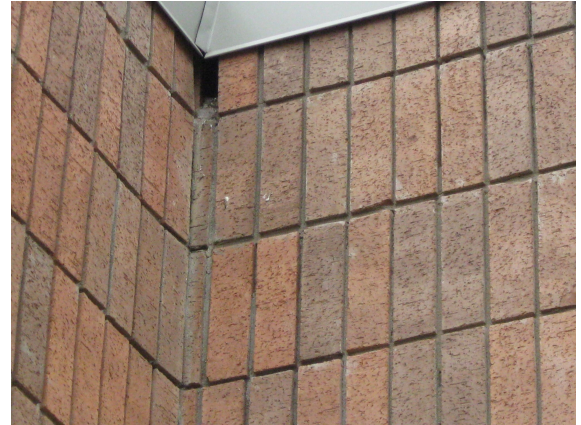
Missing bricks at soffit in corner.

Missing brick at soffit.

Repair areas where brick are missing.

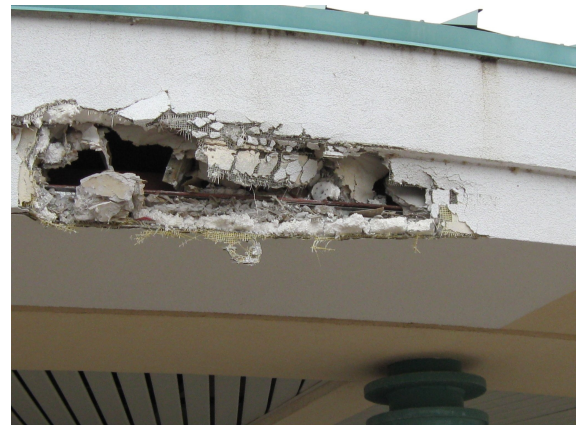
Stucco damaged at exterior face of over hang at pavilion.

Damaged stucco at fascia of pavilion.

Repair damaged areas.

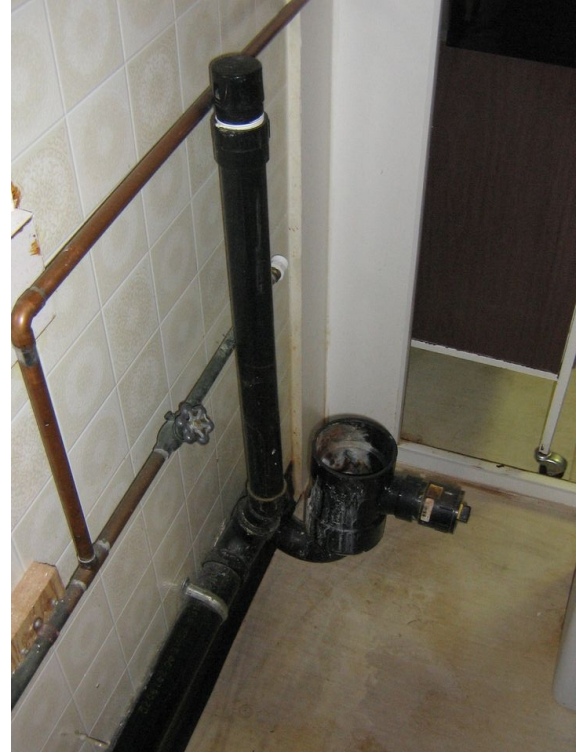
Open pipe.

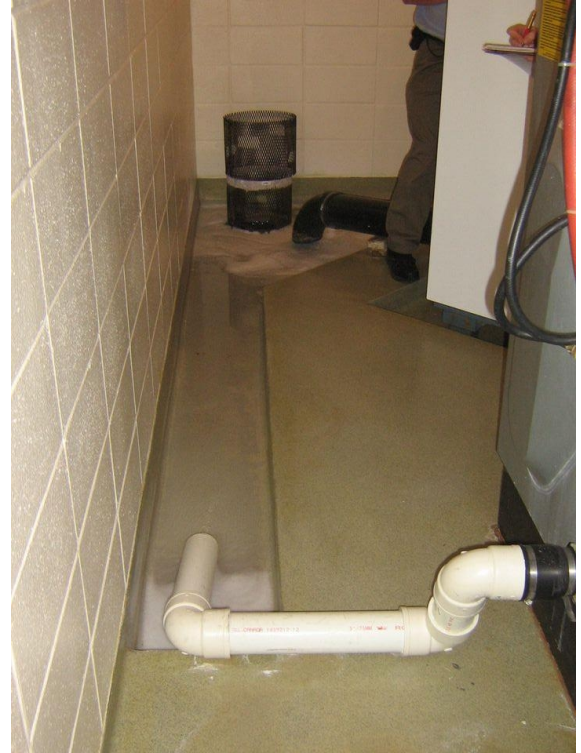
Washing machine drains.

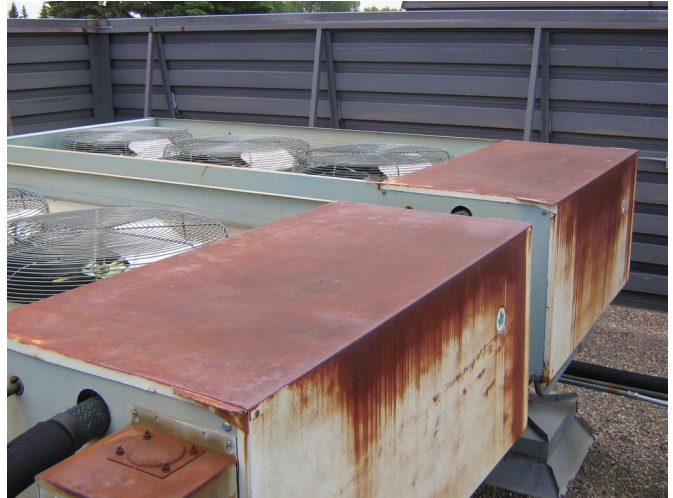
There are York air cooled condensing units on the roof that supply refrigerant to the coils in the air handling units. They use R-22 refrigerant. The name plate on the unit supplying AS-1 was not legible, AS-2's condensing unit is a York model CA340-58B and AS-3's unit is a York CA181-58A.

<u>Rating</u>	<u>Installed</u>	<u>Design Life</u>	<u>Updated</u>
3 - Marginal	1976	25	MAR-10

Rusted condensing units.

Event: Replace 3 Condensing Units

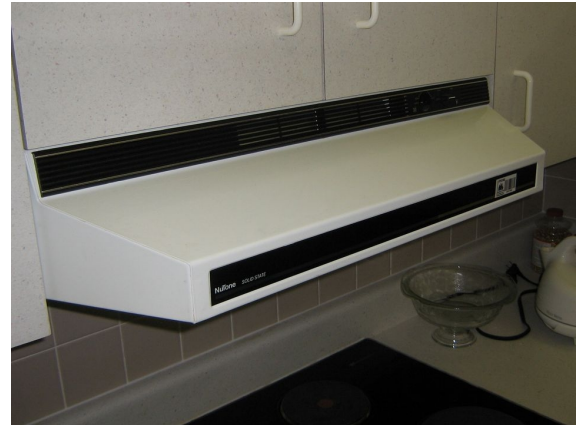
Existing range hood.

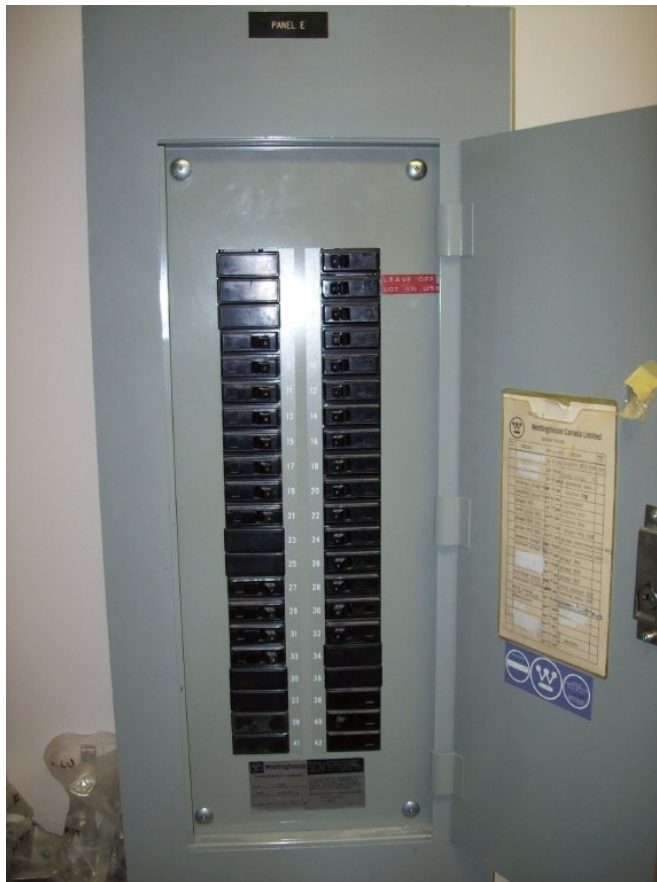
There are approximately 10 branch circuit panelboards and 5 central distribution panels that are located in the Health Centre. Panels are manufactured by Westinghouse and rated for 120/208V or 347/600V 3ph 4w. Panels are color coded for the voltage of the system. Sand color for 347/600V and gray for 120/208V. There is approximately 25% spare capacity overall in the panels and approximately 60% space capacity in the CDP panels. There is 1-50A 120V isolation panel for the O.R. Rooms. The isolation panel is manufactured by Measurement Engineering Limited. The panel is located at the mop sink in the janitor room.

<u>Rating</u>	<u>Installed</u>	<u>Design Life</u>	<u>Updated</u>
2 - Poor	1976	30	MAR-10

Typical Westinghouse branch circuit panel

Event: Replace 11 branch circuit panels and 5 CDP's

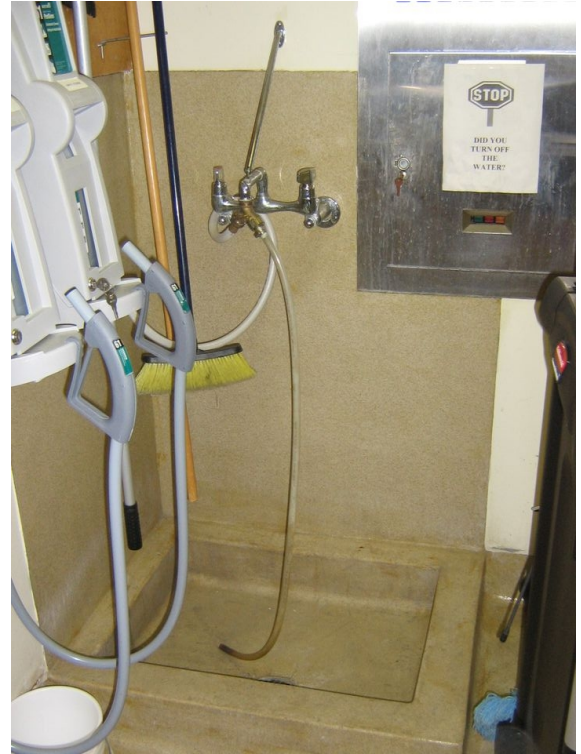
Isolation panel located at the mop sink

Event: Relocate 1 isolation panel

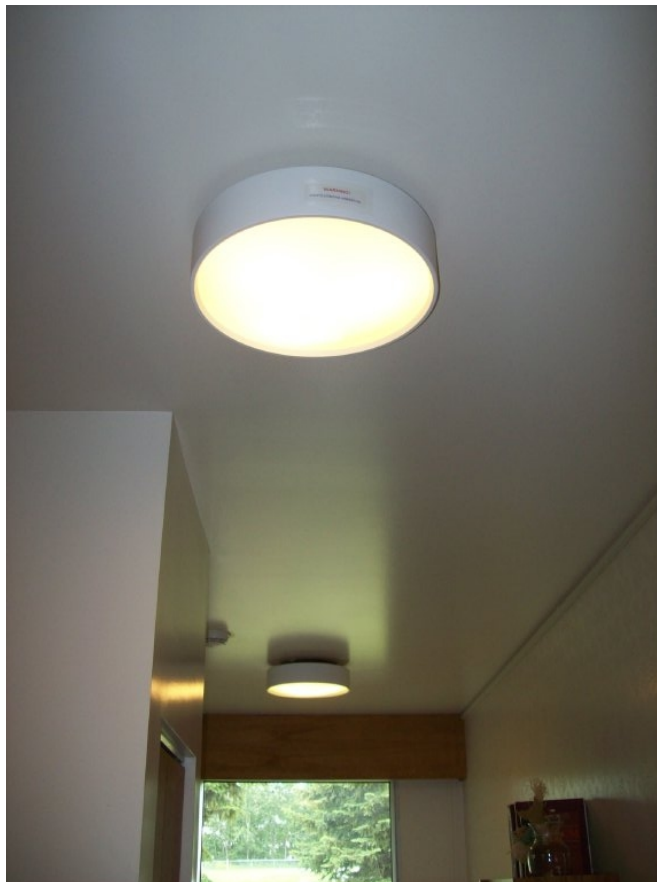
Incandescent drum lights that contain asbestos

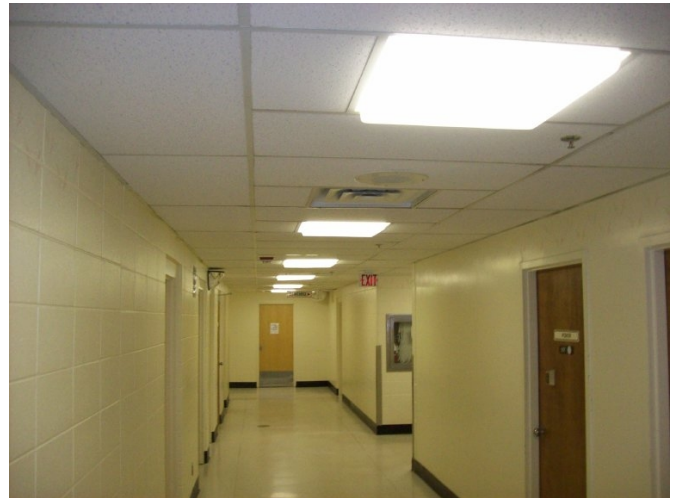
T12 lamps and ballasts will no longer be available for purchase after 2011. Lamps and ballasts will need to be retrofitted at once, or part of a maintenance program by 2010.

Drop lens fluorescent fixtures in health centre corridor.

Event: Replace Interior Fluorescent Fixtures (3180sq m)

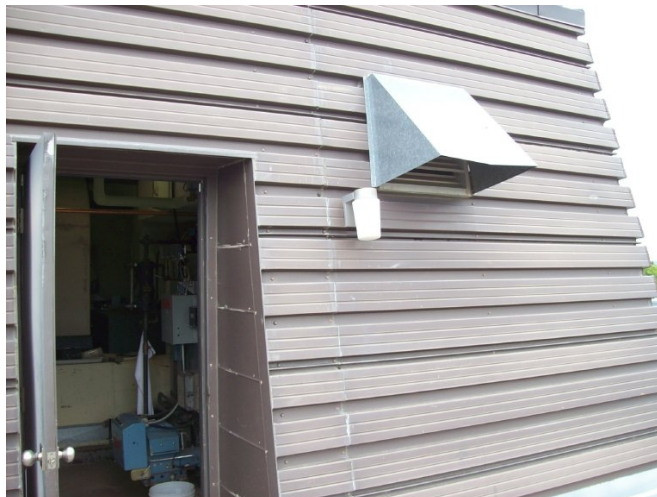
<u>Rating</u>	<u>Installed</u>	<u>Design Life</u>	<u>Updated</u>
3 - Marginal	1976	30	MAR-10

Exterior incandescent fixture at roof

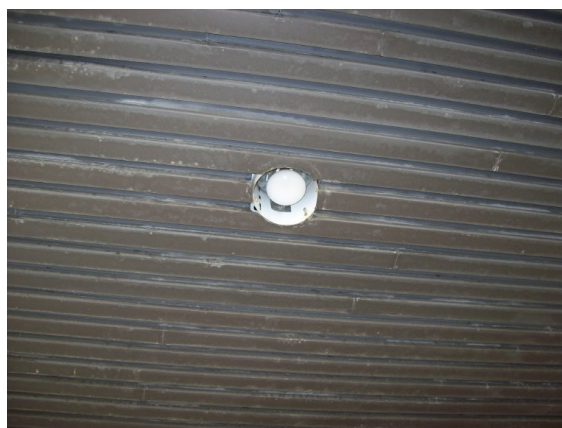
Missing trim on downlight

Event: Replace 3 downlight trims

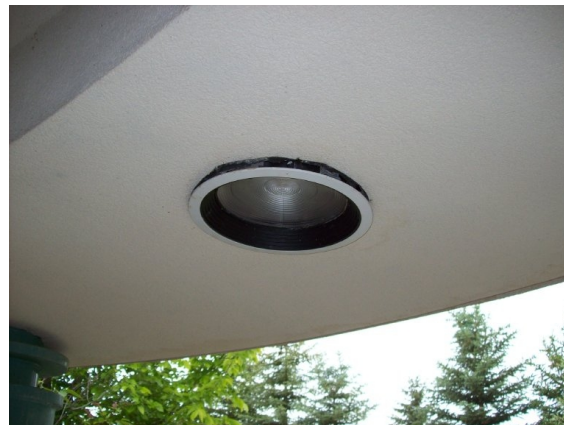
Trims separating from downlights.

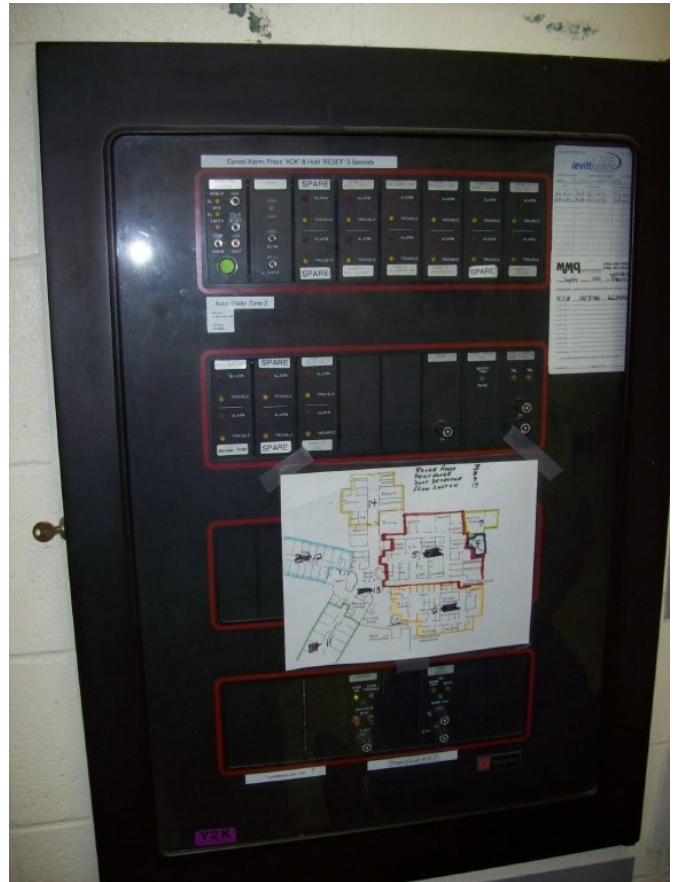
<u>Rating</u>	<u>Installed</u>	<u>Design Life</u>	<u>Updated</u>
2 - Poor	1976	25	MAR-10

Simplex FACP dating from 1976 Const.

Event: Replace Fire Alarm System (4120sq m)

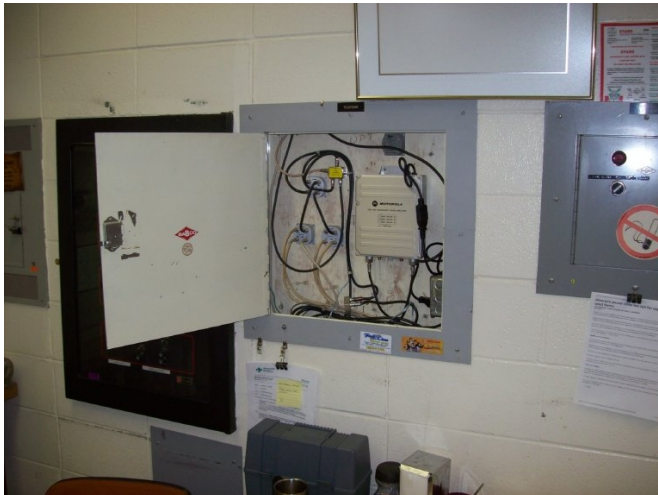
<u>Rating</u>	<u>Installed</u>	<u>Design Life</u>	<u>Updated</u>
3 - Marginal	1976	20	MAR-10

The main CATV demarcation

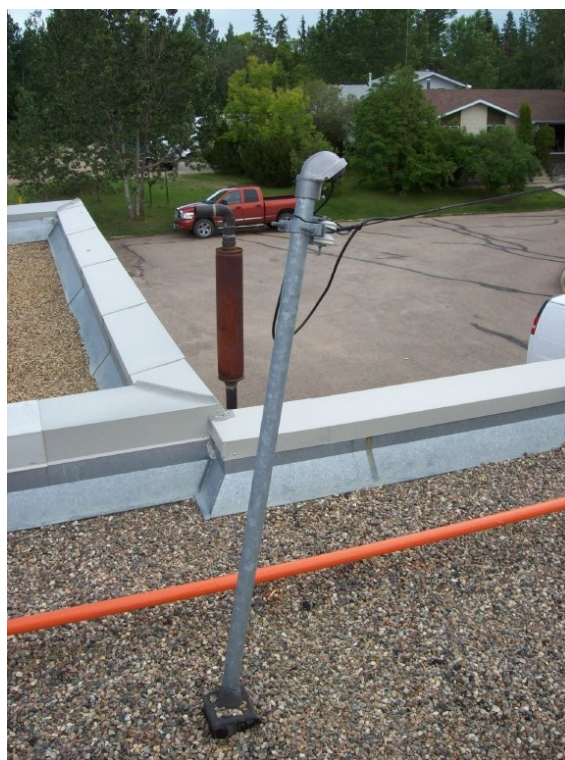
Crooked CATV service mast

Event: Repair CATV service mast
