Worker crushed by hydraulic equipment

January 19, 2020

A worker sustained fatal injuries when crushed by hydraulic equipment on a drilling rig at an oilsands mine north of Fort McMurray, Alberta.

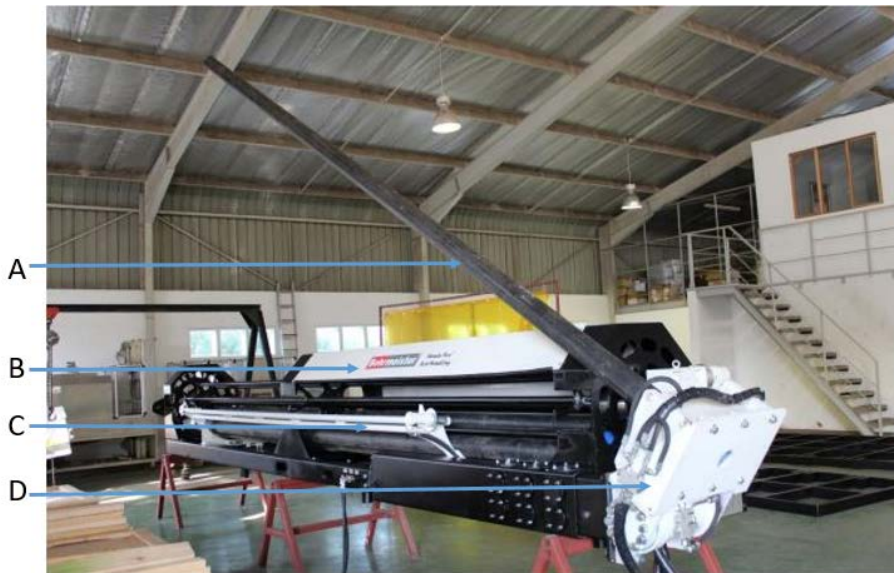
Figure 1. Bohrmeister rod handler. Image provided by Google Images.

- A. Pipe/rod
- B. Carousel housing
- C. Lifting skirt
- D. Pipe clamp

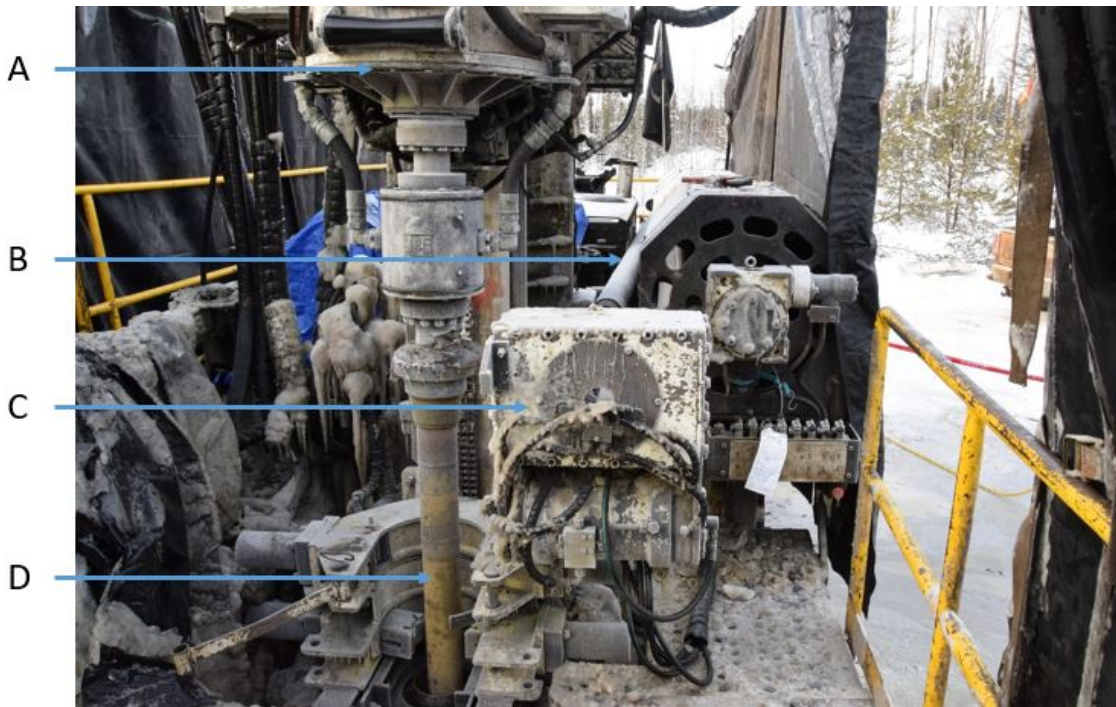
Figure 2. Sonic Rig 701, rig floor.

The Driller also noticed that the rod unloading from the carousel was crooked (Figure 2) and that the Floor-hand’s knee was stuck on the telescopic arm control lever that moved the clamp in towards the carousel (Figure 3). The Driller moved the Floor-hand’s leg off the telescopic arm control lever and released the pressure on the Floor-hand’s back by pulling the lever and retracting the pipe clamp away from the carousel.

- A. Drill head
- B. Jammed rod
- C. Pipe clamp
- D. Pipe (mostly drilled down hole)

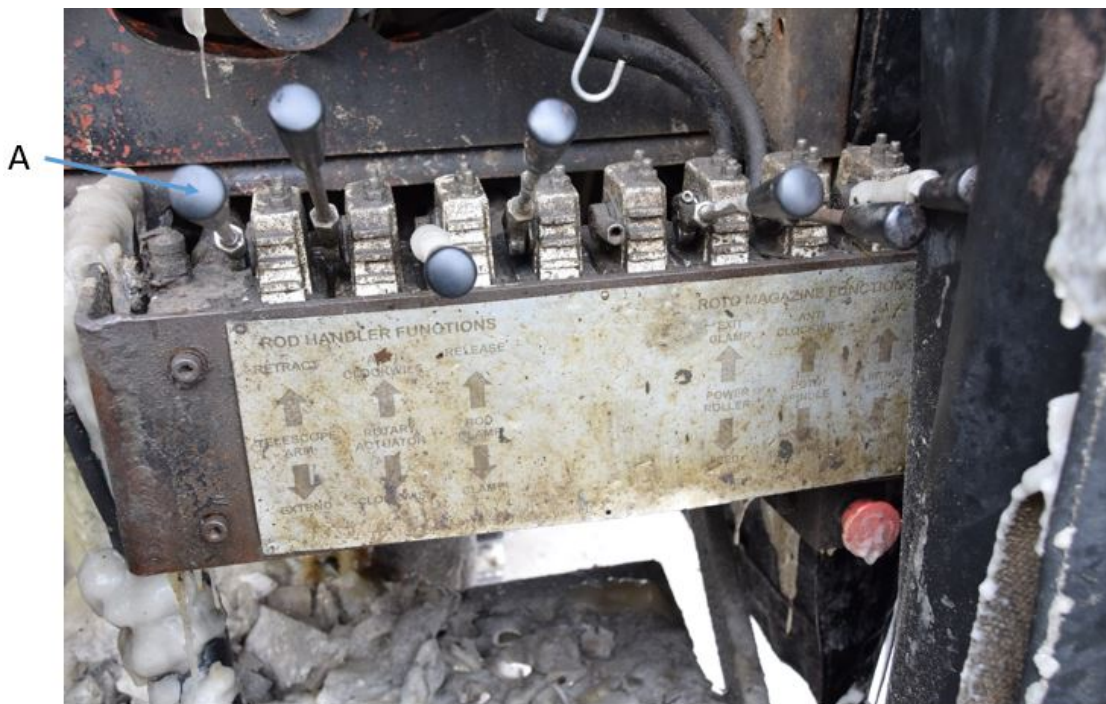
Figure 3. Rod handler control levers.

- A. Telescopic arm control lever

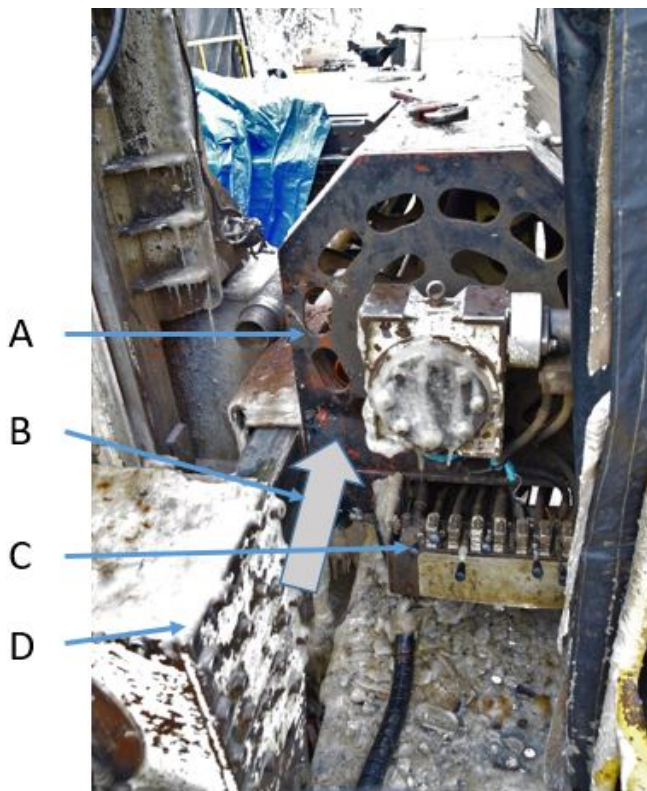
Figure 4. Rod handler work area.

- A. Crush point between rod carousel and rod clamp
- B. Arrow shows direction of travel for the rod clamp when lever (C) was pushed forward
- C. Telescopic arm control lever
- D. Pipe clamp
