**Worker Struck by Equipment**

Type of Incident: Fatality

Date of Incident: February 20, 2012

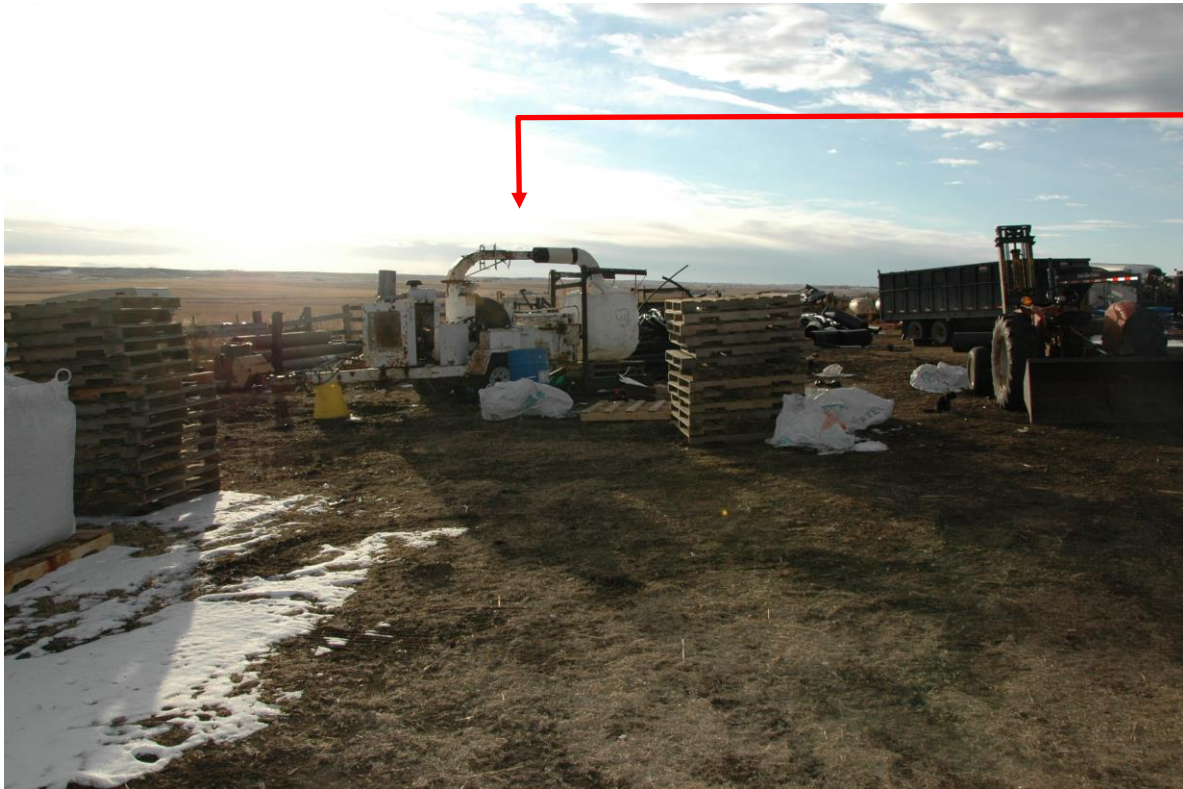
**Photograph 1** – Shows the incident scene looking south/southwest.

5.1.1 Brush Bandit Model 250 wood chipper (chipper) modified to chip plastic. See Attachment B – Photographs 1, 2 and 3. The chipper had been modified to chip plastic prior to its purchase.

1. Shows the chipper involved in the incident.

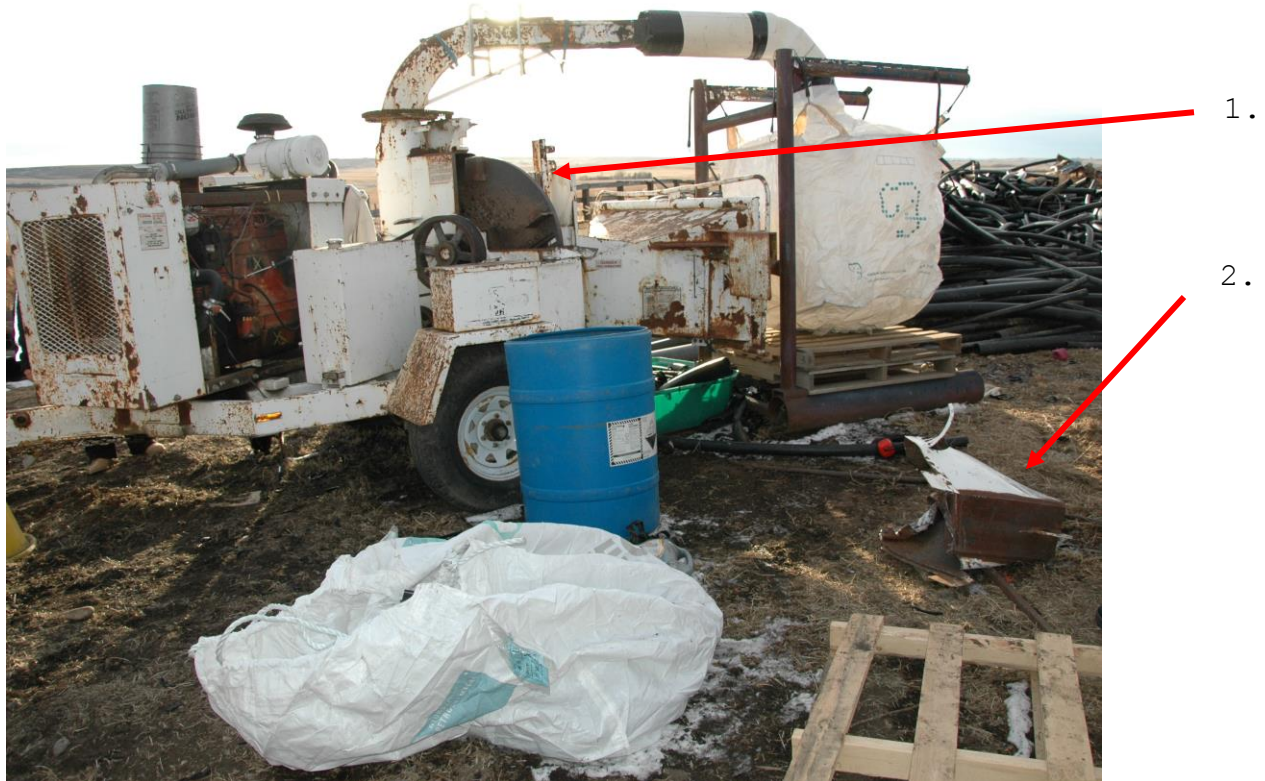
**Photograph 2** – Shows the chipper and guard.

5.2.5 A metal guard that covered the chipping wheel had detached from the chipper. The guard measured approximately 57 cm long, 49 cm high and 20.2 cm wide. See Attachment B – Photographs 2, 3 and 4. First Responder witness statements indicate the guard was found near the injured worker.

1. Shows the chipping wheel that had been covered by the guard.
2. Shows the guard.

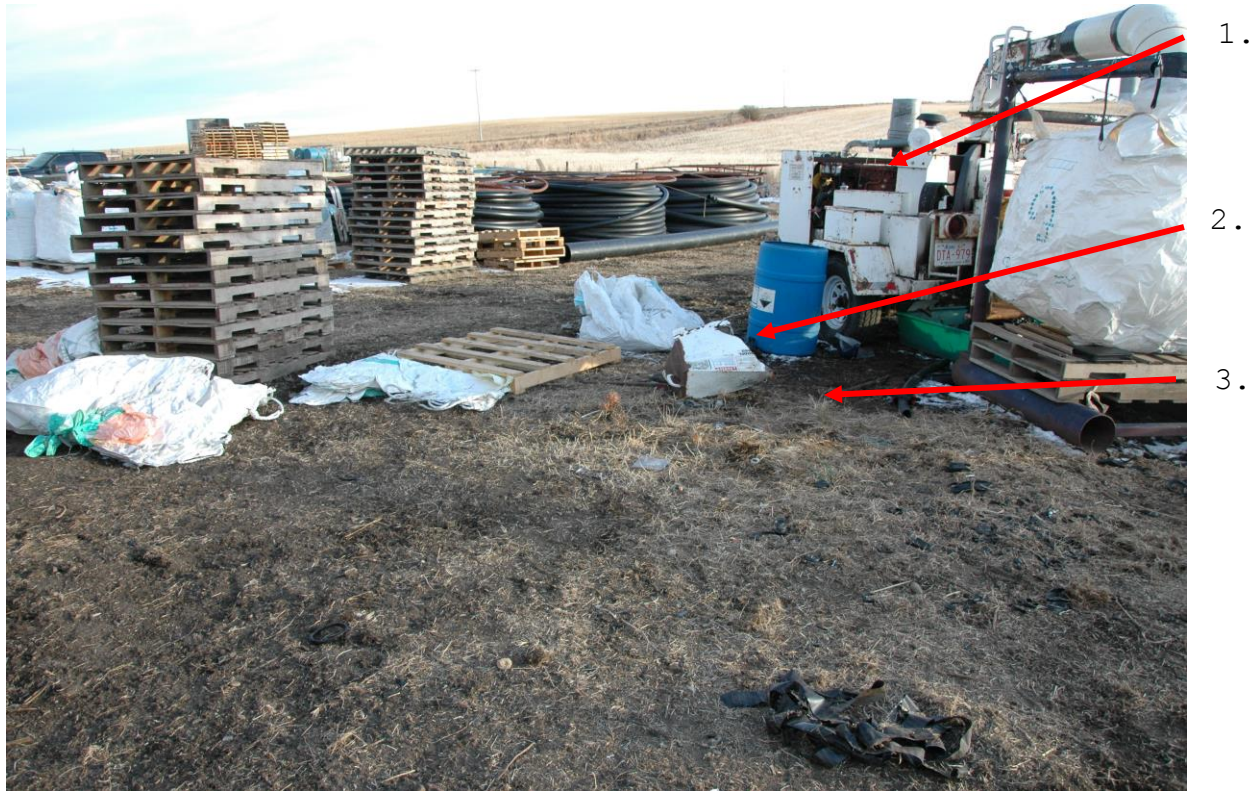
**Photograph 3** – Shows the chipper and guard.

1. Shows the chipping wheel.
2. Shows the guard.
3. Shows the approximate location of the worker after the incident.

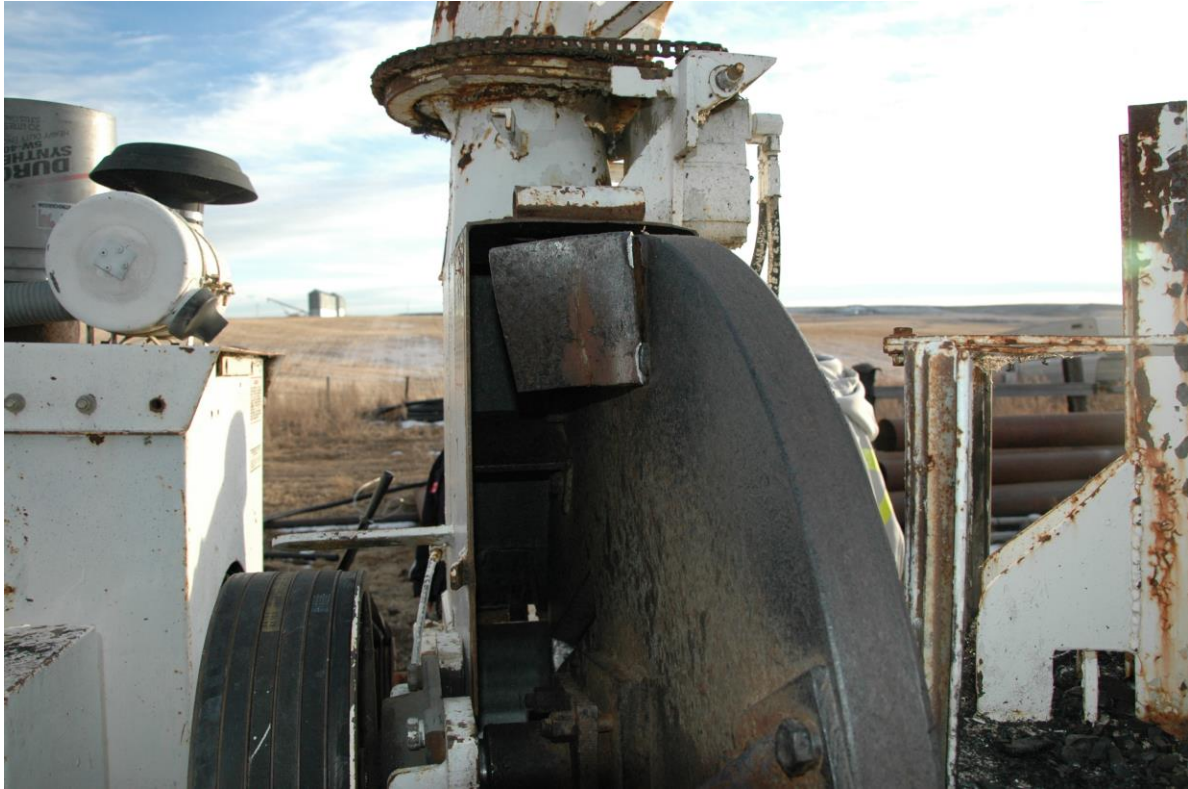
**Photograph 5** – Shows the chipping wheel with a damaged paddle.

5.2.4 One paddle on the chipping wheel was damaged.
