# Worker electrocuted

September 29, 2021

A Journeyman Electrician was conducting thermal imaging of electrical systems in an electrical room at the Southcentre Mall in Calgary when they were fatally injured after coming into contact with an energized high-voltage transformer.

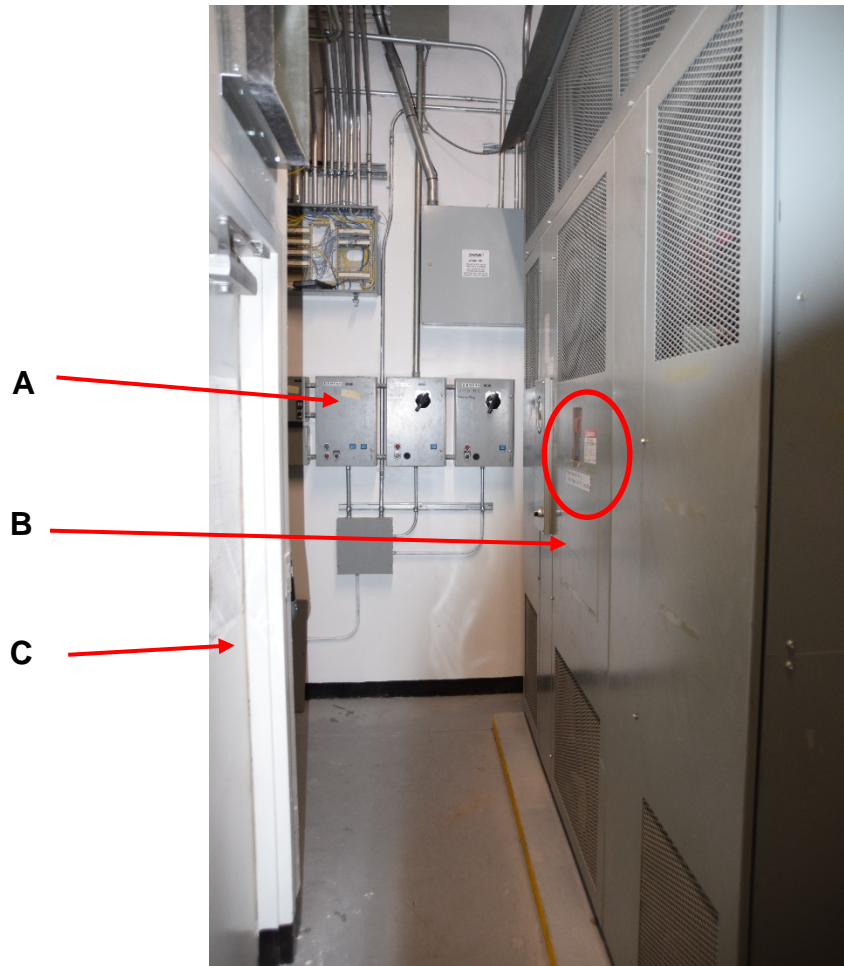
Figure 2. Room 110 as viewed looking to the left of the door.

- A. Identifies some of the low voltage electrical panels located on the periphery of the room
- B. Identifies transformer T-13 (Circle indicates the labels shown in Figures 3 and 4)
- C. Identifies the location of the door to enter Room 110

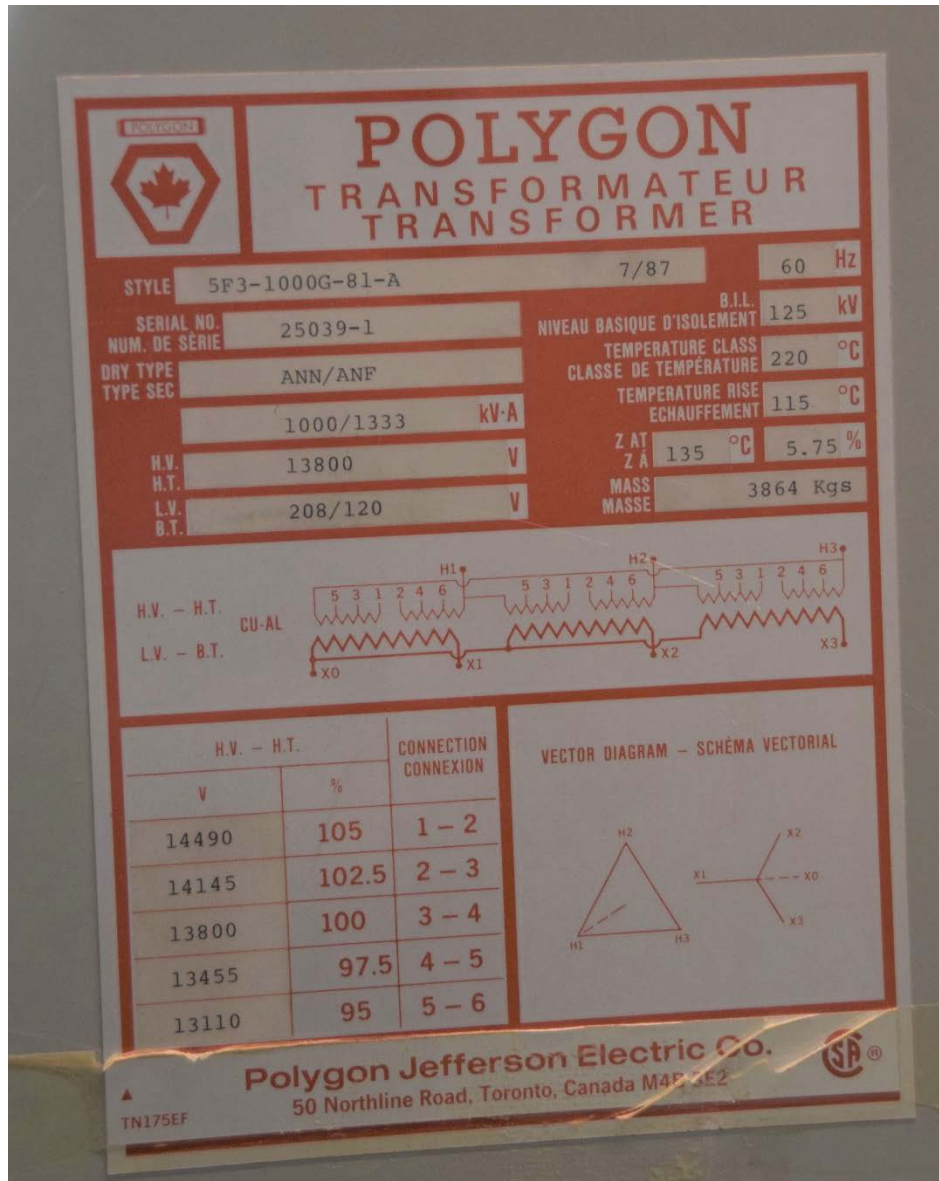
Figure 3. Manufacturer plate on electrical transformer T-13

The electrical transformer involved in the incident was a Polygon 13 800 V 1000/1333 kilovolt-ampere (kV-A) transformer (identified as T-13) that had been manufactured by the Polygon Jefferson Electric Co. in 1987 (Figures 3 and 4). This unit was a three-phase, dry-type power transformer and was located in Room 110 in the Southcentre Mall.

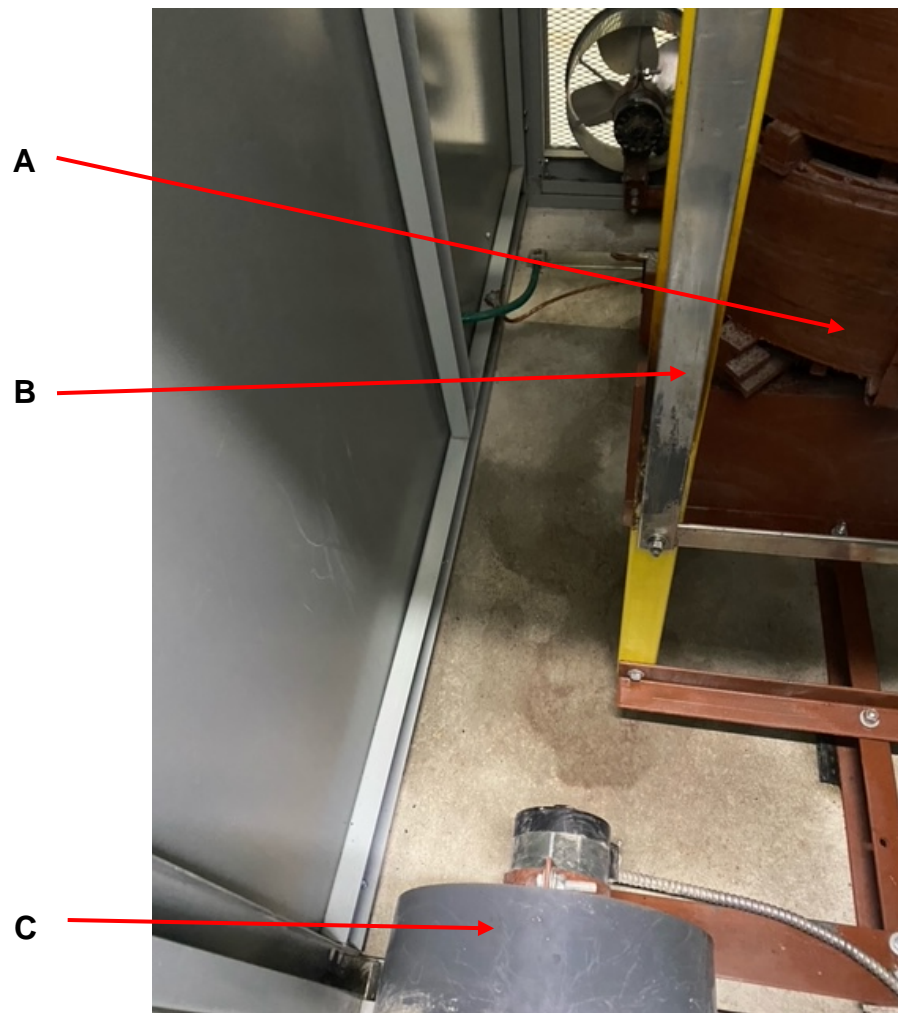
*Figure 5. View inside the cabinet of electrical transformer T-13 (Photograph submitted to Occupational Health and Safety by Oxford Properties Group)*

The electricians had completed the thermal imaging of the low voltage equipment, and the Journeyman Electrician had cleaned the various electrical panels and had tightened electrical connections in the low voltage panels. Once this was completed, the Journeyman Electrician had moved to the area behind transformer T-13 and proceeded to open the back panel to transformer cell H3. The Journeyman Electrician came into contact with the energized busbar on transformer cell H3 and was fatally electrocuted (Figure 5).

*A. Identifies the transformer cell H-3*

*B. Identifies the H3 busbar*

*C. Identifies the fan that the worker was laying on at the time of incident*
