**WORKER STRUCK BY FUEL
TANK FILLER NECK**

Type of Incident: Fatality

Date of Incident: October 17, 2010

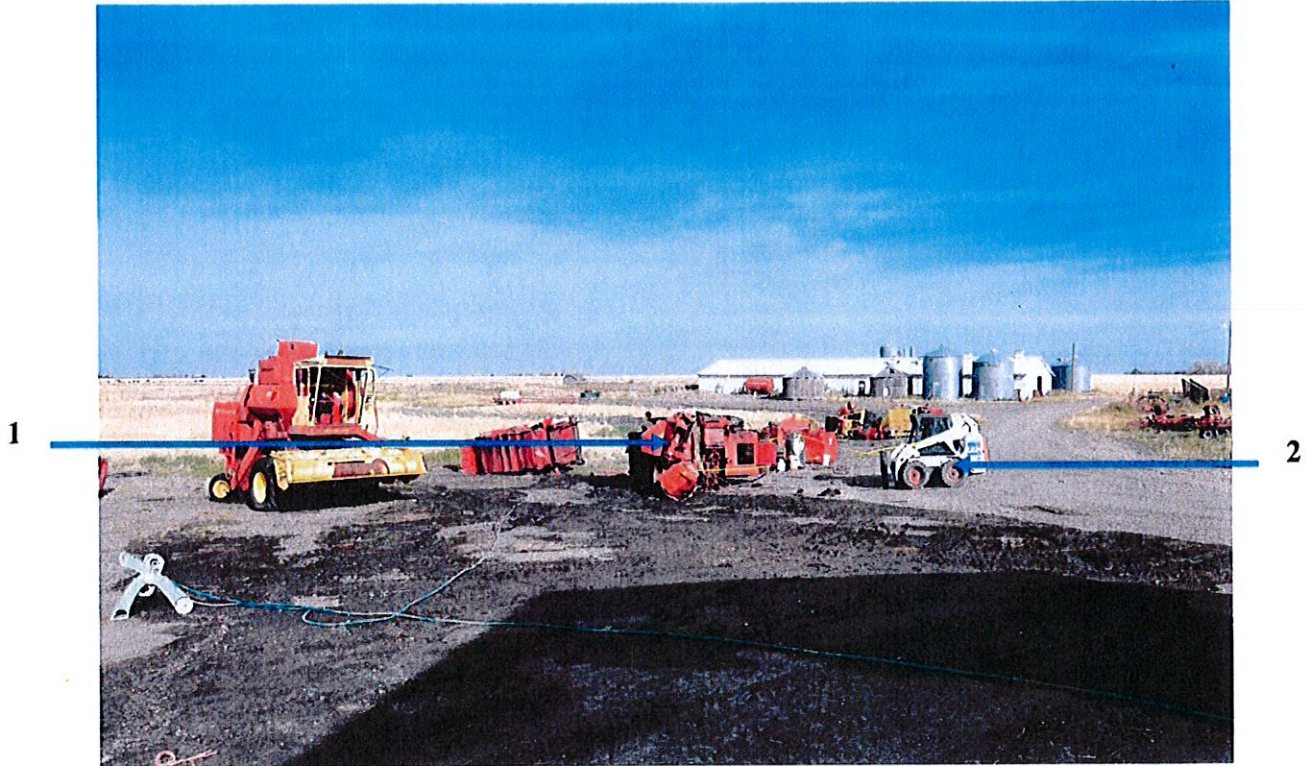
Photograph #1: Shows the site of the incident.

1 The scrap combine.

2 The bobcat.

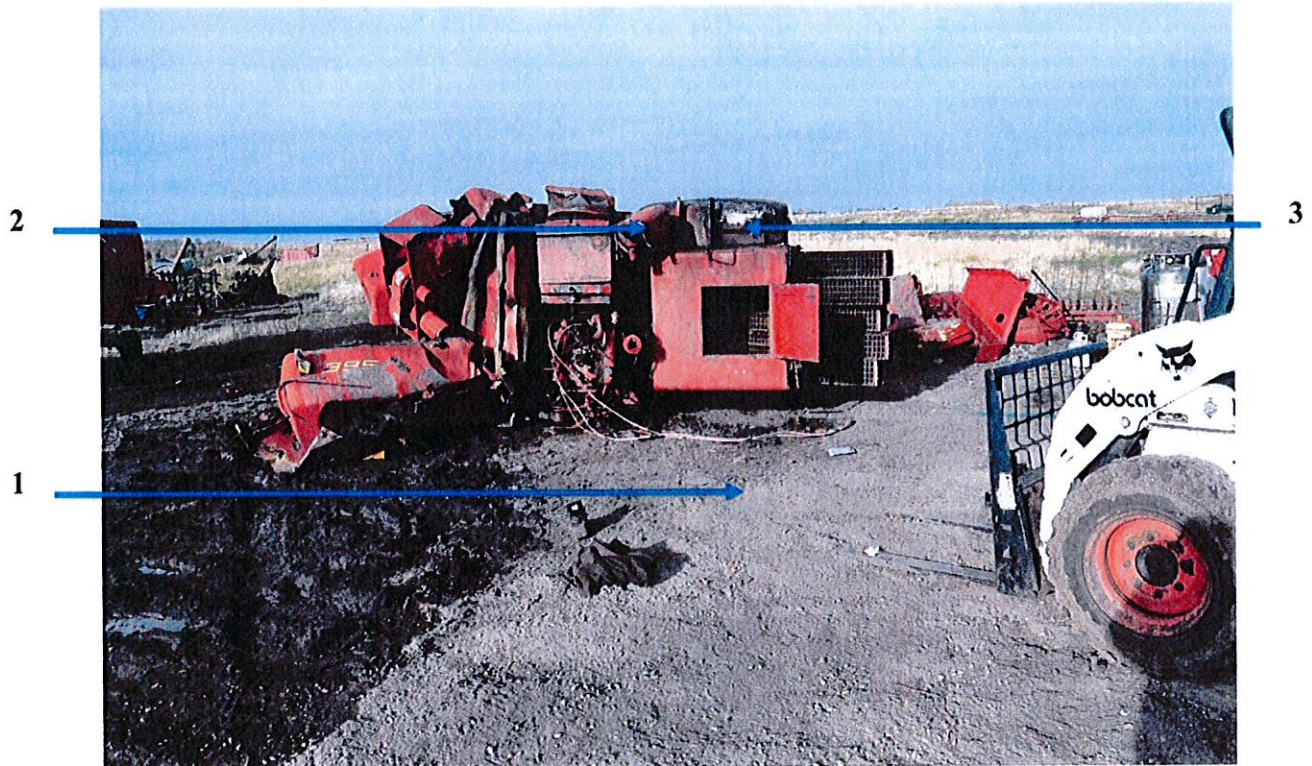
Photograph #2: Shows the scrap combine on its side.

- 1 The worker's location when he was struck by the filler neck.
- 2 The location where the torch cutter was cutting the metal with a torch.
- 3 The fuel tank.

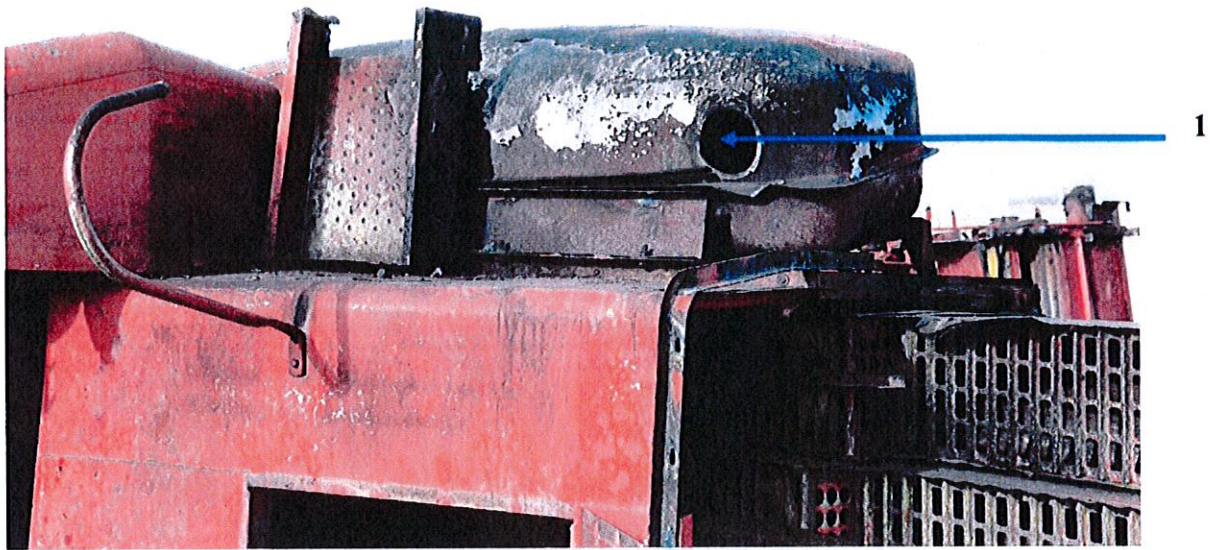
- 7.2.1 There was residual gas vapour in the fuel tank.
- 7.2.2 The sparks from the cutting torch ignited the gas vapour.
- 7.2.3 The filler neck blew off the fuel tank due to the explosion.
- 7.2.4 The scrap collector was directly in the path of the flying filler neck.
- 7.2.5 The workers did not recognize the presence of gas vapour in the fuel tank, after it was flushed with water.
- 7.2.6 Testing for an explosive atmosphere was not conducted.

Photograph #3: Shows a close up view of the fuel tank after the incident.

- 1 Location where the filler neck was located prior to the incident.

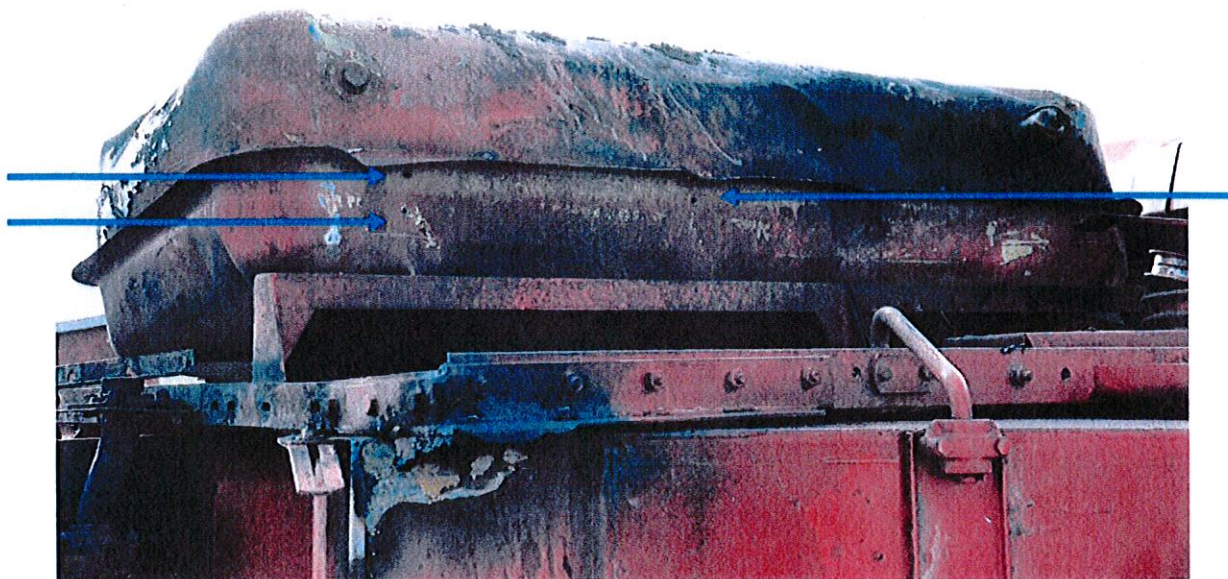
Photograph #4: Shows the rear view of the fuel tank.

Arrows point to the drilled holes in the bottom of the fuel tank.

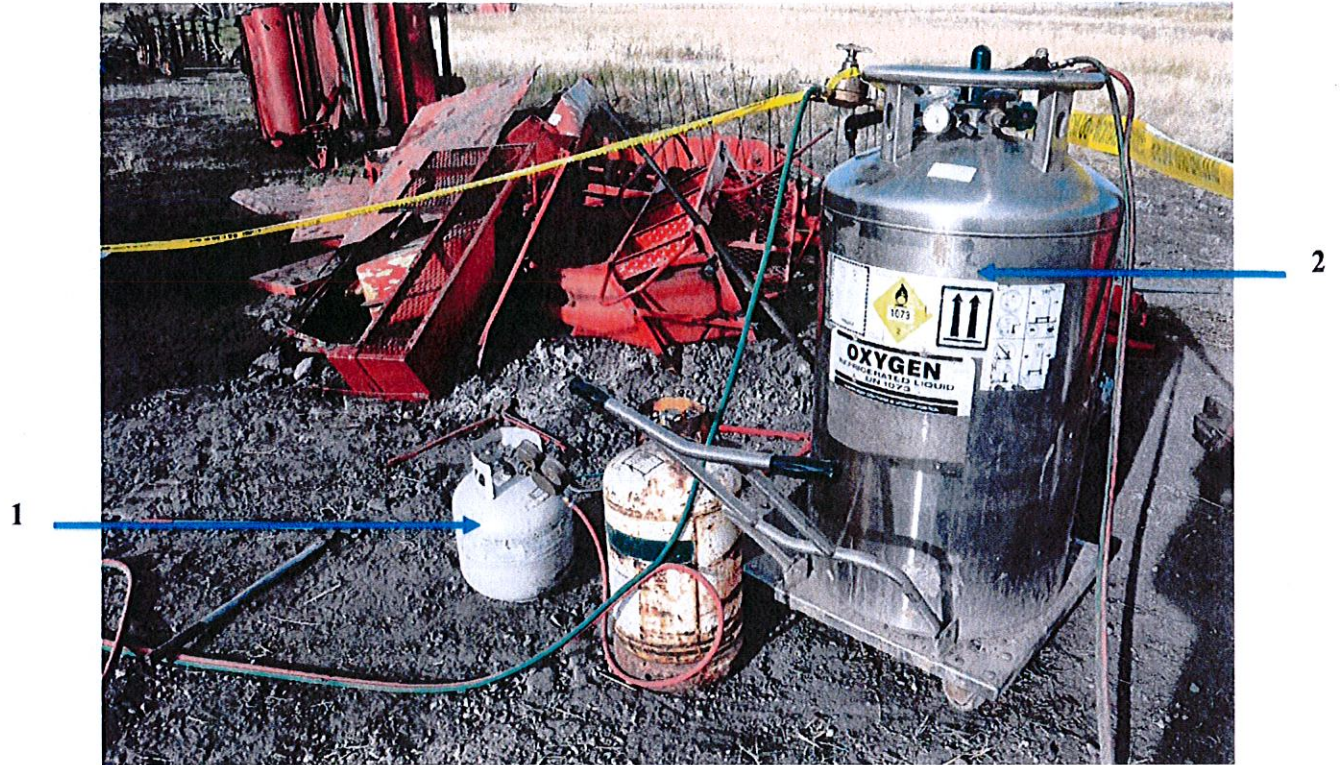
Photograph #5: Shows the gas cylinders used for torch cutting.

1 The propane cylinder.

2 The oxygen cylinder.

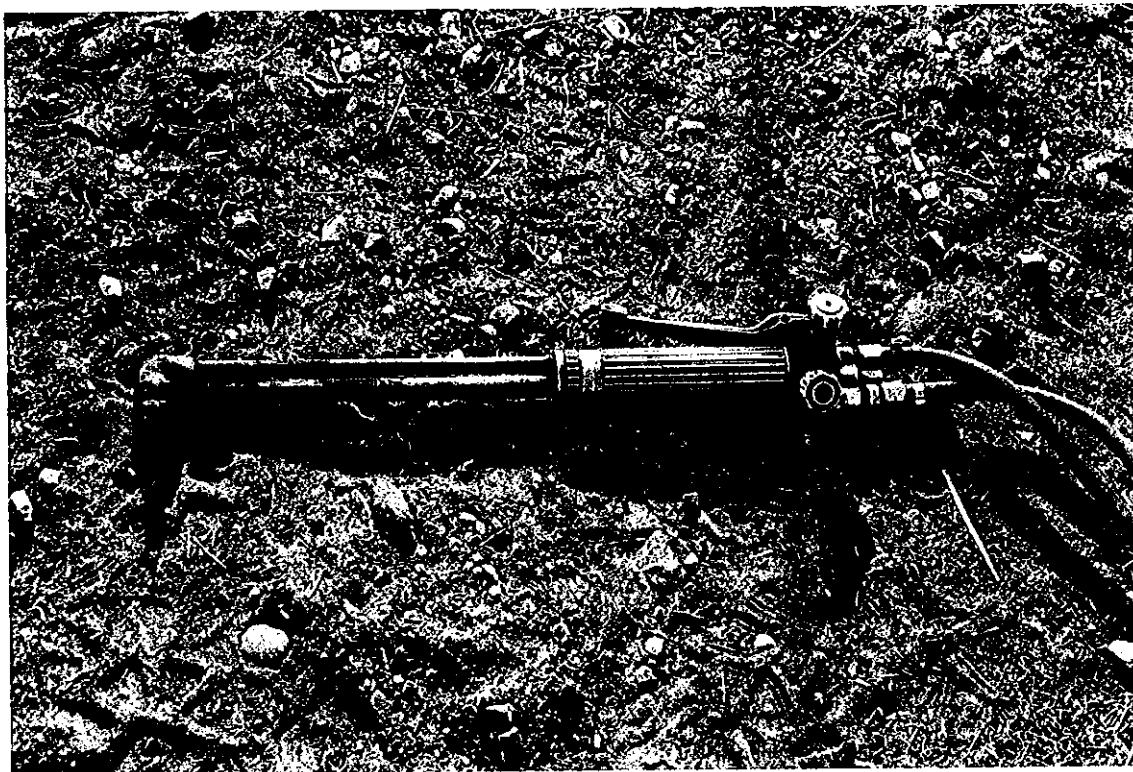
Photograph #6: Shows the torch used for cutting the scrap metal.

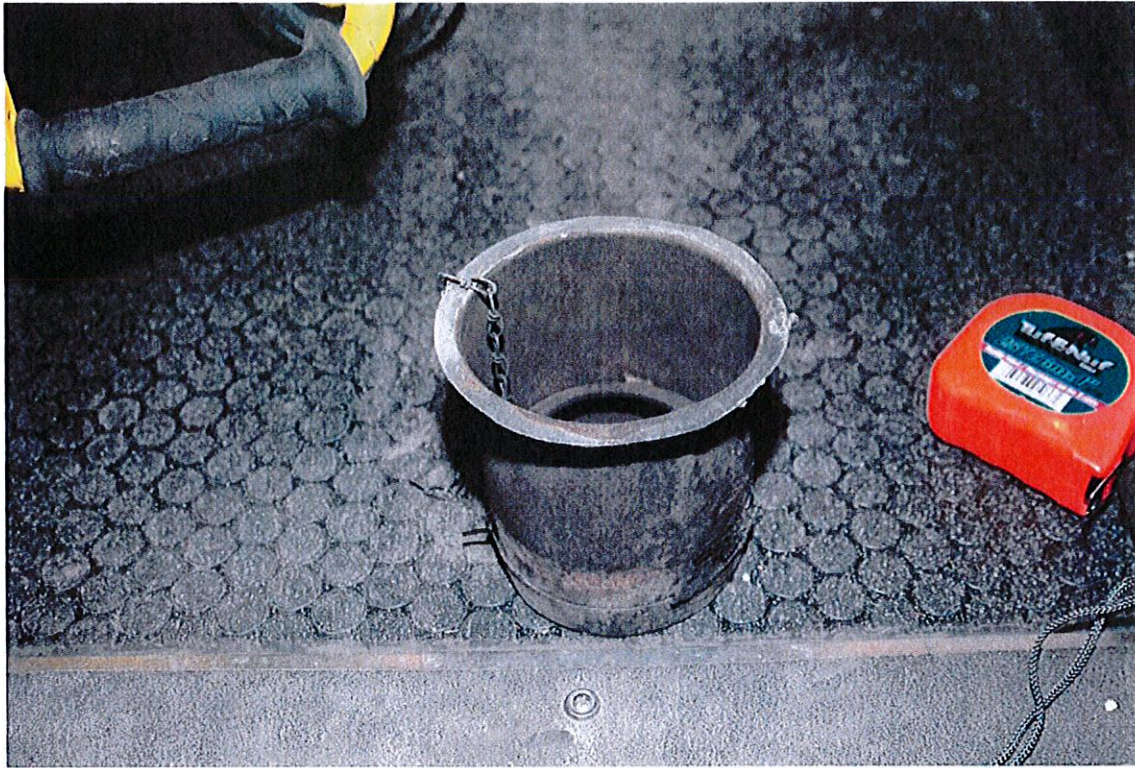
- 7.1.1 The scrap collector was struck in the chest by the filler neck of the fuel tank.

Photograph #7: Shows the fuel tank filler neck that struck the worker.
