RECAPP Facility Evaluation Report

Stettler Hospital and Care Centre

B1162A

Evaluation Company: L. M. O'Connor Consulting Inc.
Evaluation Date: October 30 2013
Evaluator Name: Len O'Connor
Evaluation FCR: 18.09%

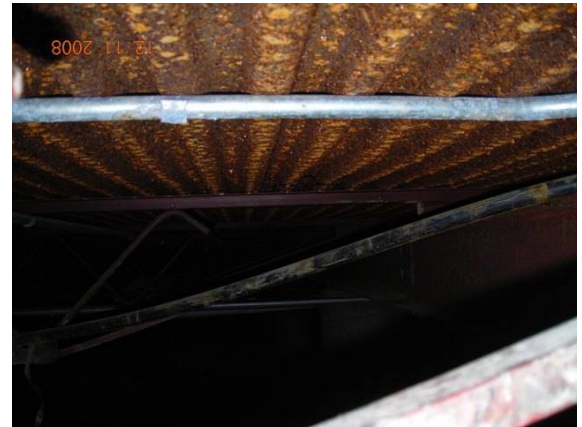
floor deck.JPG

The floor deck in the area viewed is rusted.

Recommendation:

Mechanically remove humidity.

Option-1: Remove rust scales with sandblast. Apply paint to underside of floor deck.

Option-2: Spray on rust inhibitor.

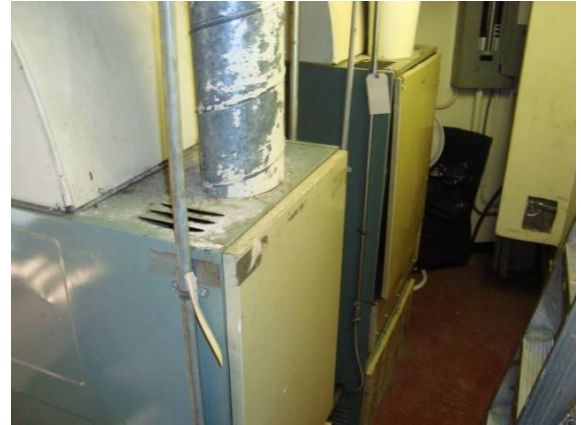
DSC01170.JPG

Furnaces show signs of deterioration. Replacement parts no longer available.

Replace two furnaces.
