Investigation Report
Worker fatally injured by a steer while loading cattle
August 17, 2017

This document reports Occupational Health and Safety's (OHS) investigation of an incident when a worker was fatally injured by a steer while loading cattle into a cattle liner in August 2017. It begins with a short summary of what happened. The rest of the report covers this same information in greater detail.

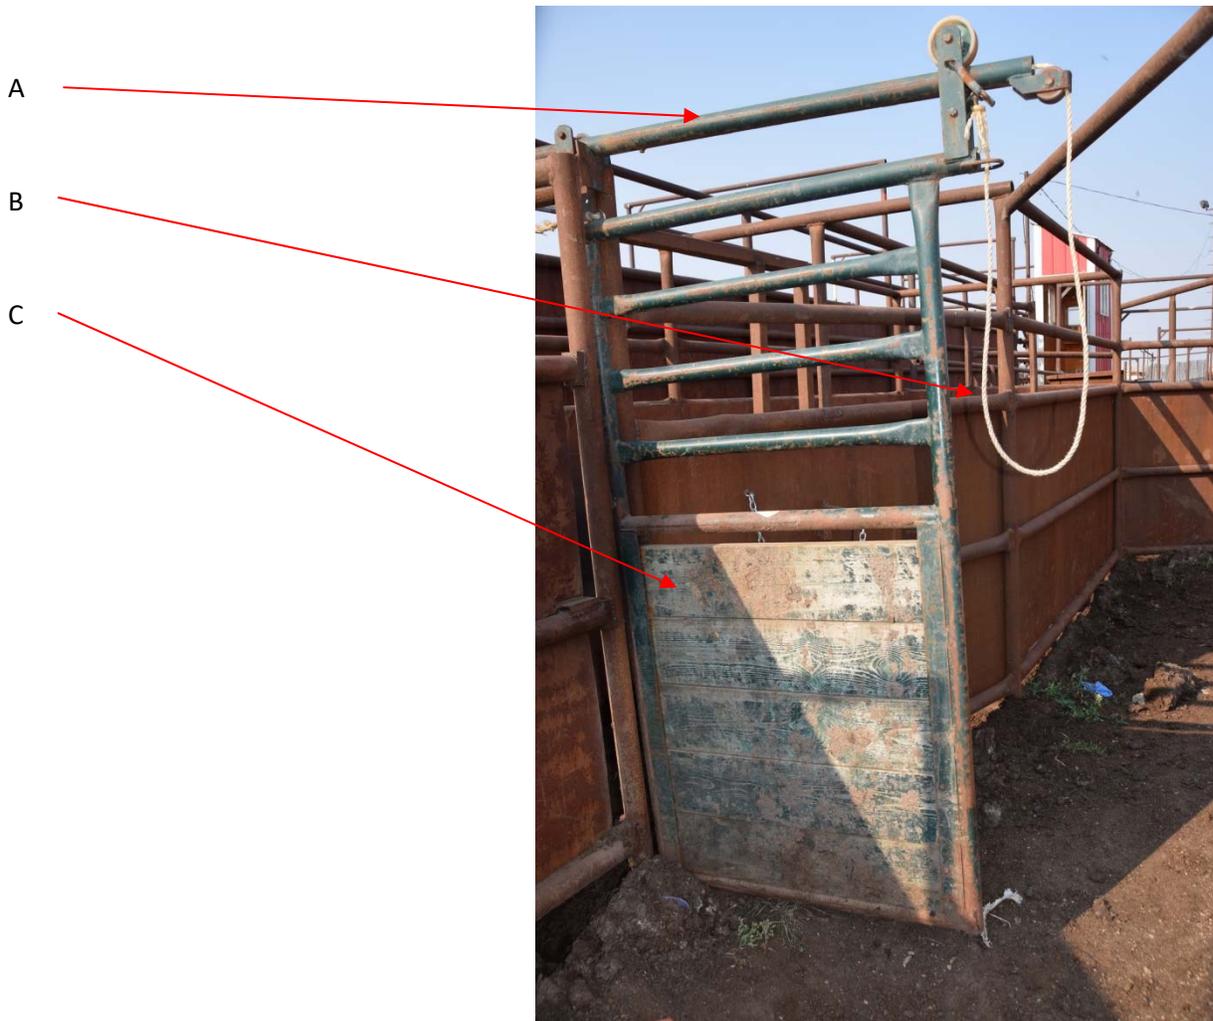
Figure 8. Slide gate in open position at bottom of loading chute/ramp to cattle liner.

A slide gate was located between the paired chutes and the chute leading up to the cattle liner back door. The slide gate had a solid bottom panel and four rails (Figure 8B and Figure 8C). The sliding gate rested on wheels on a rail and was operated by a pull rope (Figure 8A). The rails and wheels were worn and effort was needed to move the gate.

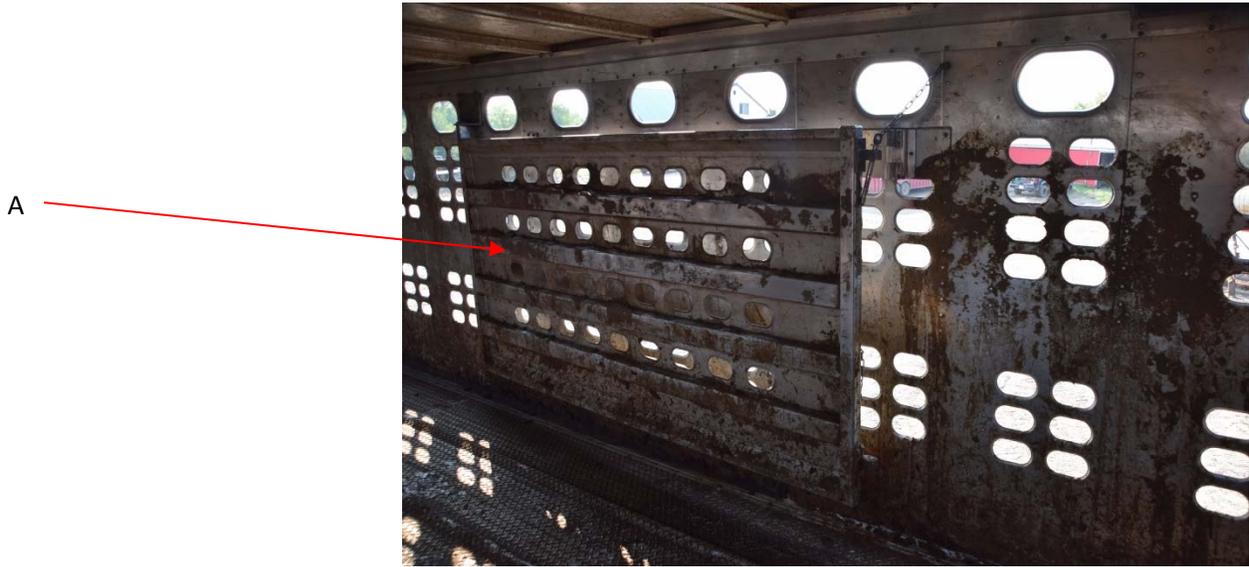
Figure 16. Midgate on top deck in open latched position.

The midgate was used to swing behind the cattle and keep them from turning back (Figure 17). Immediately following the incident, the midgate was found locked in place to the passenger side of the cattle liner's wall and pinned in place (Figure 16A)

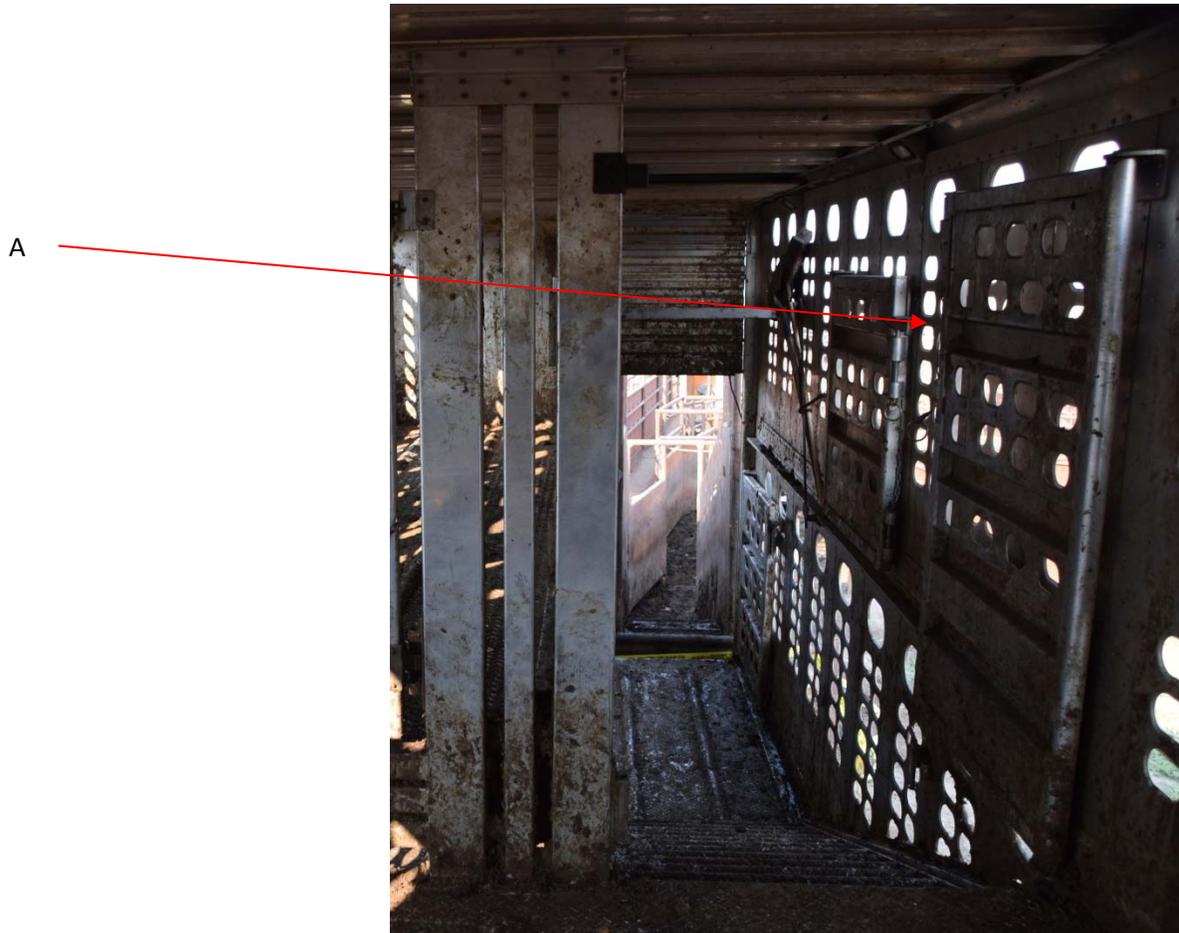
Figure 19. Gate at interior ramp in open locked position.

The gate located at the top of the cattle liner entry ramp would swing rearward only. It was found locked in place to the driver's side of the cattle liner wall (Figure 19 and Figure 20).

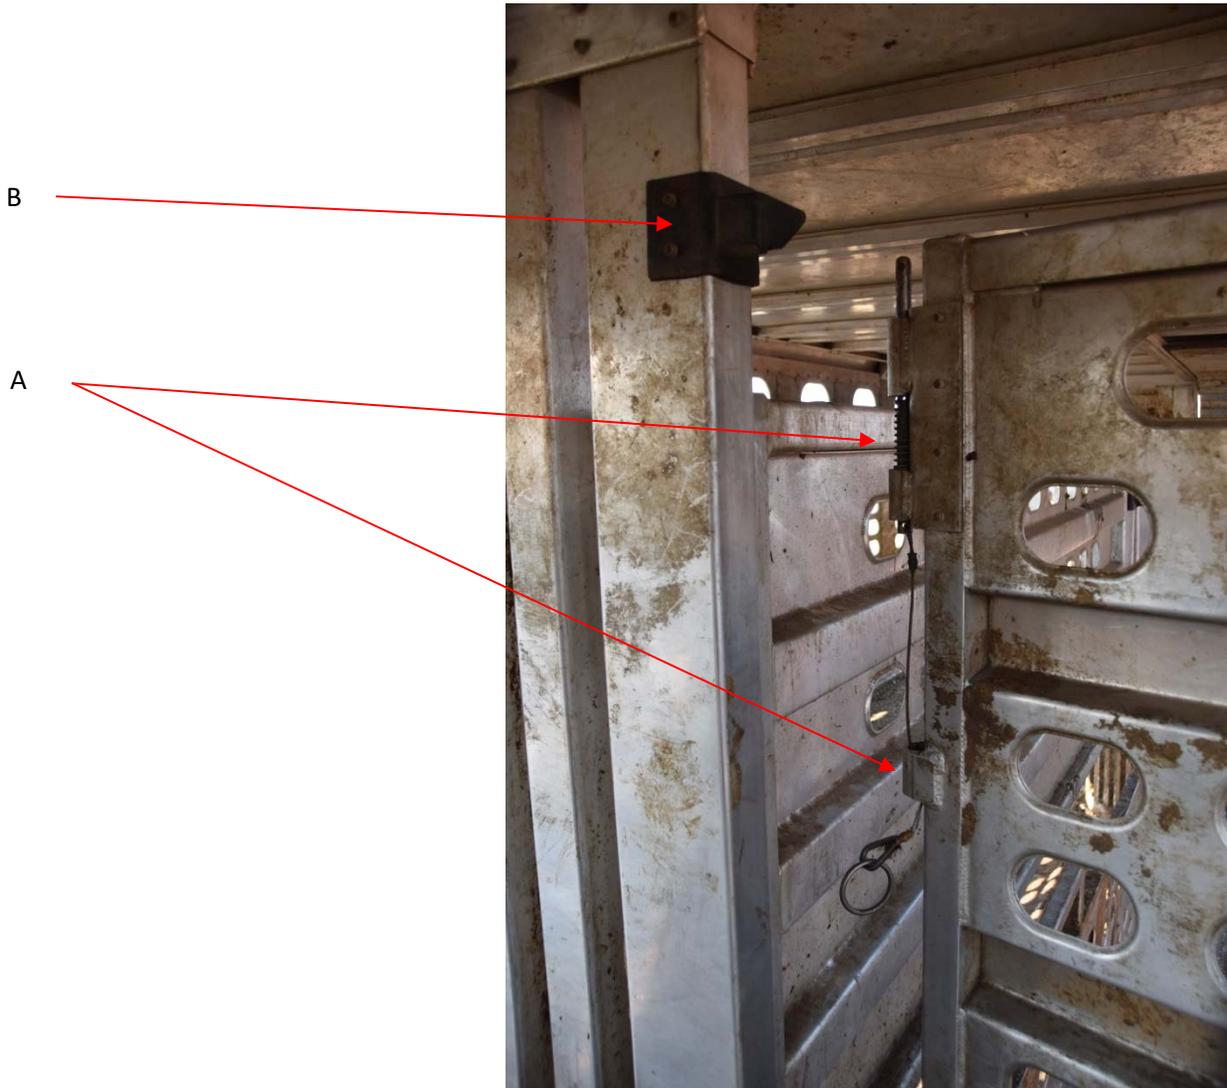
Figure 21. Interior ramp gate with pull release and structural brace with gate stop tab.

The interior ramp gate was operated by a pin with a pull release (Figure 21A). A structural brace on the inside of the cattle liner was a stop tab to prevent the ramp gate from going forwards at the top and bottom of the gate (Figure 21B). Unlatching the interior ramp gate required several actions to unlock, push or pull into closed position and to latch into closed position.

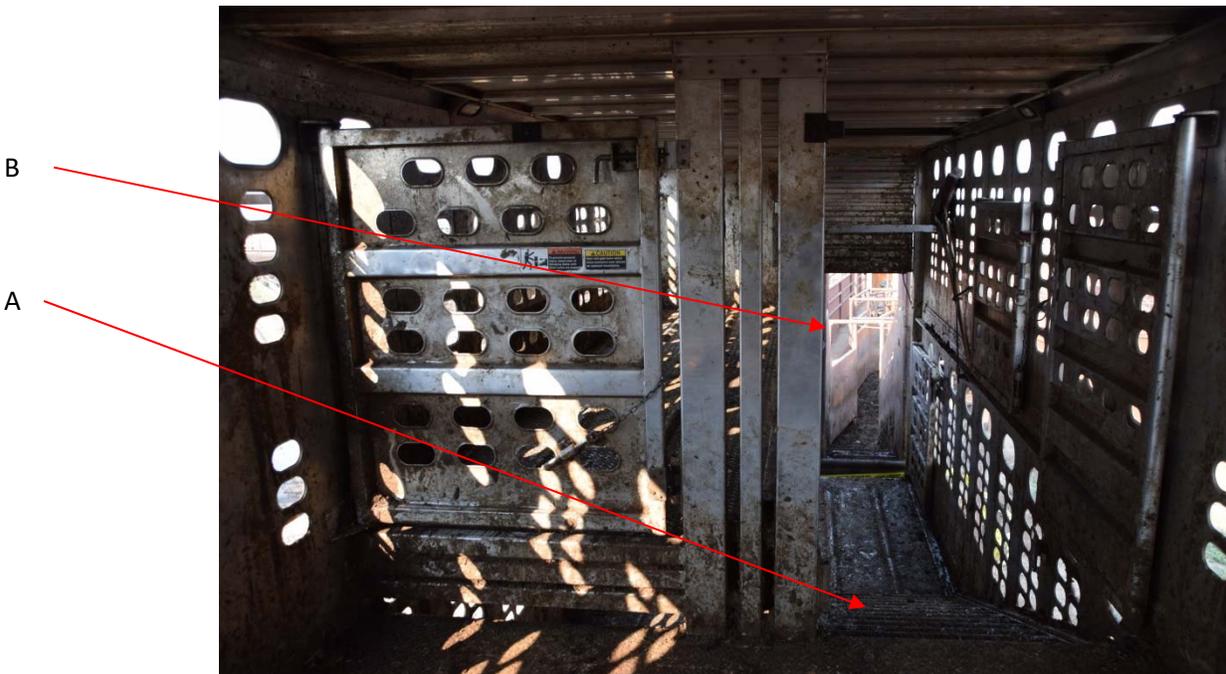
Figure 22. Interior cattle liner ramp facing the rear door and towards the loading chute/ramp.

Worker 1 and driver 2 heard driver 1 change tone of voice and believed that it indicated distress or alarm. Driver 2 saw driver 1 turn and run down the loading ramp inside the cattle liner (Figure 22A) towards the rear door (Figure 22B).

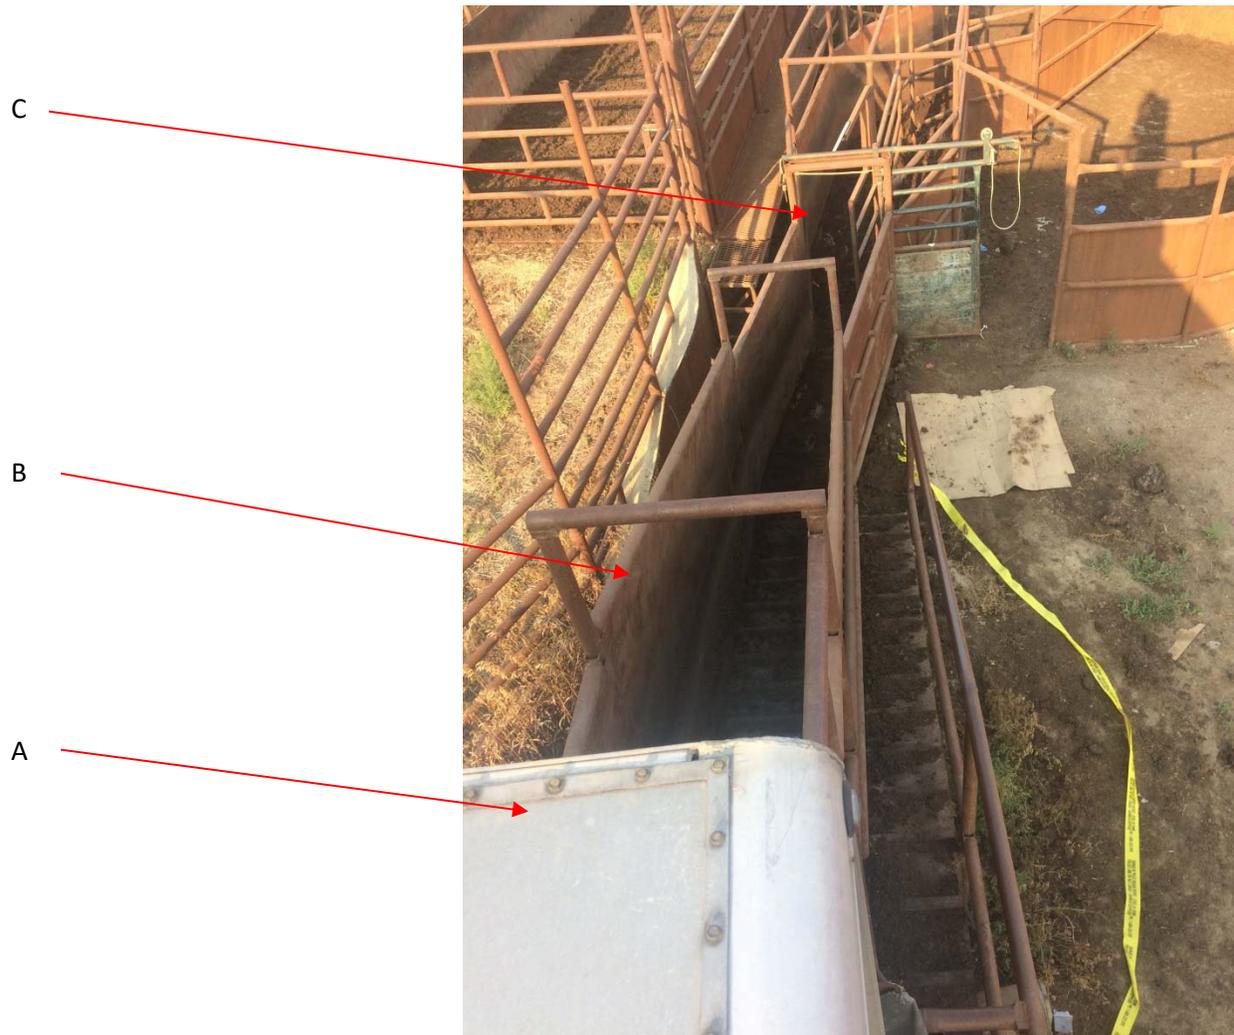
Figure 23. Loading ramp/chute looking towards slide gate. Photograph provided by Coro View Farms.

Driver 2, worker 1 and worker 2 saw driver 1 run down the chute (Figure 23B) to the closed slide gate (Figure 22C) with the horned steer following immediately behind. The horned steer ran into driver 1 and repeatedly head butted driver 1 against the gate. Driver 1 tried to move into a corner of the slide gate and chute railing while standing. The two remaining steers followed the first steer down the ramp.

- A. Cattle liner*
- B. Loading ramp/chute*
- C. Slide gate where worker was injured*
