Worker fatally injured in tractor rollover

July 17, 2021

This document reports the Alberta Occupational Health and Safety (OHS) investigation of a fatal incident that occurred in July 2021. It begins with a short summary of what happened. The rest of the report covers this same information in greater detail.

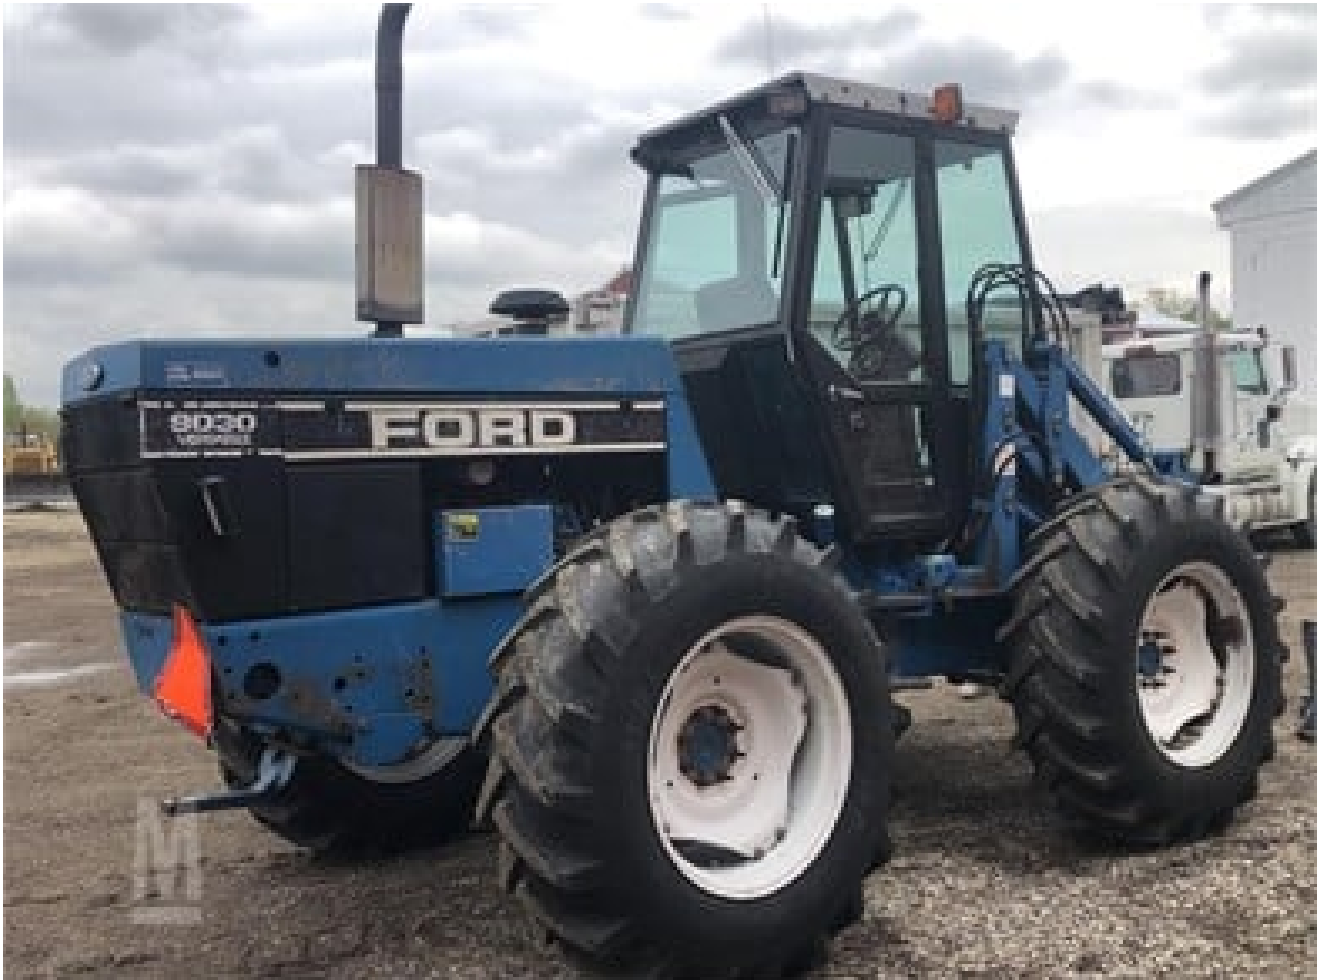
Figure 1. Ford New Holland 9030 Versatile bidirectional tractor. Photo obtained from the web showing the type of tractor involved in the incident.

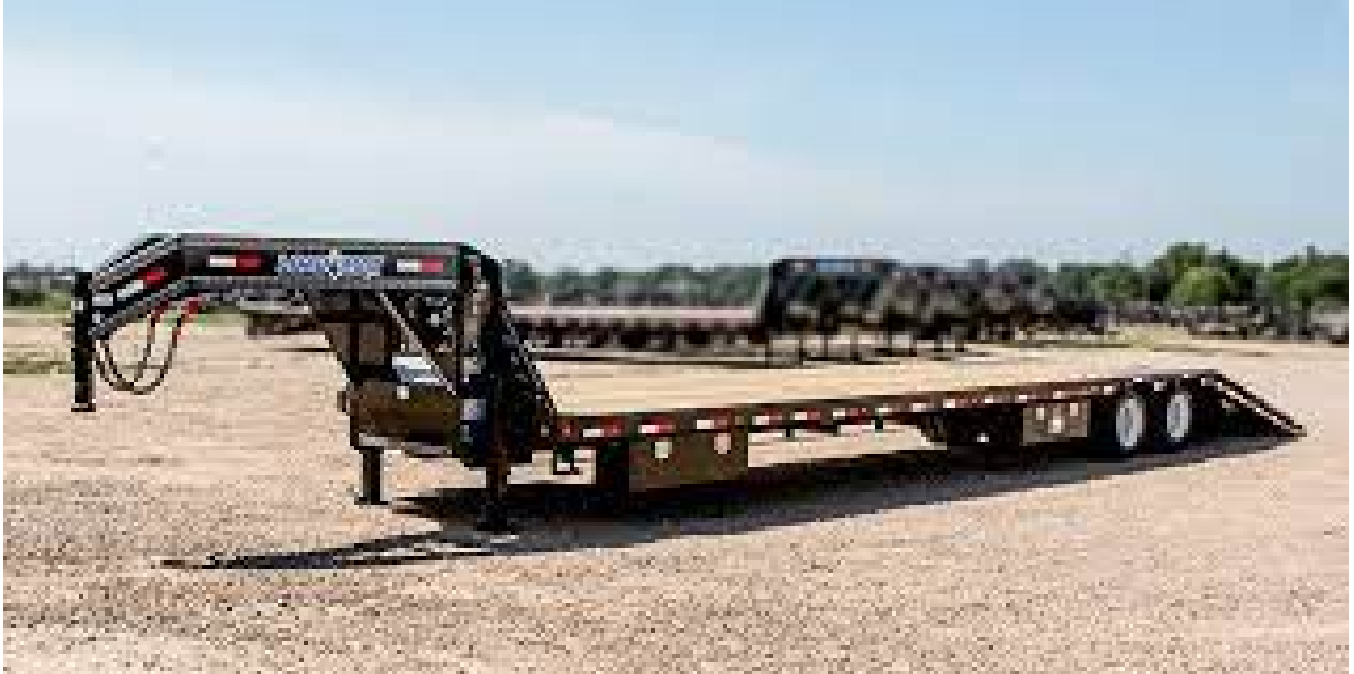
Figure 2. Represents what a gooseneck trailer would look like. Photo obtained from the web showing the type of trailer involved in the incident.

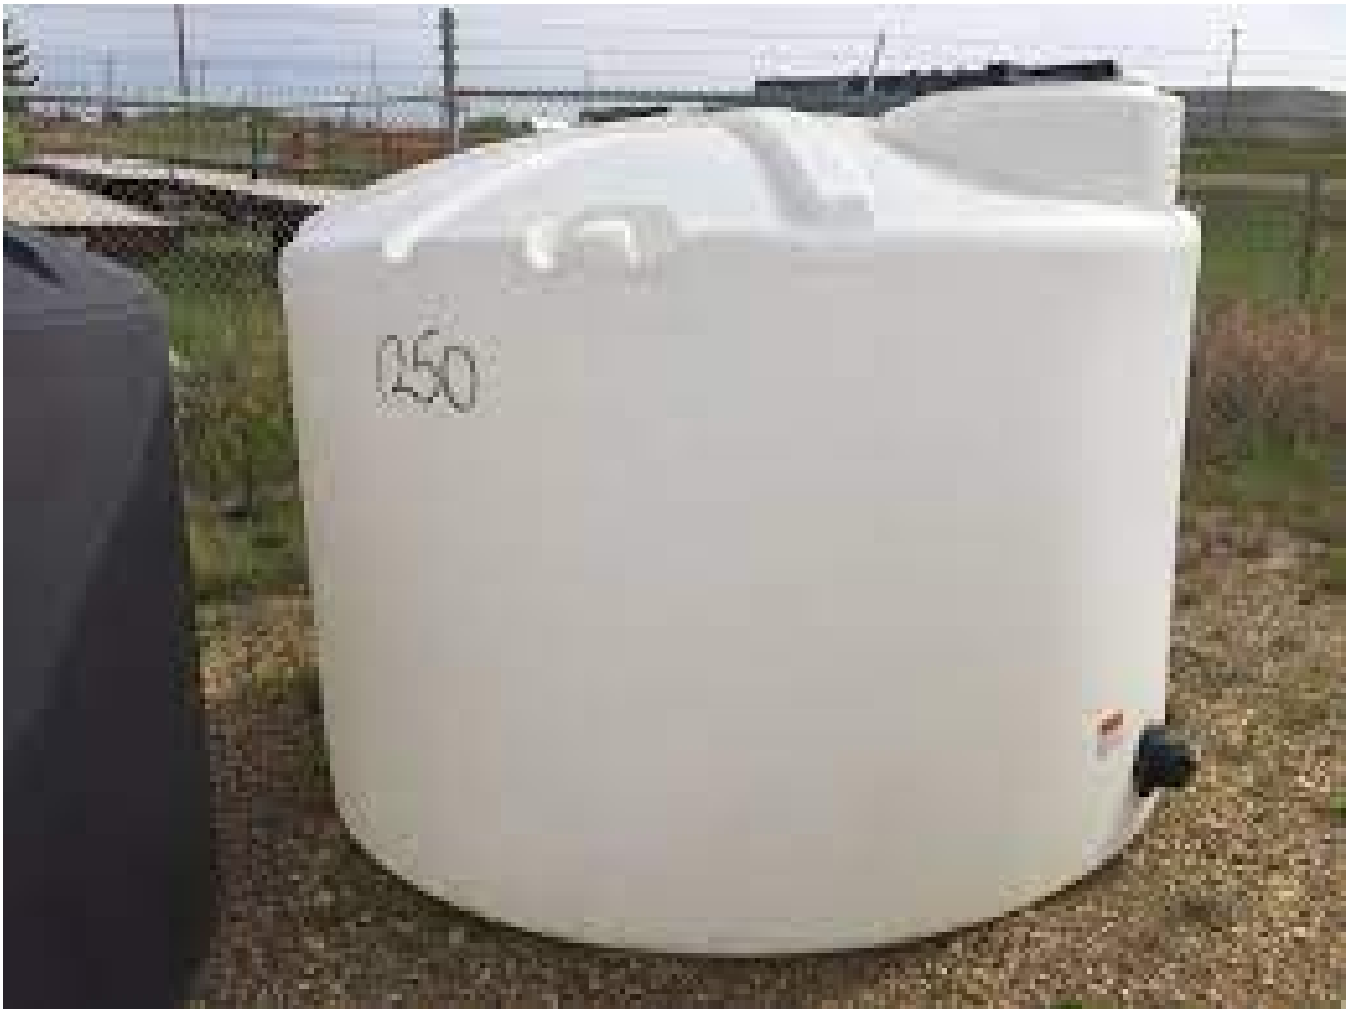
Figure 3. Represents what a 2500-gallon water tank would look like. Photo obtained from the web showing the type of water tank involved in the incident.

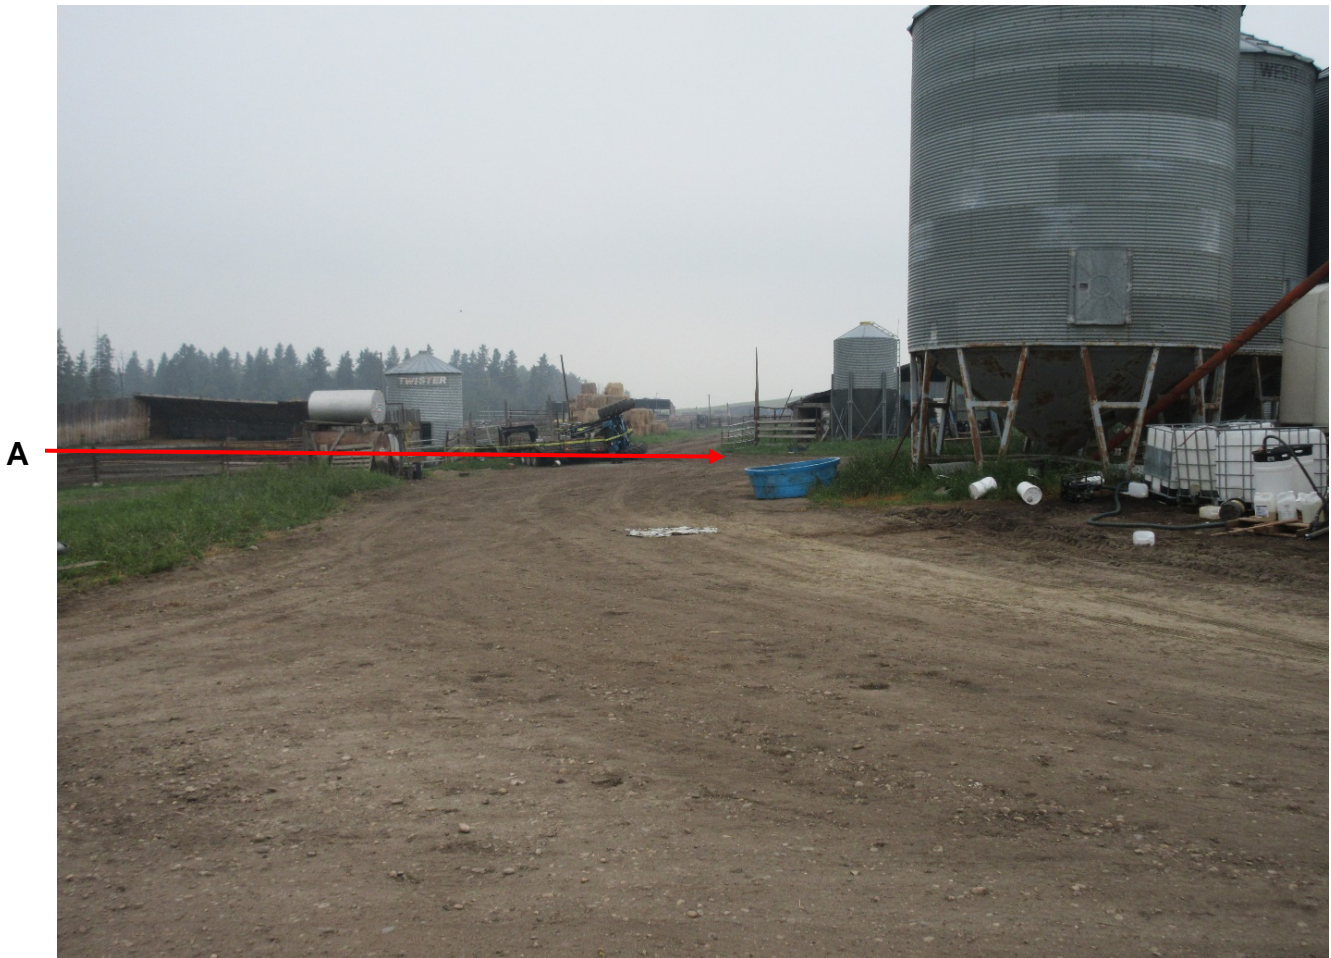
Figure 4.

A. One of the smaller water bins that was on the trailer
