Investigation Report

Worker fatally injured when crushed between tractor trailer unit and
locked gate

November 24, 2019

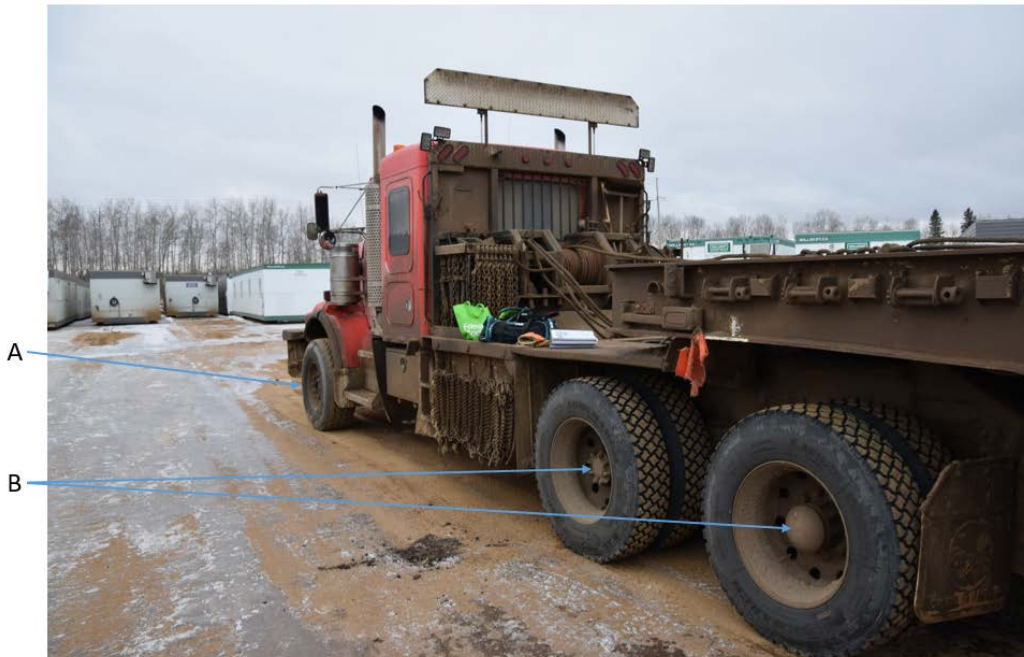
The tractor (commonly referred to as a truck) involved in the incident, operated by worker 1, was a 2007 Kenworth C500 heavy-duty winch truck (Figure 2). The winch capability of this large truck would be used to load and unload large cargo safely and efficiently.

Figure 2. Kenworth C500 Winch Tractor.

A. Steer axle

B. Drive axles

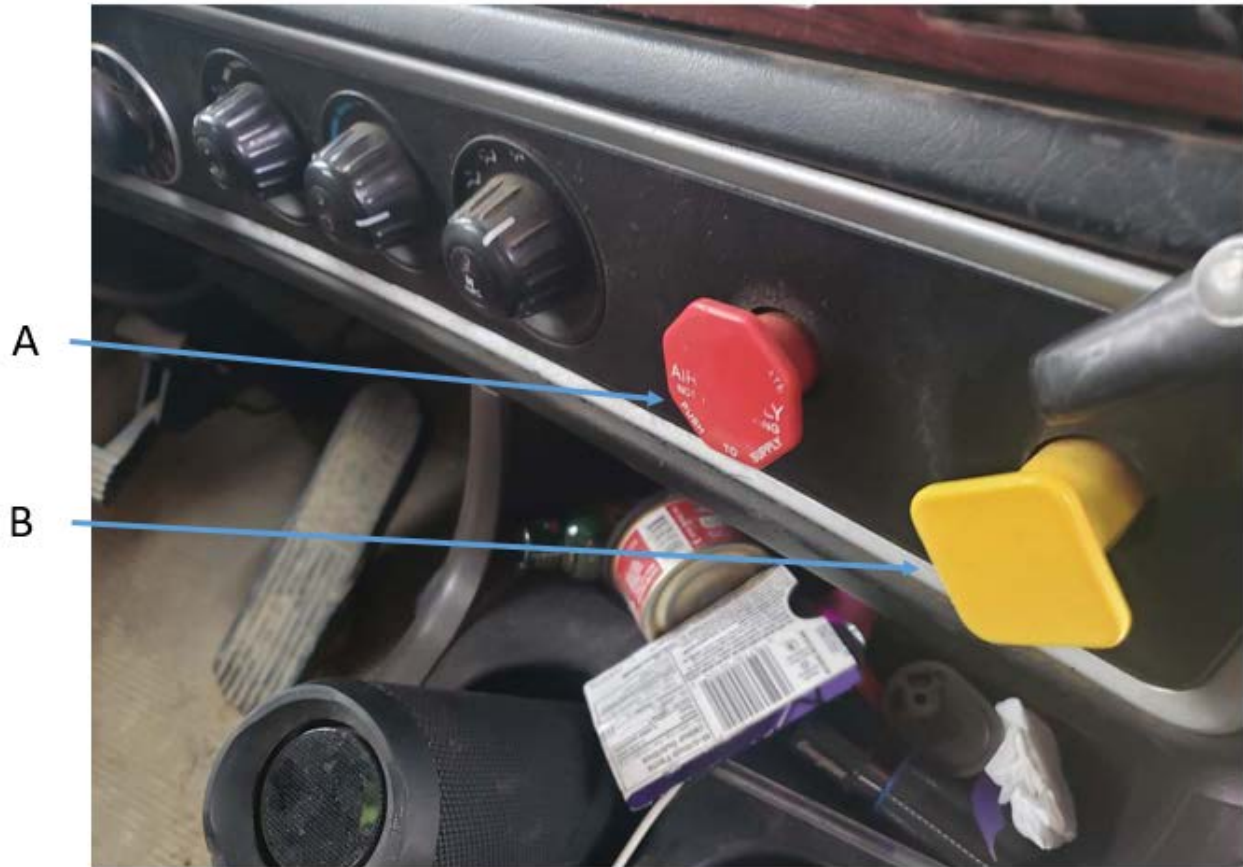
The truck was equipped with air brakes for parking the truck and a separate air brake system for parking the trailer. The driver would deploy the air brakes on the tractor by pulling a yellow plunger located in the cab of the truck. Without any other driver intervention, this action would also deploy the trailer air brakes, typically operated by a red plunger beside the yellow one (Figure 3). The driver could bypass the trailer air brake deployment by holding their thumb against the red plunger while pulling the yellow plunger; this action would set the air brake on the tractor only. The bypass of trailer brakes was common practice in winter conditions as trailer brakes often froze up and required driver intervention to free up the drum brakes on the trailer. This could occur when snow and ice melted in the trailer brake drums and then froze while the brake was activated. The driver would typically have to lay underneath the trailer with a hammer to break the ice in the drum to allow the wheel to turn freely before commencing travel after parking.

Figure 3. Brake controls at the time of the incident. Photograph courtesy of the Royal Canadian Mounted Police (RCMP).

- A. Trailer brake off*
- B. Tractor brake on*

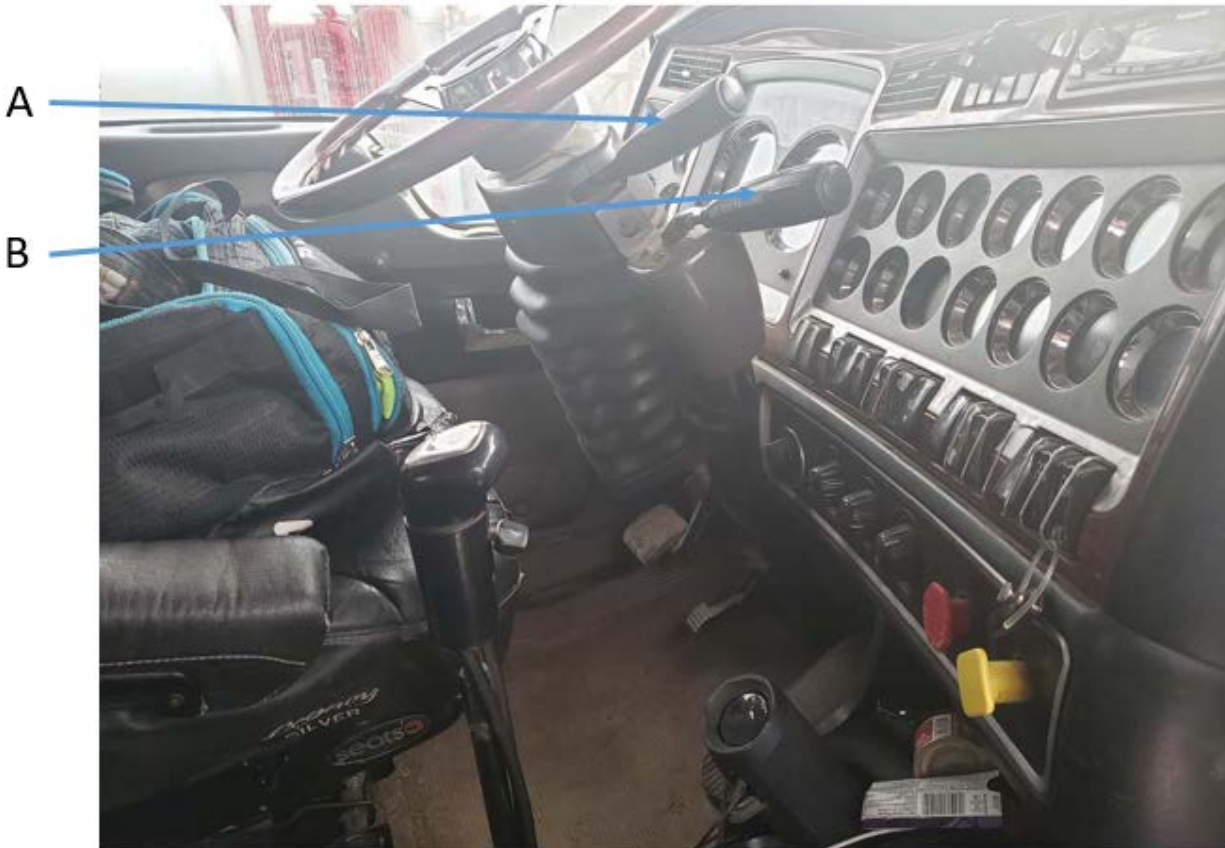
This particular tractor also had hand operated service brakes, also known as spike brakes (Figure 4) on the steering column for additional control of the truck and/or trailer while loading and unloading cargo. Both spike brake levers were clearly marked “not for parking”.

Figure 4. Spike brakes. Photograph courtesy of the RCMP.

- A. Trailer spike*
- B. Tractor spike*

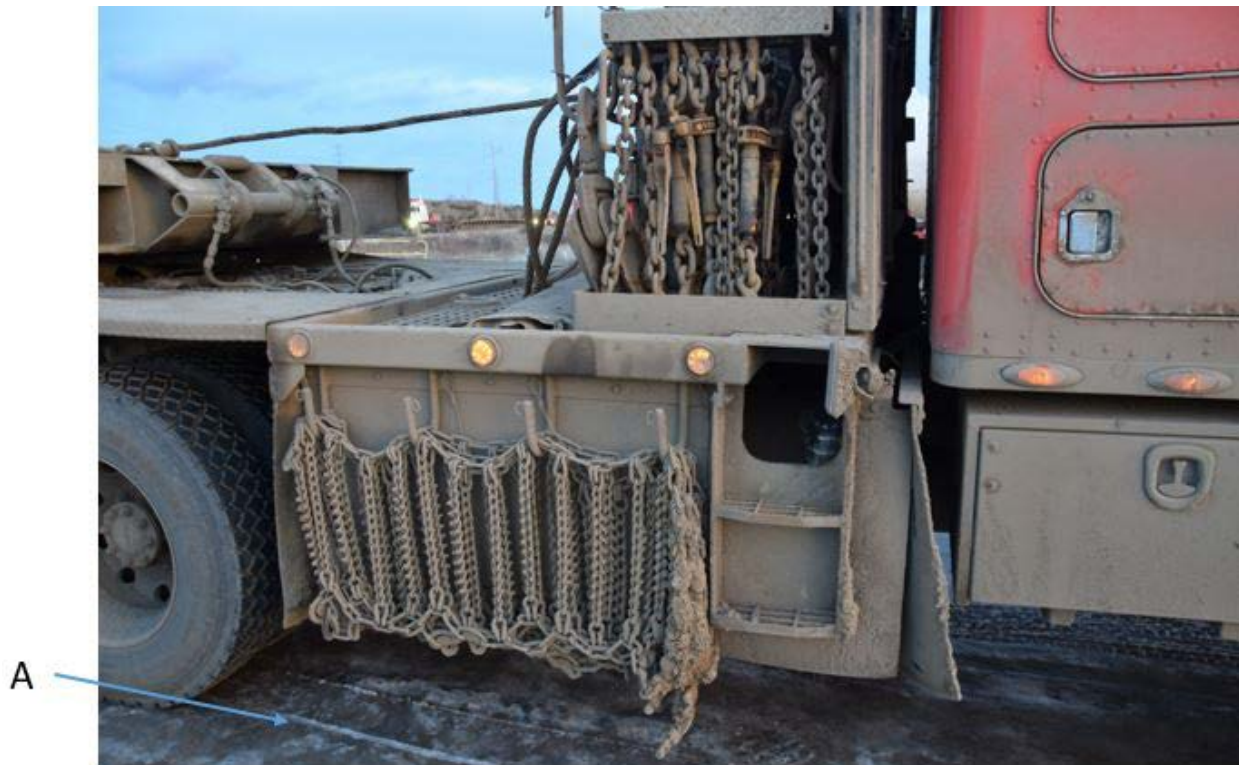
A scuff mark on the ice in front of the tires after the truck had been towed away from the gate post incident serves as confirmation of the tractor air brakes being applied at the time of the incident (Figure 5).

Figure 5. Passenger side of tractor, post tow.

A. Ice scuff mark.

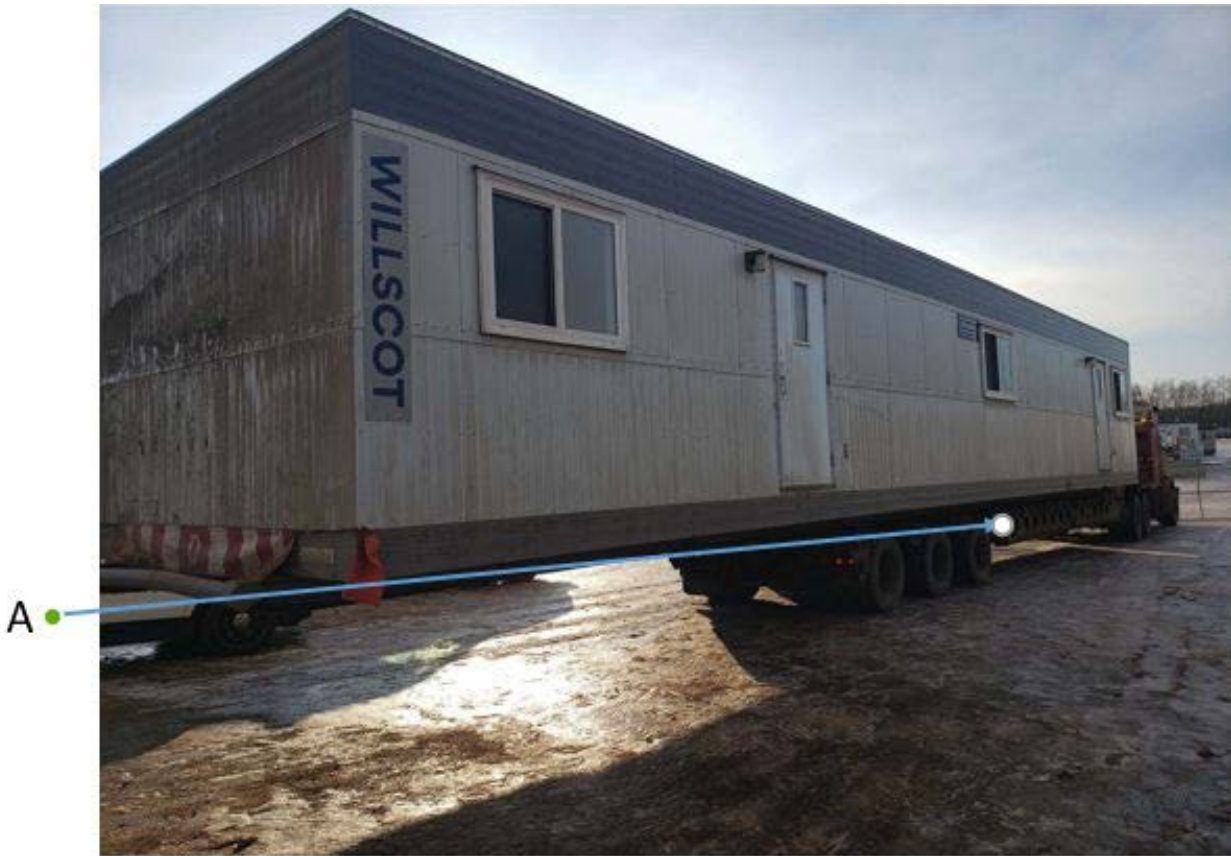
Figure 6. Willscot office trailer loaded on lowboy trailer. Photograph courtesy of the RCMP.

A. 1996 Alco trombone tri-axle lowboy trailer

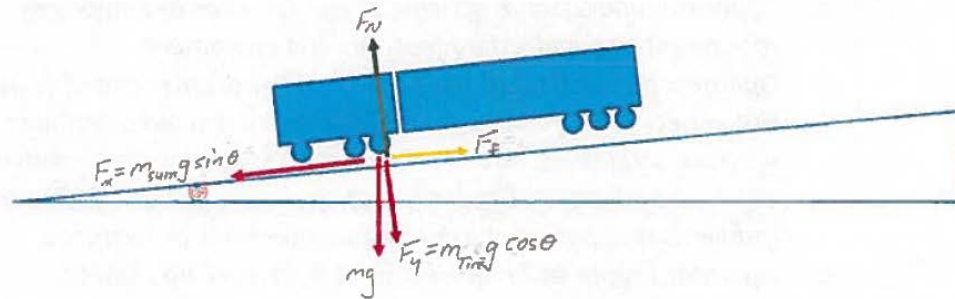
The approach driveway was included with the Willscot Ruth Lake Yard. Willscot leased the property from a neighbouring business (NCS Properties Ltd.). Under the terms of the lease agreement, the tenant (Willscot) was responsible for maintenance of the property. At the time of the incident, the 4 to 5 percent sloped driveway (Figure 7) was ice covered. Recent weather data from a nearby station included a freeze/thaw cycle that occurred during the night prior to the incident (after the staff at Willscot had left work for the weekend - on the afternoon of Friday, November 22, 2019).

Figure 7. Slide calculation diagram showing the driveway slope of 2.3 to 2.9 degrees (4 to 5 percent) (not to scale). Diagram courtesy of OHS Specialized Professional Services branch.
