Investigation Report
Worker fatally injured after fall from roof
January 9, 2015

Incident summary

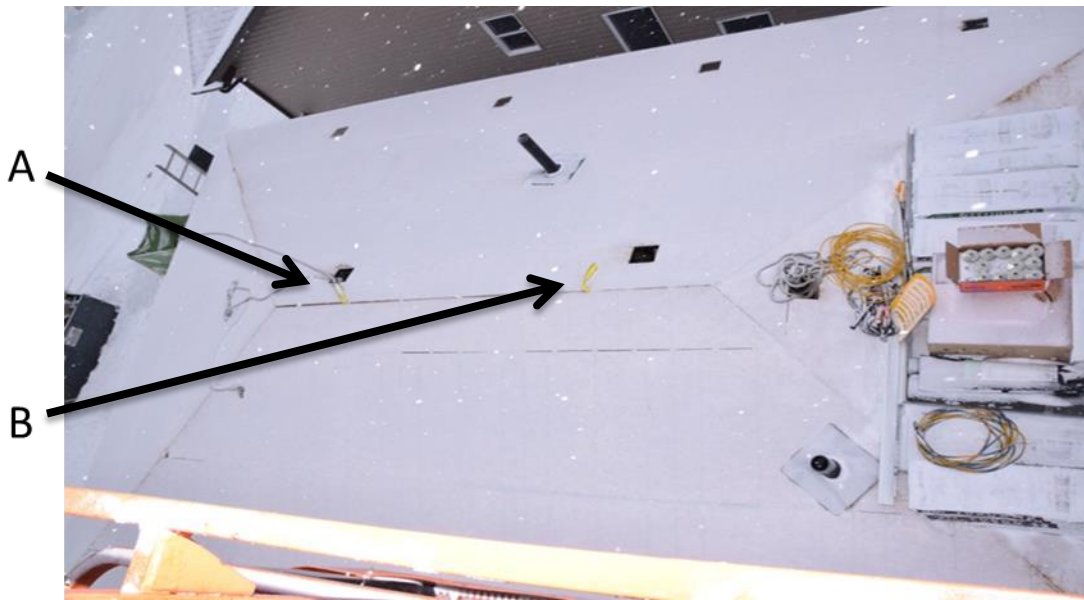
Two sling anchors were installed in the roof, prior to the arrival of Roofer 1 (see photos below). They sling brand was Safety Direct Ltd. and had a breaking strength of 5000 lbs. One anchor was located on the West side of the roof with two life lines affixed to it, and the second was installed on the east side of the roof. The east sling anchor did not have a lifeline attached to it as roofer 1 had unclipped the lifeline to untangle it immediately prior to the incident.

Figure 1 - West sling anchor (A) with two lifelines attached to it. The materials on the right side of the photo included the life line worker one had been using and the extension cord which became tangled. The site had been cleaned up prior to OHS arrival.
East Sling Anchor (B) - anchor worker one had been connected to prior to the incident.

While trying to set up various equipment, roofer 1 detached his lifeline from the east anchor as it had become tangled with an extension cord. Shortly after disconnecting his life line, roofer 1 lost his footing, slid down the roof and fell off the roof edge which was approximately 6.7 meters from the ground.

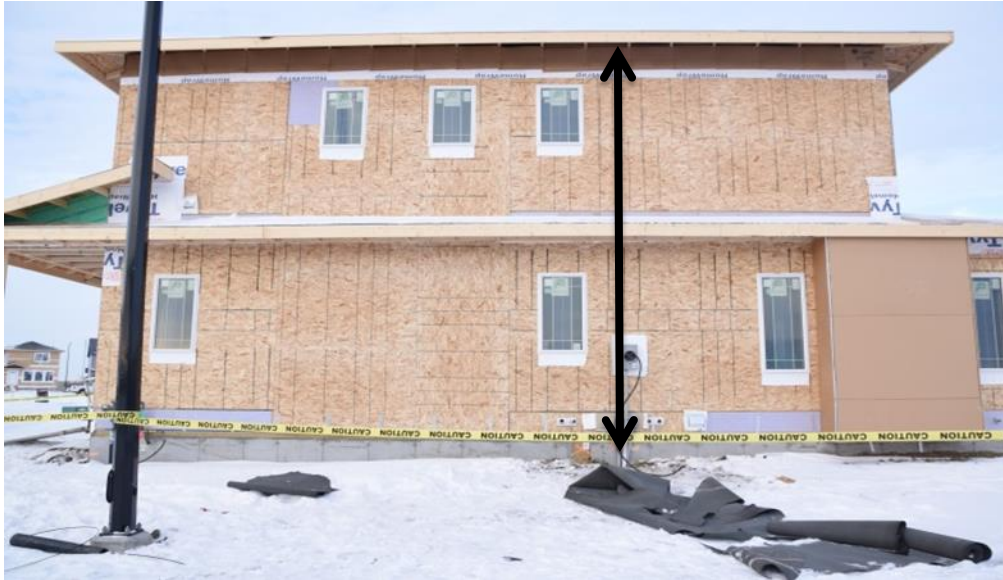
The house being built by Hopewell Residential was a two story single family home and the roof was approximately 6.7 metres high as shown in Figure 2 below. The roof pitch was approximately 22 %.

Figure 2- The roof height approx. 6.7 metres.

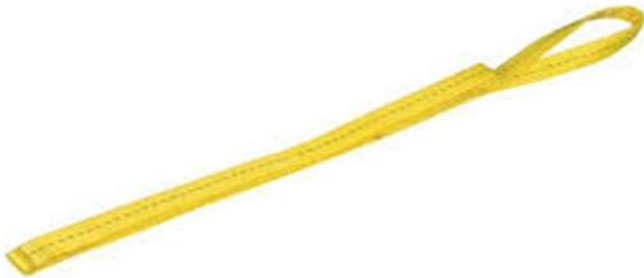
Figure 3 - The anchor sling is a component intended to couple the personal fall protection system to an anchor. This is the type of anchor installed at the incident location.
