Fatality Investigation Report  
Worker Fatally Injured from Cinderblock Wall Collapse  
November 20, 2014

This document reports Occupational Health and Safety's fatality investigation following a cinderblock wall collapse that occurred on November 20, 2014, in which one worker was fatally injured. It begins with a short summary of what happened. The rest of the report covers this same information in greater detail.

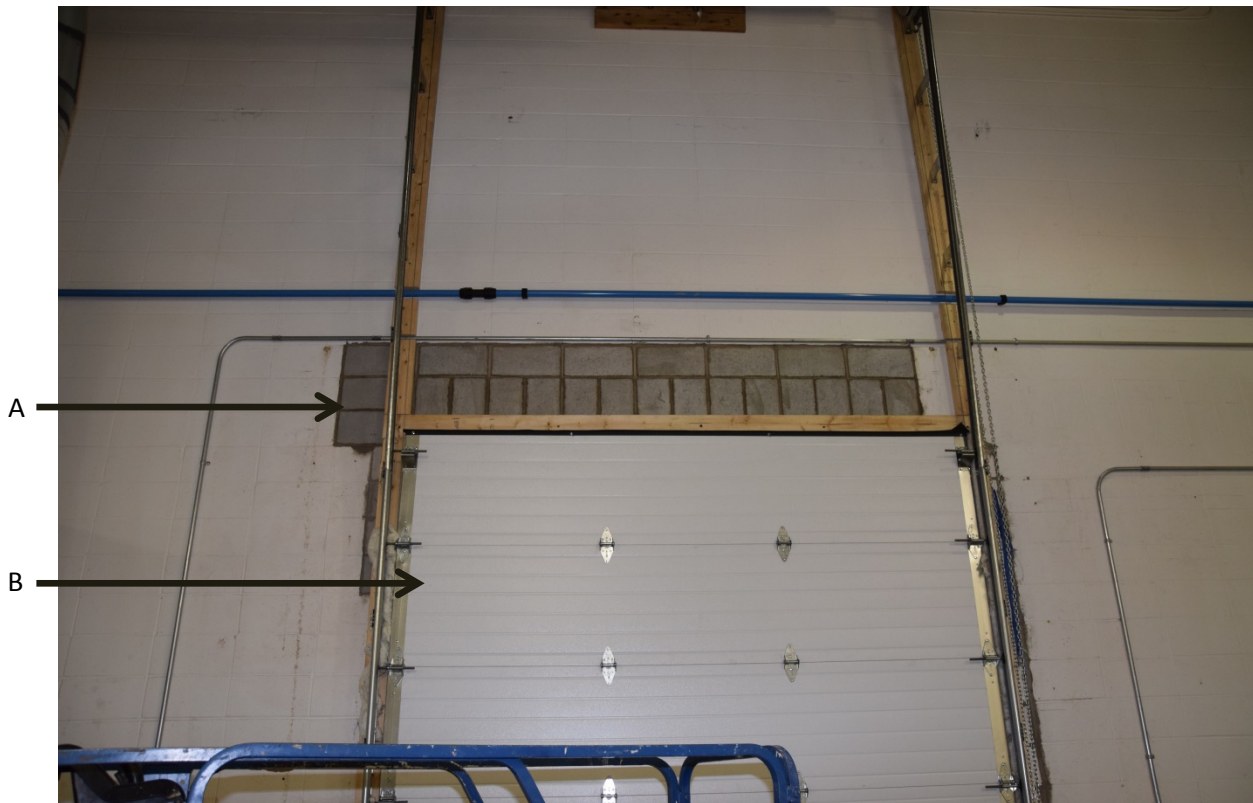
The commercial building located at 601-28 St NE, Calgary, AB was constructed of cinderblocks, reinforced with rebar and concrete, and vermiculite insulation. A lintel is a structural requirement of cinderblock walls when an opening in an exterior cinderblock wall is required (Figure 1).

*Figure 1. Cinderblock lintel construction and new bay door installation. View from inside 601-28<sup>th</sup> St NE commercial building.*

A: New lintel construction in existing cinderblock exterior wall  
B: New Bay Door

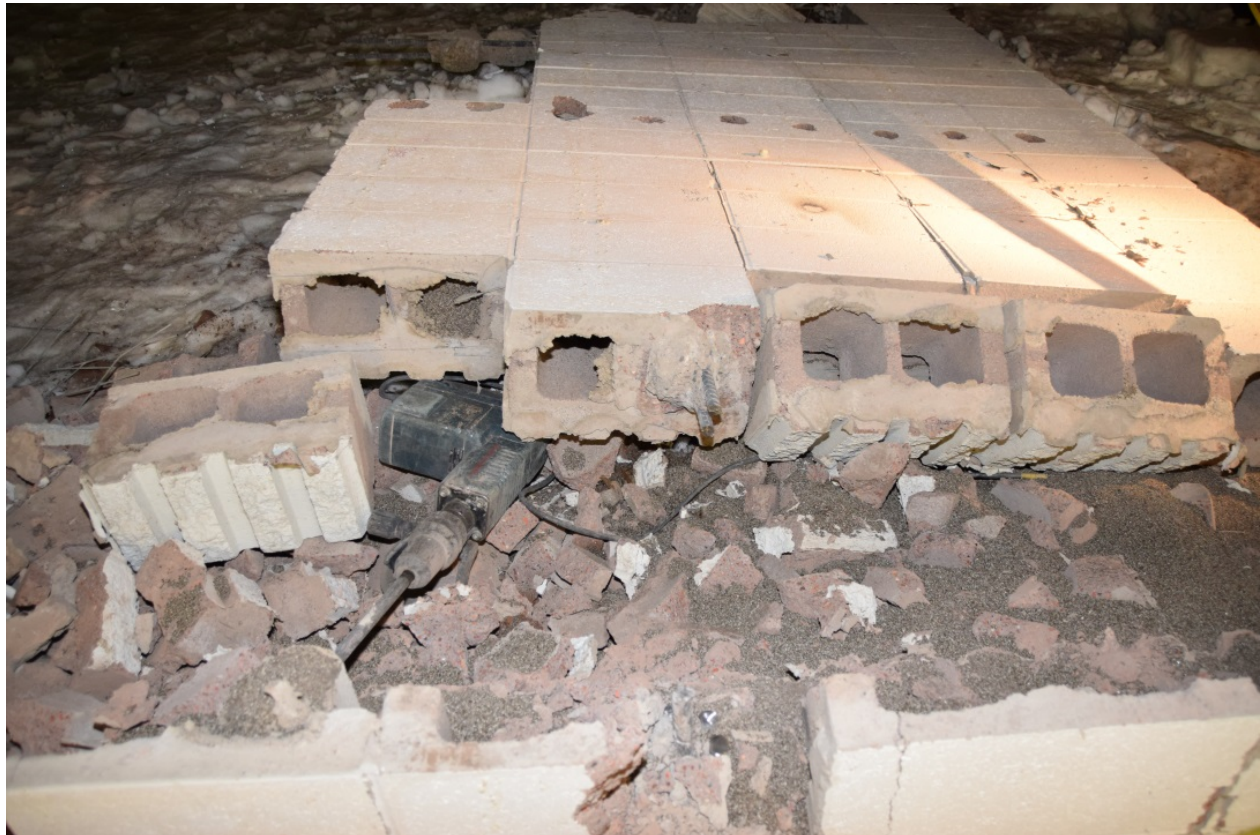
An electrically powered demolition hammer manufactured by Bosch was used to remove concrete from within the cinderblock structure (Figure 2). It was rented by maintenance and construction manager (manager) from Rogers Rent-All on November 20, 2014, for the cinderblock wall demolition.

*Figure 2. Shows a Bosch electric demolition hammer under collapsed block wall.*

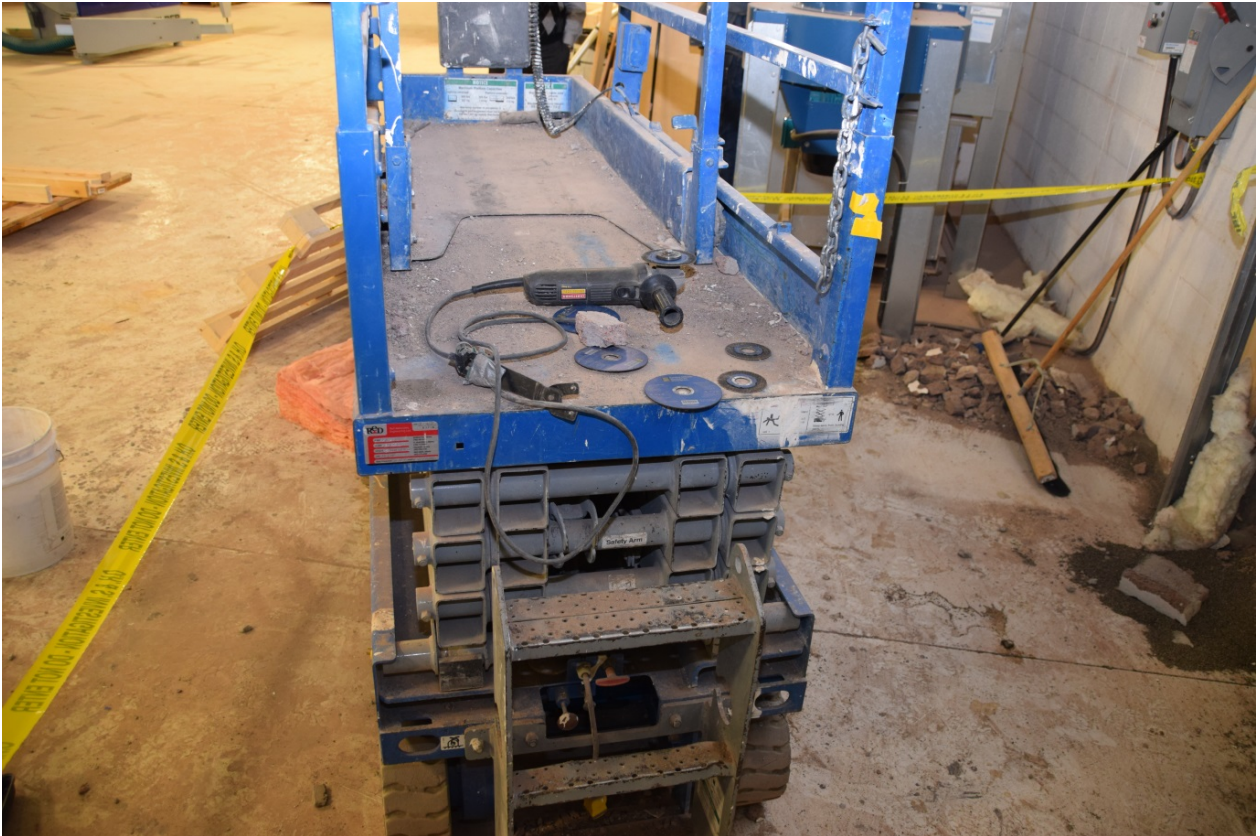
*Figure 3. Shows Craftsman portable electric grinder on Genie scissor lift.*

A Craftsman 4 ½ inch portable electric grinder, with 4 ½ inch Powerfist cutting wheels, was used to cut through the structural rebar within the cinderblock wall (Figure 3).

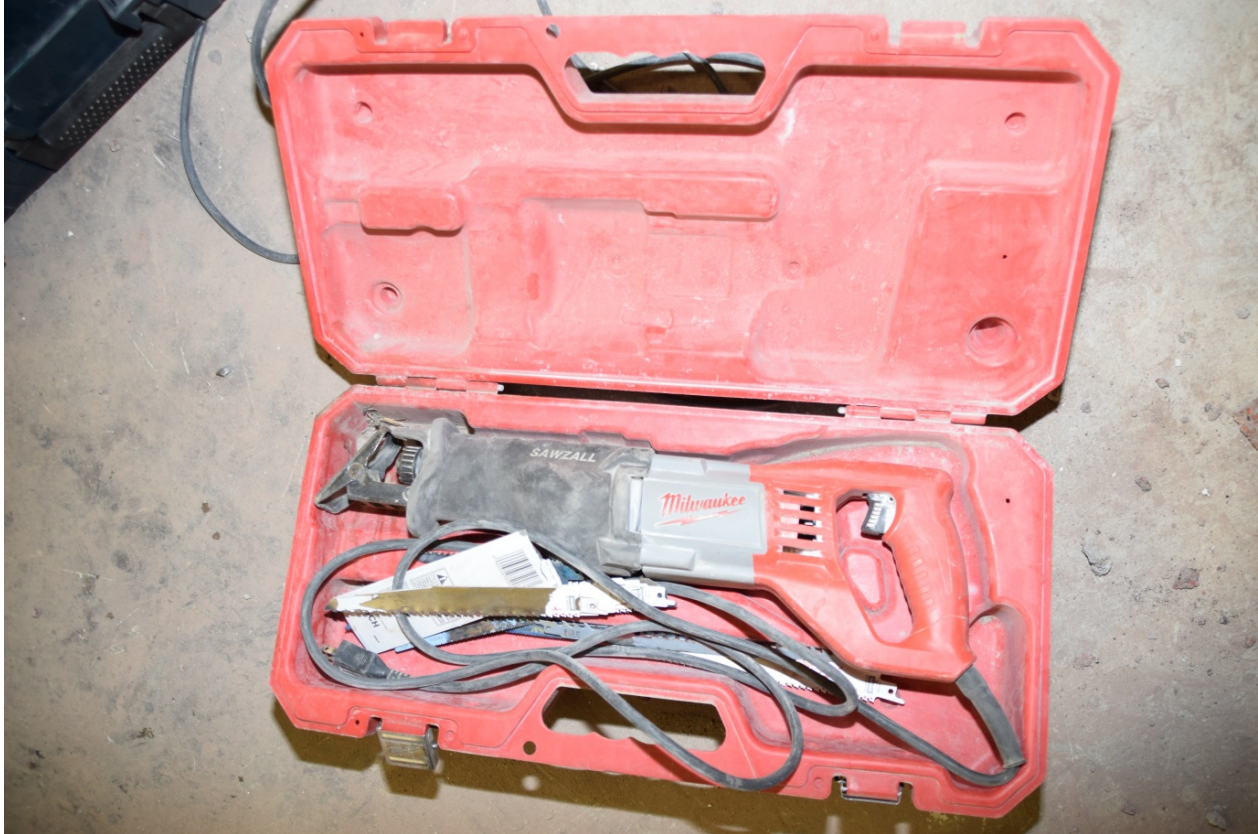
A Milwaukee Sawzall 6509 reciprocating saw was used to cut through the structural rebar within the cinderblock wall (Figure 4).

Figure 4. Shows Milwaukee Sawzall 6509 reciprocating saw.

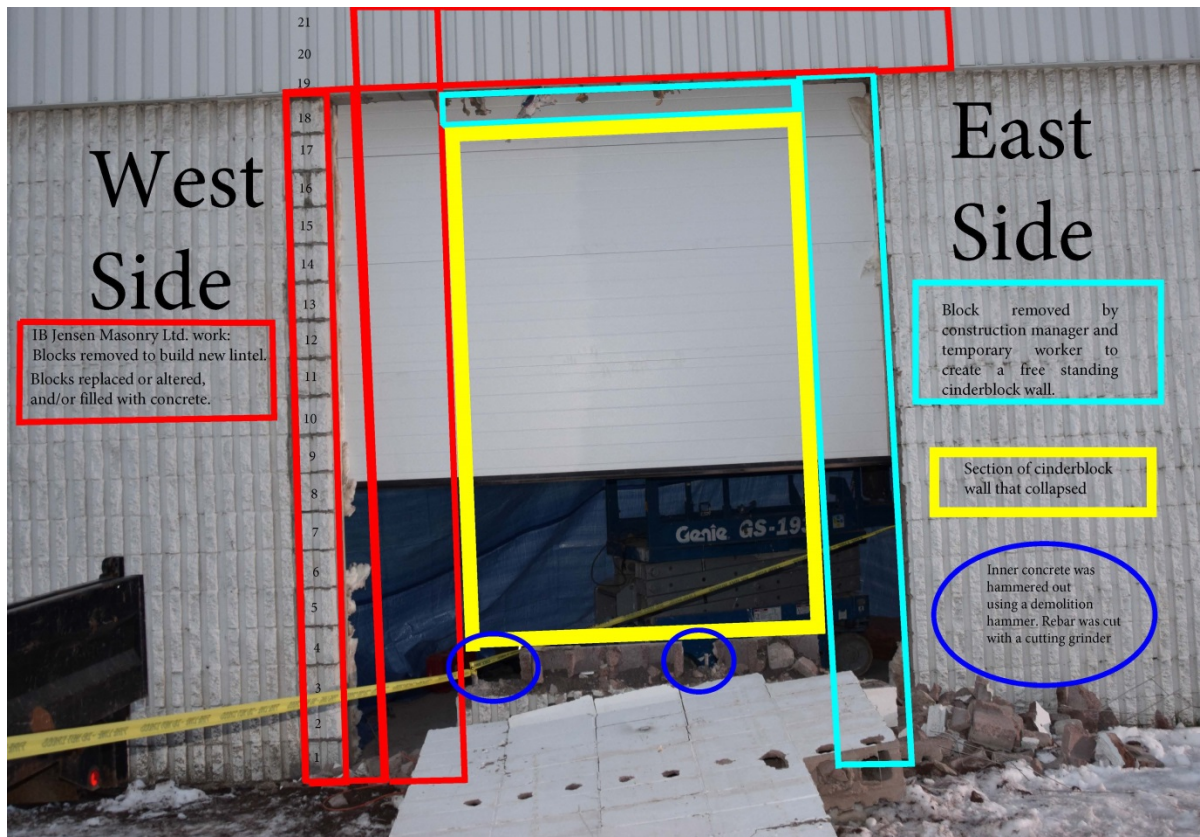
On October 27, 2014, IB Jensen's masonry crew began to prepare for the installation of the lintel. The masons removed two vertical columns of cinderblocks on the west side of the intended door opening. They cut one of those blocks in half and re-laid them back against the existing wall. This would be the west side of the intended bay door. The masons moved to the east side of the intended bay door opening and started removing cinderblocks at approximately 3.65 m height to facilitate pouring of concrete in the vertical column on the east side of the intended door opening. The masons then removed block courses 21, 20, 19, and 18 to be able to install the new horizontal lintel blocks. The masons cut two vertical concrete rebar supports once the 18<sup>th</sup> block course was removed. The vertical concrete rebar supports had to be cut for the masons to install the new lintel. The new lintel was installed at the 19<sup>th</sup> and 20<sup>th</sup> block courses and filled with concrete (Figure 5). The masons slid a temporary 18<sup>th</sup> block course below the new lintel to support it. This 18<sup>th</sup> block course was not mortared as this course would be removed once the lintel set.

Figure 5. Block removal by IB Jensen (red) and Norcal Construction (blues). The number's 1-21 are the horizontal block courses involved in this door installation process.

On November 20, 2014, the manager and the worker returned to continue with the cinderblock wall demolition work. The manager rented an electric demolition hammer in the morning to expedite the cinderblock removal (Figure 2) and purchased a large tarp. The manager and the worker set up the large tarp on the inside of the building over the bay door area. The tarp was to prevent concrete dust from affecting DreamSpace's adjacent equipment. The scissor lift was positioned inside the tarped area along the wall. Using the scissor lift, the worker completed the removal of the 18<sup>th</sup> horizontal block course using the rented electric demolition hammer. The worker then started demolishing down the far east column which paralleled the newly installed bay door (Figure 5). Once the east cinderblock column was removed, this left a freestanding section of cinderblock wall. This freestanding section of cinderblock wall was structurally supported to the concrete foundation by two internal columns of concrete reinforced rebar (Figure 5).

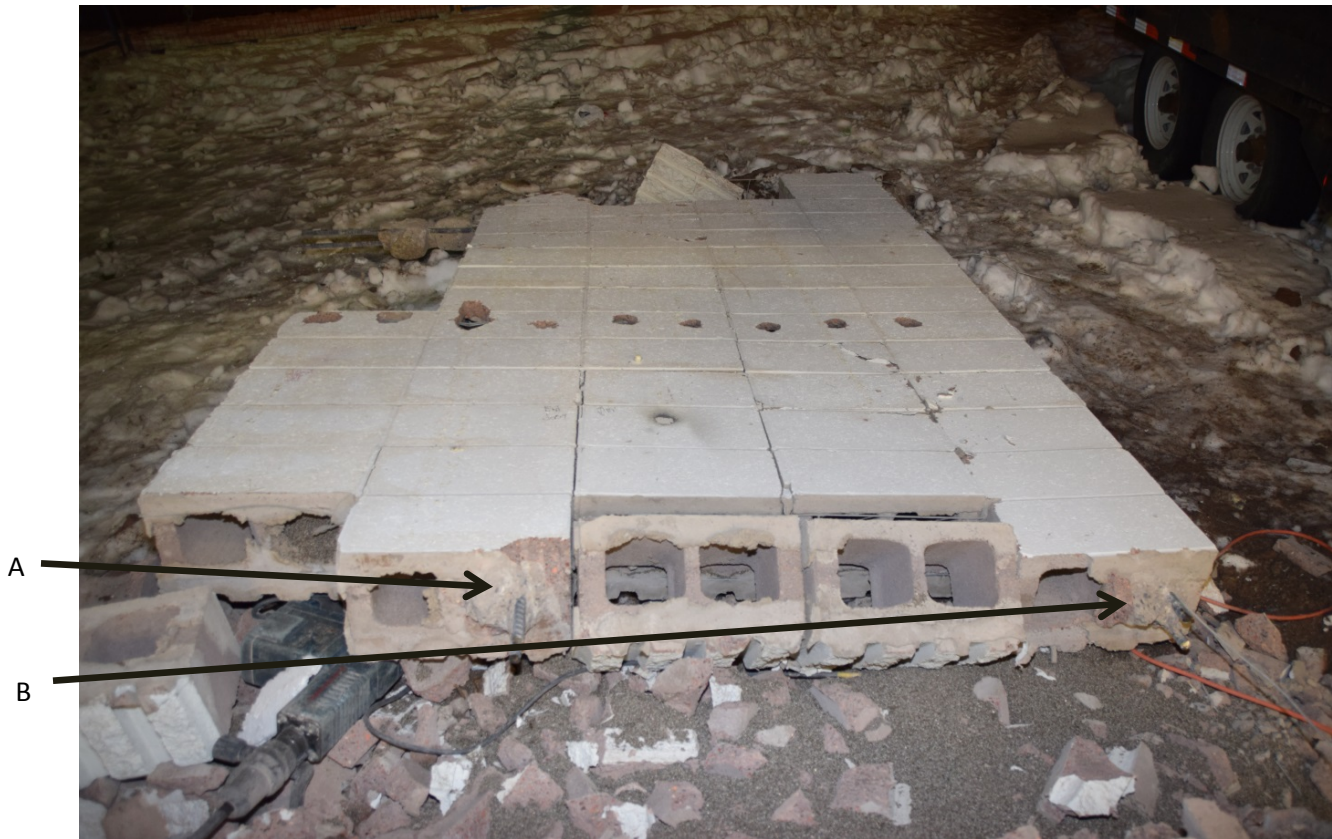
Along the third horizontal block course, the manager and worker used the rented electric demolition hammer at two points to remove the surface of the cinderblock to be able to chip out the concrete found within the block column. This demolition was required to access the structural steel rebar encased within the concrete (Figure 5 & 6). Once the concrete was adequately removed from the two points, the electric grinder with a cutting wheel and/or a reciprocating saw were used by the temporary worker to cut the vertically situated rebar found within the blocks (Figure 5 & 6). Once the internal rebar was cut this left a free standing 2.0 m wide by 3.4 m tall cinderblock wall.

*Figure 6. Steel rebar encased in concrete within the exterior cinderblock wall.*

*A & B: Two cinderblock columns of the concrete reinforced steel rebar. All pieces of rebar cut.*

The manager then instructed the worker to clean up the concrete and cinderblock debris while he left to attend an appointment with a commercial client. While the manager was away, the worker was working outside next to the wall. At approximately 1:00 p.m., the standing 2.0 m wide by 3.4 m tall cinderblock wall collapsed toward the exterior of the building landing on the worker. No one witnessed the wall collapse.
