RECAPP Facility Evaluation Report

Aspen Regional Health Authority

Seton Jasper Healthcare Centre

B1102A

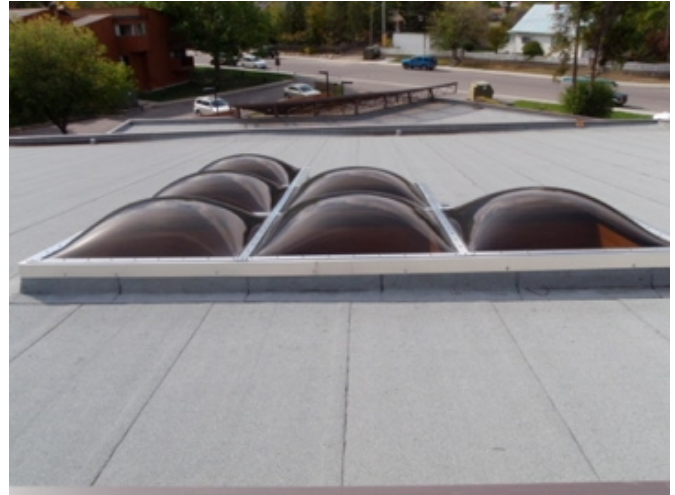
PA020265.jpg

Glazed bubble skylight located above a waiting area.

<u>Rating</u>	<u>Installed</u>	<u>Design Life</u>	<u>Updated</u>
4 - Acceptable	1974	20	MAR-10

Event: Replace Skylight**

Recommendation:

Replace one glazed bubble skylight, approx. 5 m2.

<u>Type</u>	<u>Year</u>	<u>Cost</u>	<u>Priority</u>
Lifecycle Replacement	2013	\$16,400	Unassigned
