Investigation Report
Worker Fatally Injured After Falling From a Roof
January 19, 2017

This document reports Occupational Health and Safety's investigation of a fatal injury when a worker fell from the roof of a house in January 2017. It begins with a short summary of what happened. The rest of the report covers this same information in greater detail.

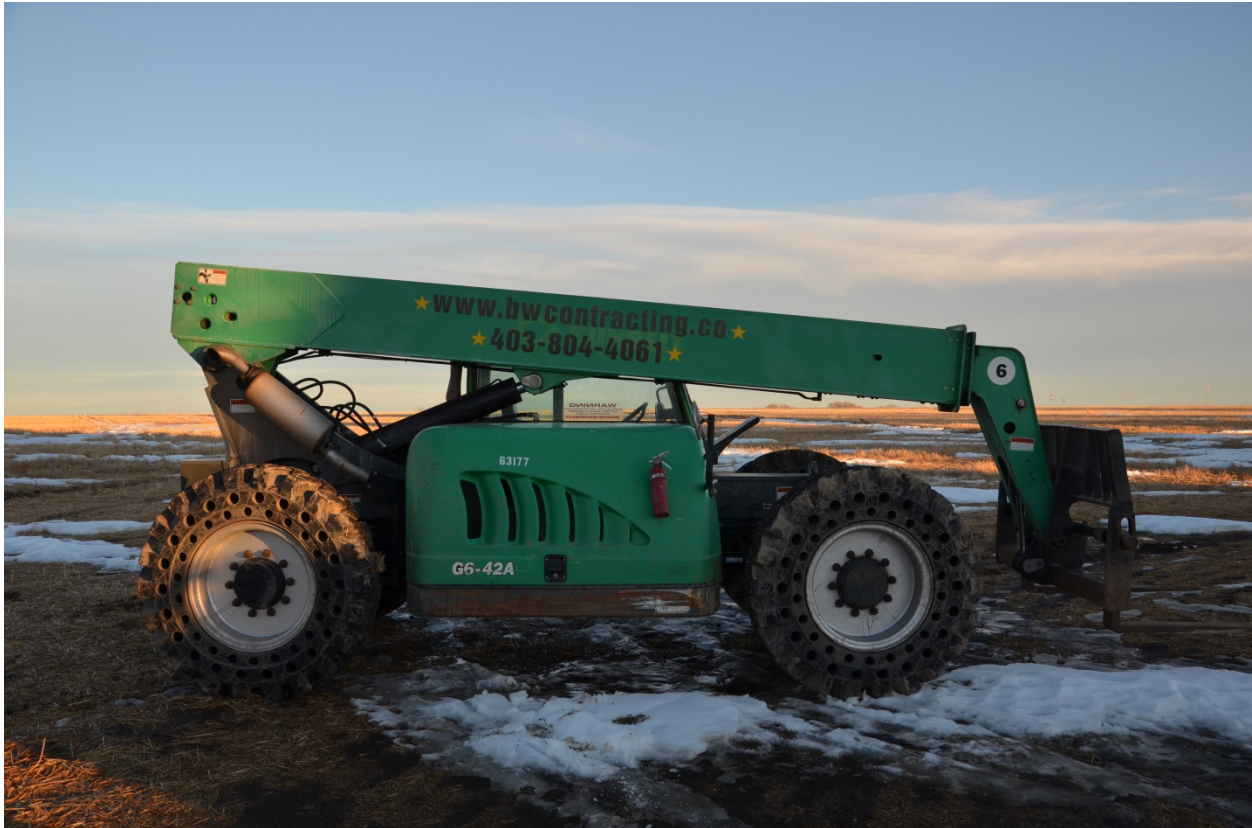
The 2005 JLG Model G6-42A (telehandler) was equipped with telescopic forks (Figure 1) and had a rated capacity of 2994 kilograms (kg) with a maximum lift height of 12.8 m. The telehandler was used to lift the trusses to the roof of the house for installation.

Figure 1. Telehandler from the incident

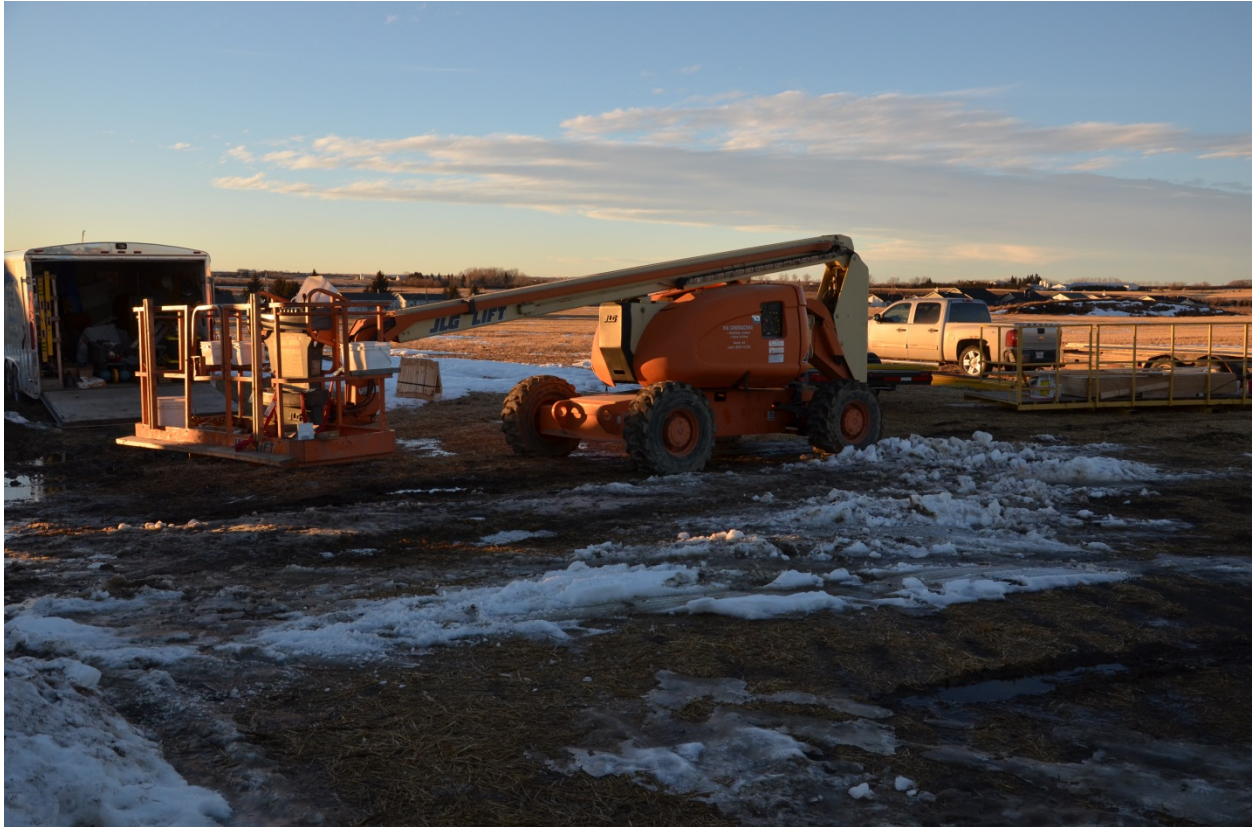
The JLG model 600A (JLG) narrow articulating boom lift with a man basket attached (Figure 2) was used to transport workers from the ground to the roof of the house. The JLG had a working height of 20.42 m and a working outreach of 18.42 m. The man basket on the boom had a capacity of 230 kg with the controls located in the basket and on the side of the JLG.

Figure 2. JLG from the incident

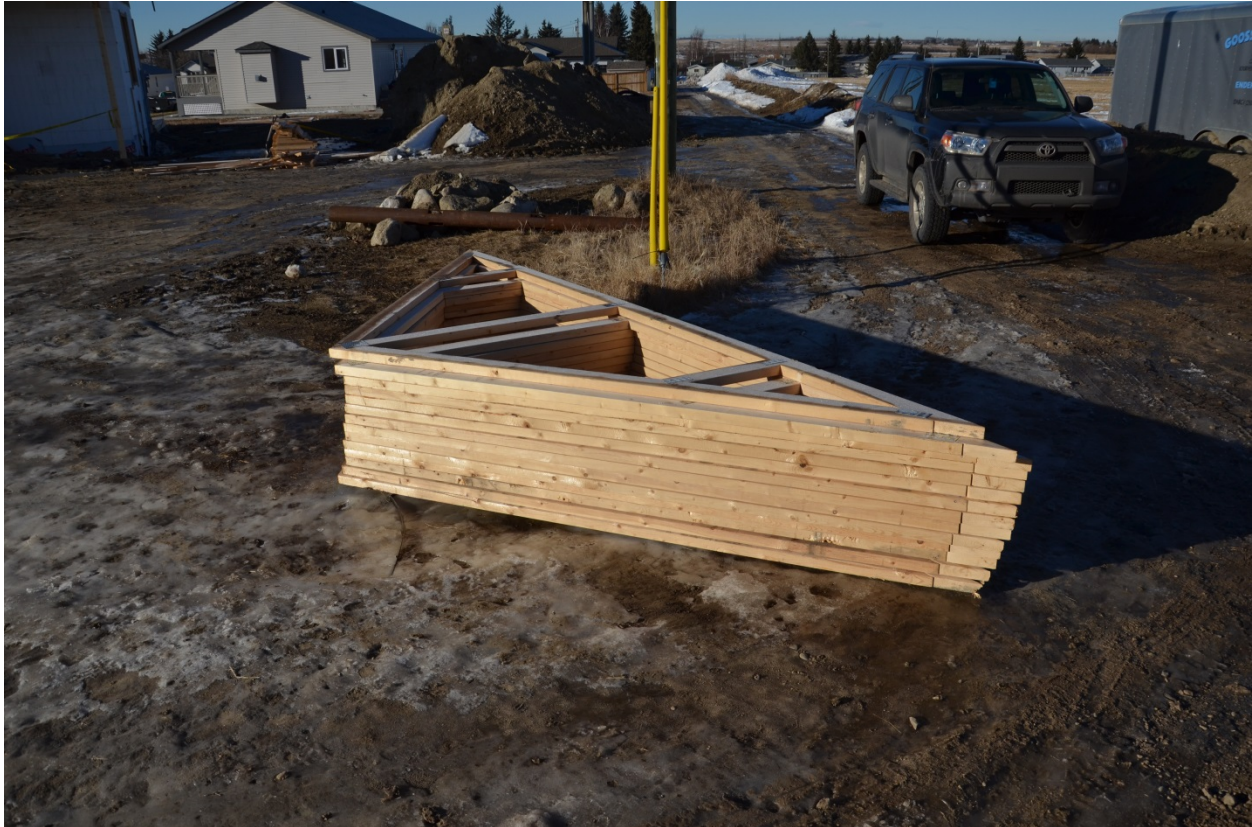
Figure 3. Trusses from the incident

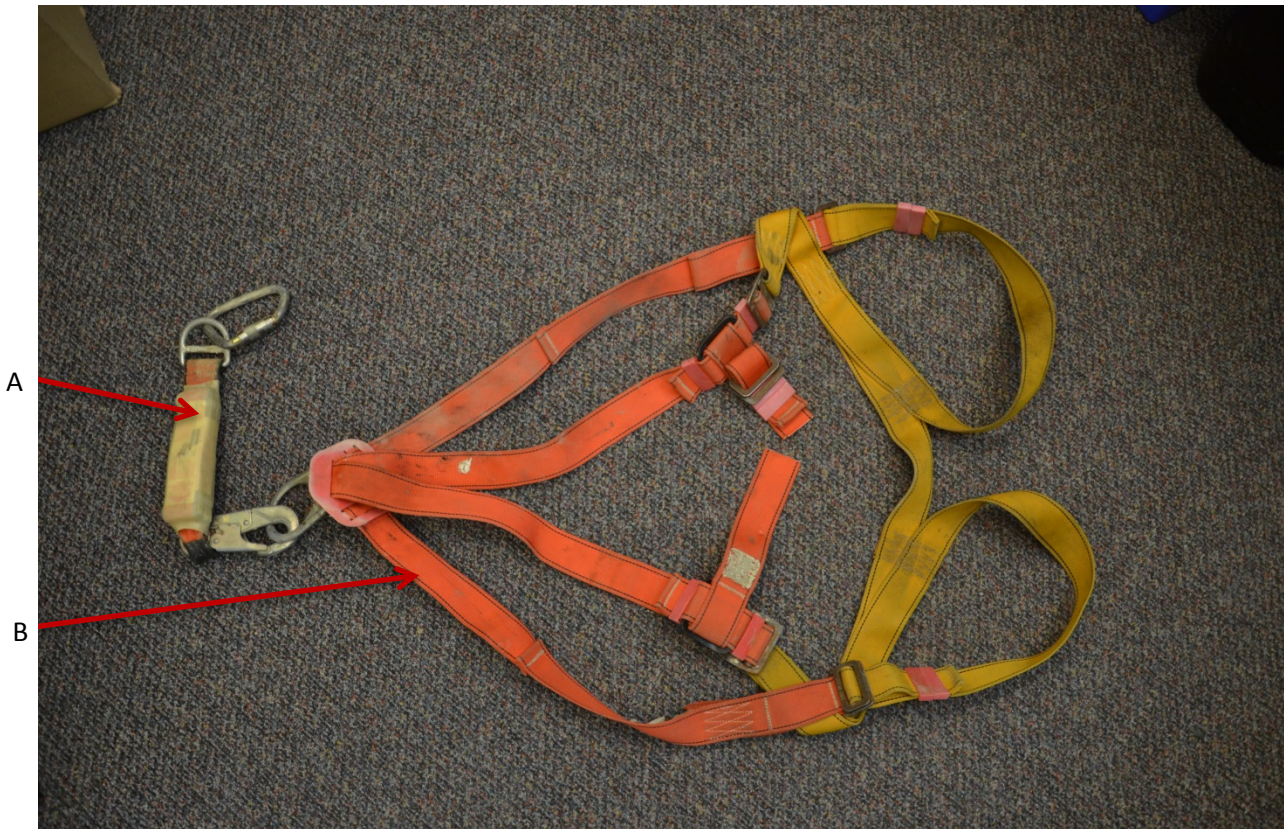
Figure 4. The full body harness and the shock absorbing lanyard from the incident

A. The shock absorbing lanyard

B. The full body harness

A shock absorbing lanyard is a device used to reduce the arresting forces during a fall by tearing and lengthening the deceleration distance. The lanyard used in the incident had a 1.55 m deployed length.

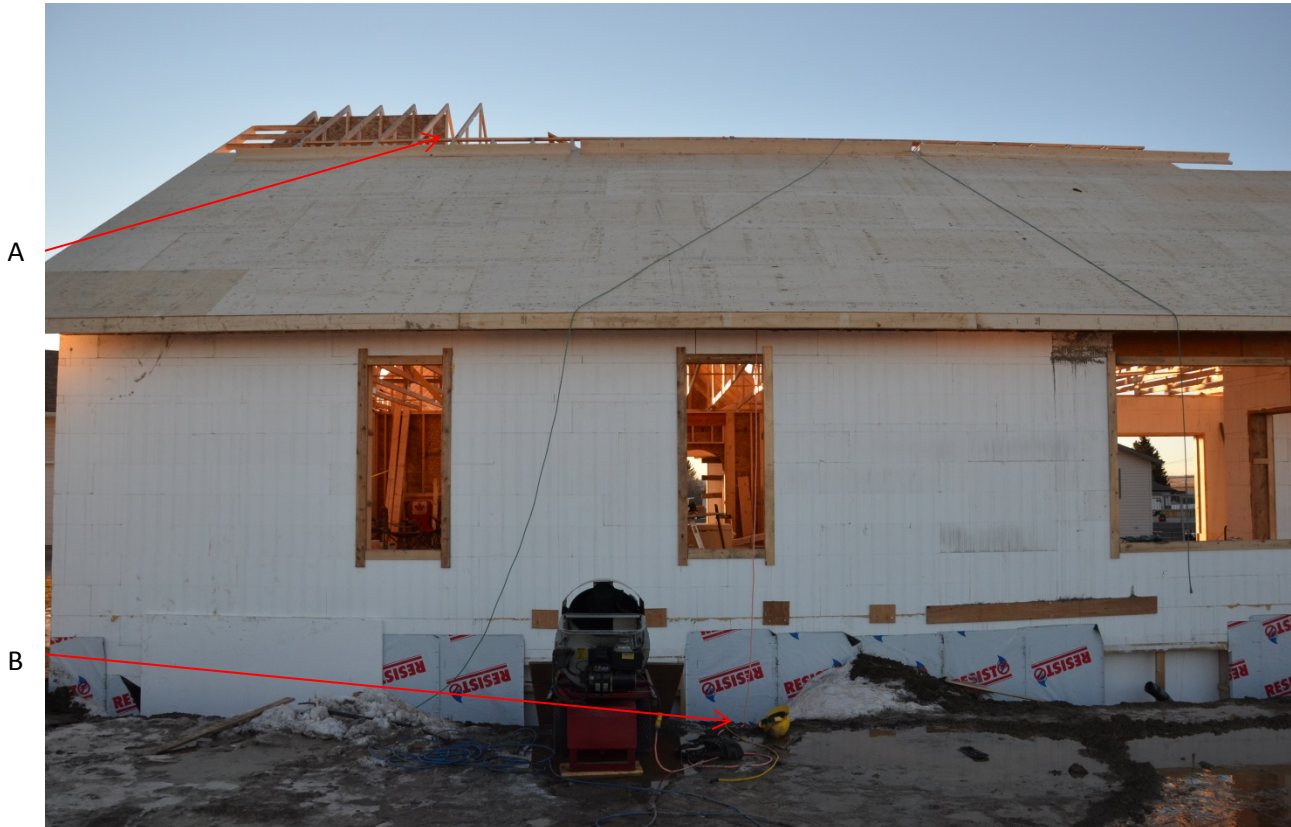
At approximately 11:30 a.m., the injured worker asked to come down off of the roof and offered to buy lunch for the crew. Since they were close to finishing installing the trusses that were brought up, the business owner said that when the last truss was installed they could go for lunch. At about 11:45 a.m., the injured worker pushed the last truss to the crew and began to get off of the roof. The injured worker unhooked from the roof and was transitioning towards the JLG when the injured worker collapsed. Worker 2 heard a “thud” and saw the injured worker slide off of the roof between the telehandler and the JLG. No sounds were heard from the injured worker, and the injured worker did not try and stop the fall (Figure 5).

Figure 5. Incident location

- A. Location of trusses that were being installed*
- B. Location where injured worker landed*

The injured worker slid off of the roof and landed on the ground 6.23 m below, striking the injured worker's head on a piece of metal. The home owner, who arrived a few minutes before from a trip to town, called 911. The rest of the crew came down from the roof and started cardiopulmonary resuscitation (CPR) while waiting for the ambulance to arrive. When the ambulance arrived, the injured worker was placed into the ambulance and at 12:00 p.m. the injured worker was pronounced deceased.
