RECAPP Facility Evaluation Report

Alberta Health Services-Central

Wainwright Health Centre

B1183A
Wainwright

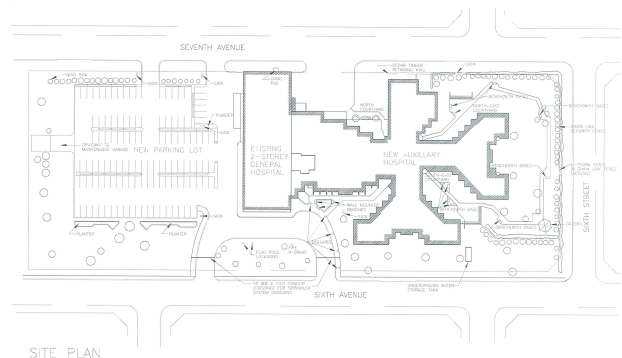
site.jpg

The Site was visited on Jan 31, 2014 by PBK Architects/GENIVAR for the building review. At that time snow was present in the landscaping areas, but all driveways and walks had been cleared and were viewable. The maintenance staff was questioned thoroughly on the state of the grass and landscaping. Of particular evidence was the frost heaving on the paving stone pathways and ice build-up from downspouts which is causing concern.

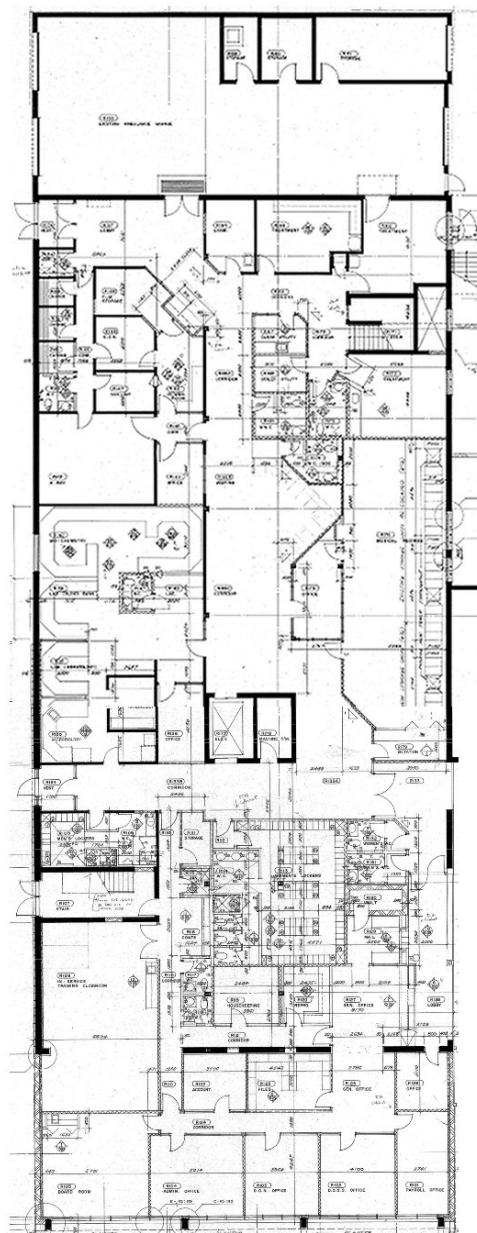
HospitalMain.jpg

The Site was visited on Jan 31, 2014 by PBK Architects/GENIVAR for the building review. At that time snow was present on the flat roof areas. The maintenance staff was questioned thoroughly on the state of the roofing, flashing and parapets which were all recently upgraded. Currently the north wing of continuing care is vacant and 2 patient rooms have been converted to offices. Not all patient rooms were viewed due to occupancy but at least one of each type of room in each wing was observed and it is assumed the other rooms were in the same condition. There were a few areas though typical were reviewed due to noted deficiencies by maintenance staff.
