Investigation Report
Worker Fatally Injured when Crushed between Equipment
November 3, 2015

The contents of this report

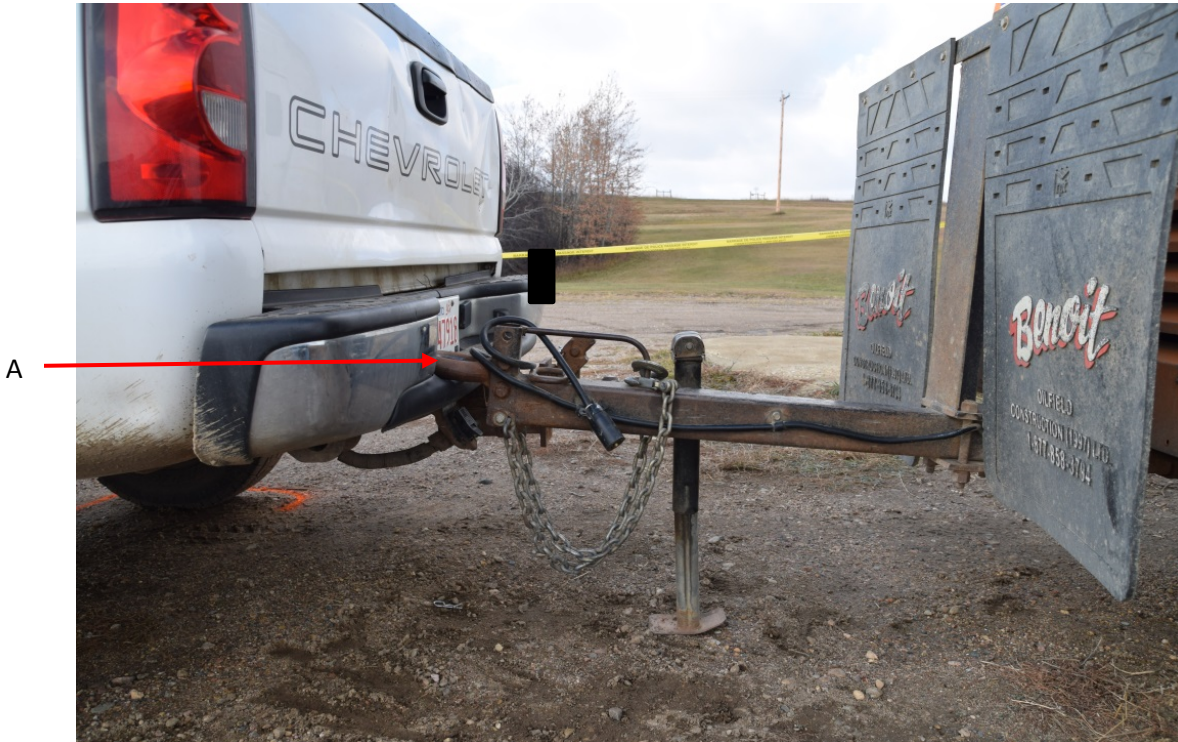
Figure 4: Tailgate of unit #151 and hitch of the compressor unit.
