**WORKER STRUCK BY
HEAVY DUTY SPRING**
Type of Incident: Fatality
Date of Incident: March 5, 2011

TABLE OF CONTENTS

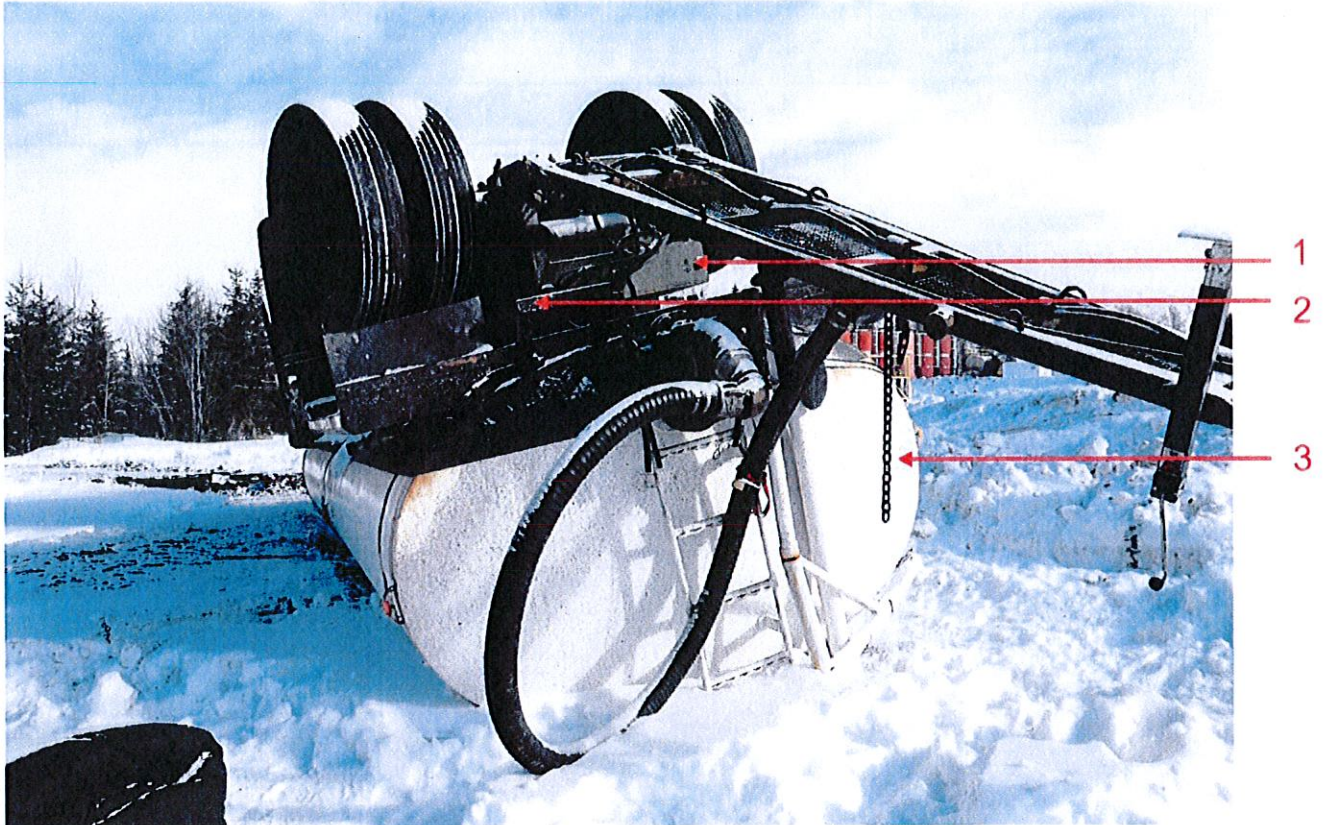
Photograph 4 – Shows a close-up of the tanker-trailer.

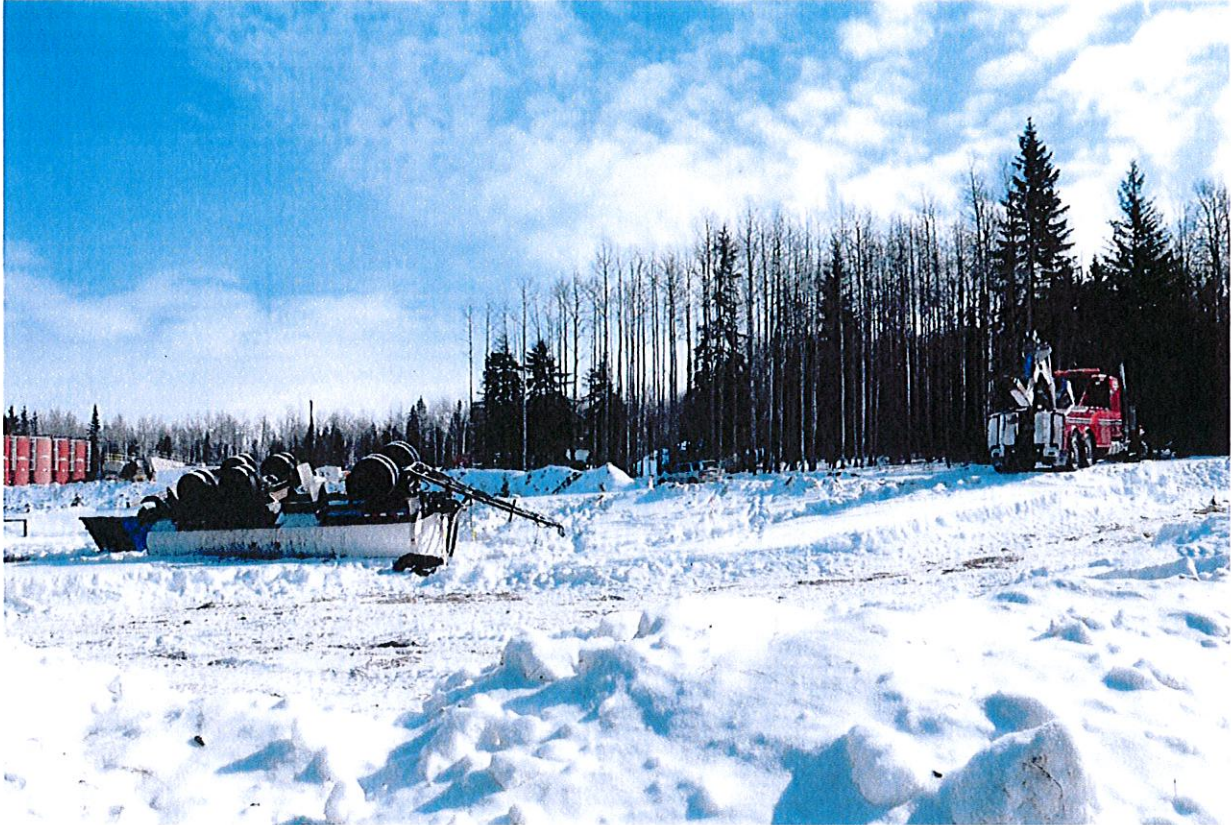
Photograph 5 – Shows the relative positions of the overturned tanker-trailer and the tow truck.
(Reconstructed scene, as the tow truck was repositioned post-incident.)
