Workplace Health and Safety Fatality Report

WORKER ELECTROCUTED DURING HIGH VOLTAGE CONTACTOR REPAIR

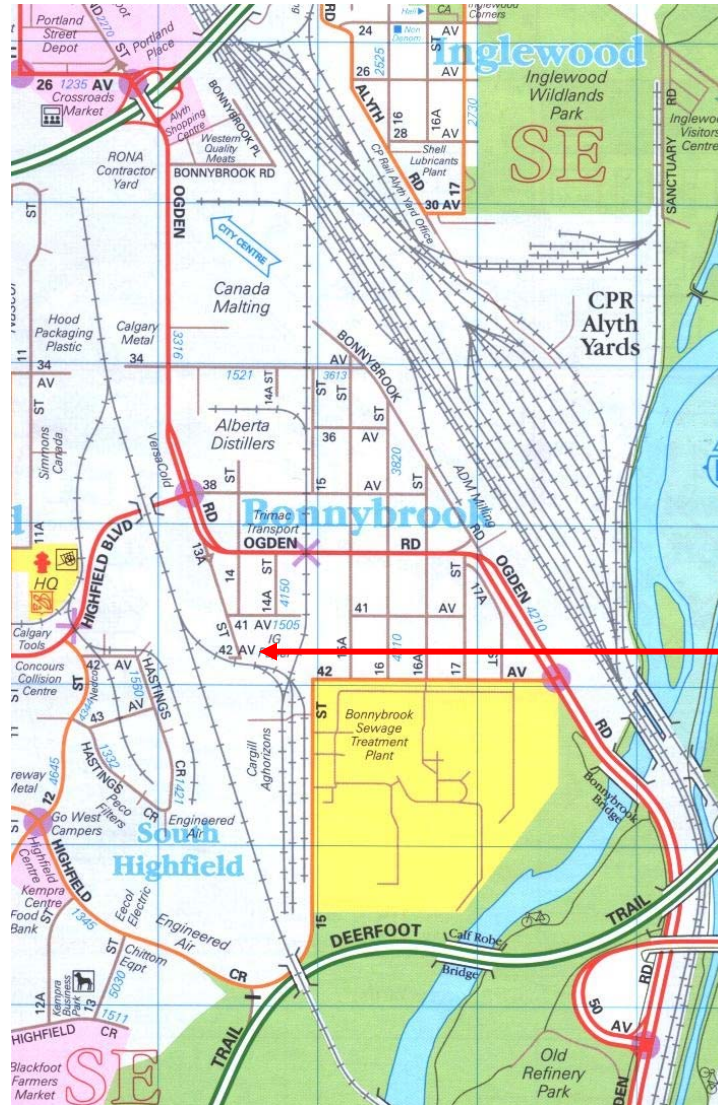
Map: Arrow shows the location of IKO Industries Ltd., where the incident occurred.

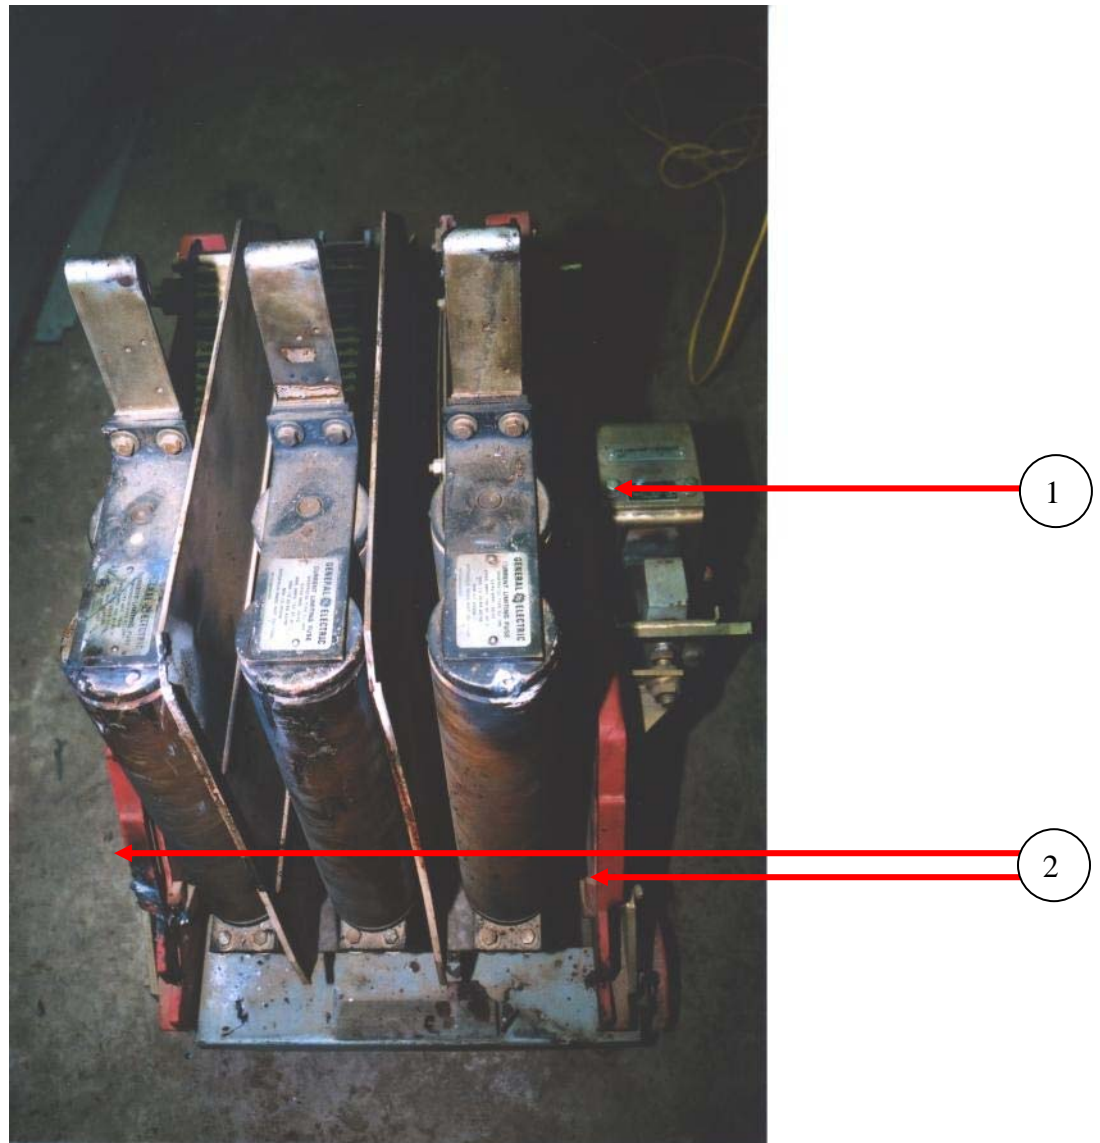
Photograph 9: Shows the high voltage of 4160 volts contactor unit taken out of the enclosure.

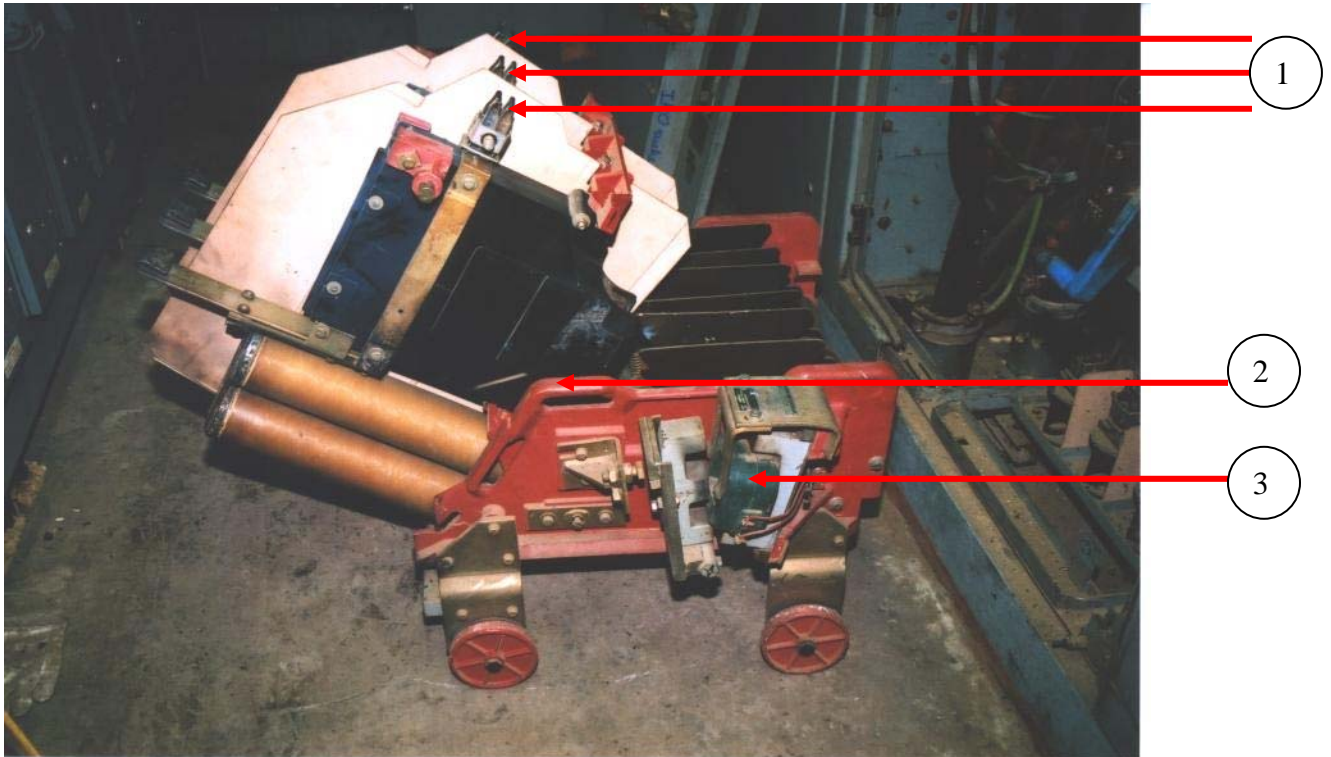
Photograph 10: Shows the high voltage of 4160 volts contactor unit with the disconnect assembly rotated backwards.
