Investigation Report

Worker fatally injured after being pinned in the equipment

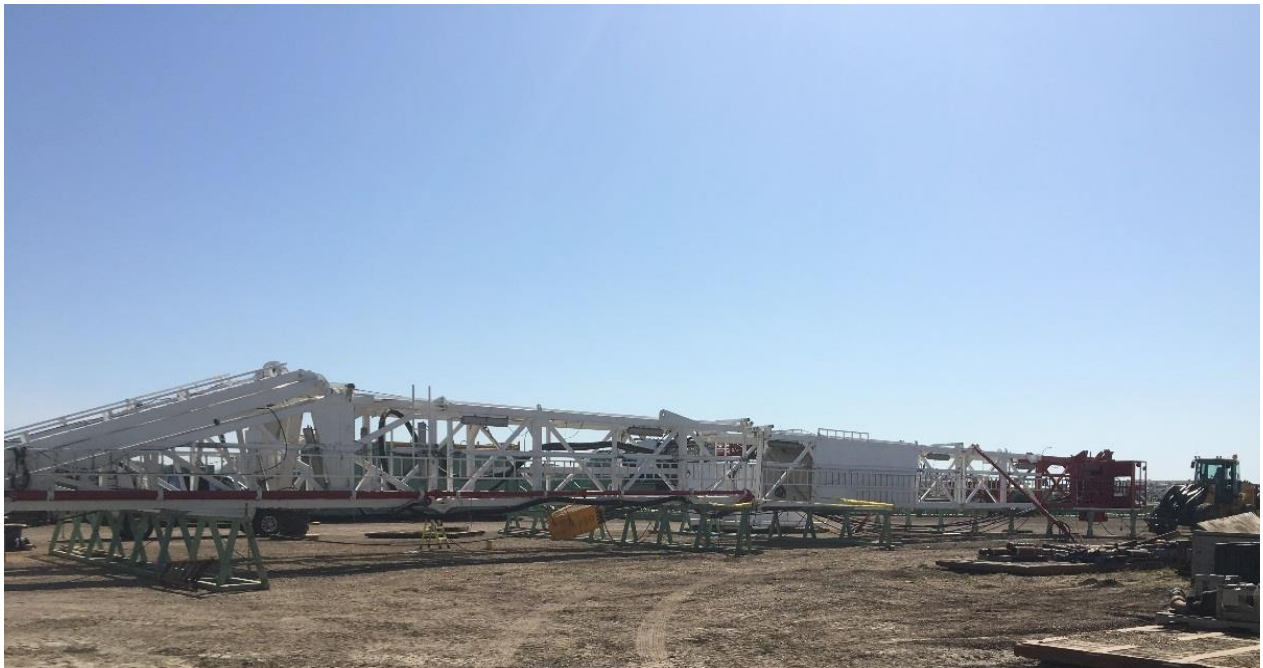
Figure 1. Rig 407 in the lay down position at the time of the incident.

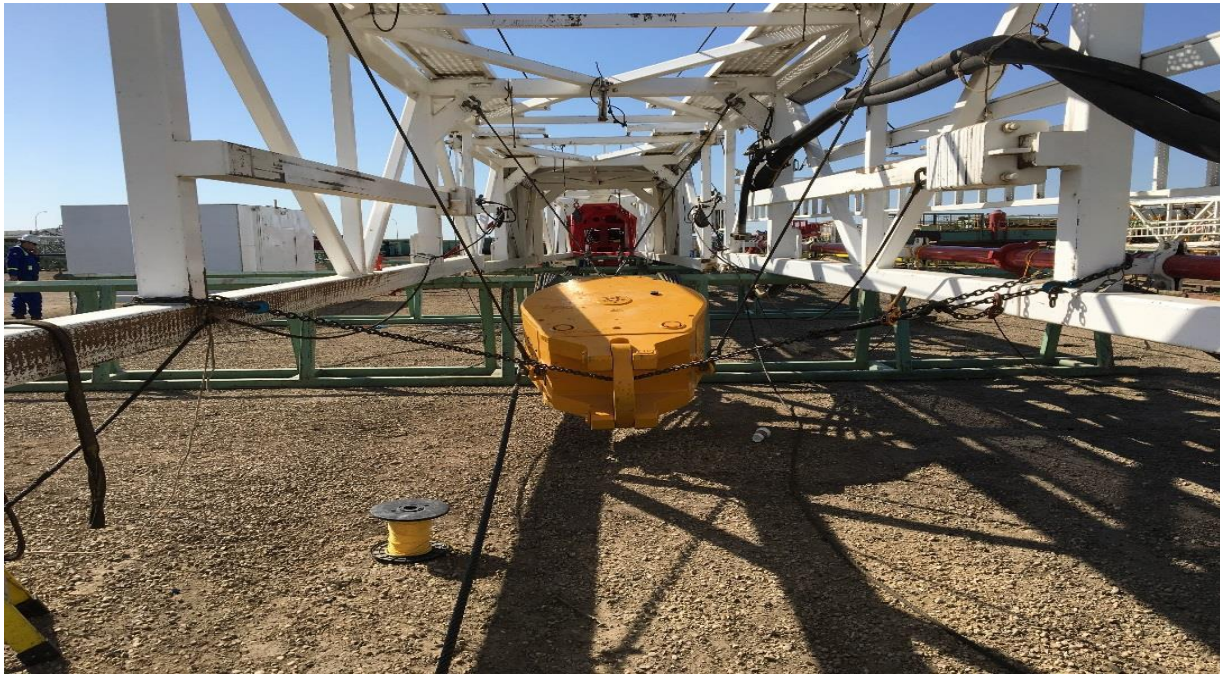
Figure 2. Travelling block on Rig 407 was hung from the travelling block attachment points in the bottom section of the mast.
