Investigation Report
Fatal Injury Incident – Worker Struck by Equipment
April 15, 2016

F-OHS-102433-96A70
January 2021
Page 1 of 9

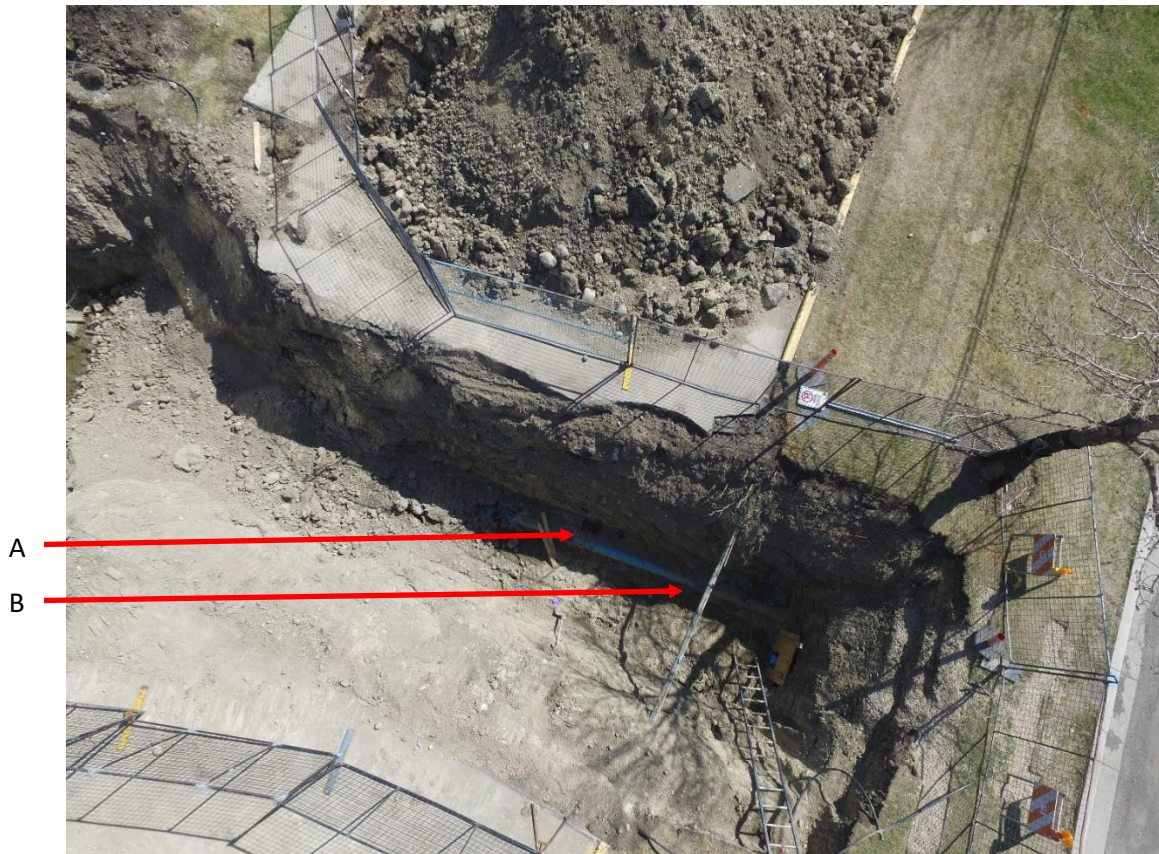
Figure 4. Aerial photograph taken on April 20, 2016. The photo captured the incident excavation, the water line and approximate location of the deceased worker .
