**ALBERTA TRANSPORTATION SPRINGBANK OFF-STREAM RESERVOIR PROJECT
RESPONSE TO NRCB AND AEP SUPPLEMENTAL INFORMATION REQUEST 1, JULY 28, 2018**

**APPENDIX IR14-5 DAM ALIGNMENT AND TOE LOCATION
RELATIVE TO THE ELBOW RIVER OF THE
SPRINGBANK OFF STREAM RESERVOIR
PROJECT**

Reference: Dam Alignment and Toe Location Relative to the Elbow River

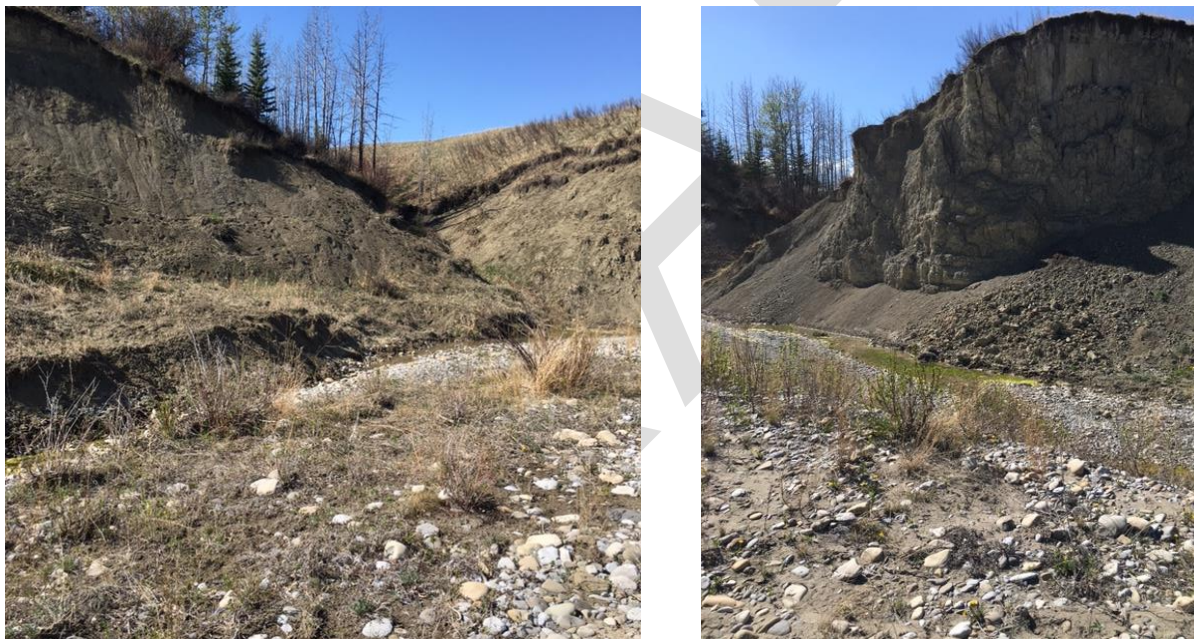
Stantec performed site reconnaissance along the toe of the Elbow River banks near the dam toe area on May 3, 2016. Two gullies were observed near the location where the dam toe is closest to the top of the Elbow River bank. The two gullies are shown in Attachment 1 in plan view. Photographs of the gullies are shown below in Figure 1; the photographs give good perspective on the size and scale of the gullies. The gullies were not reviewed in detail due to land access constraints.

Figure 1. West Gully (left) and East Gully (right).

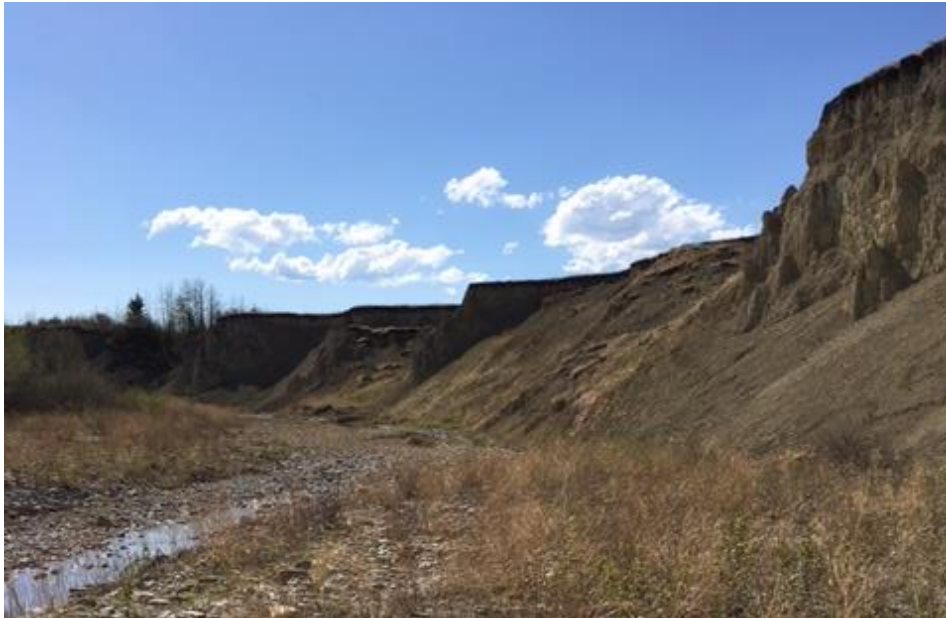
Site walkovers and aerial photographs have indicated that the natural slopes of the Elbow River downstream of the proposed dam toe undergo frequent slope instability, with complex rotation failures being the dominant failure mechanism (Figure 2 shows the river bank near the dam toe). The slopes are a dynamic system, in which equilibrium is recurrently disturbed by channel migration. Observations indicate the following cycle of slope regression:

- Slope at equilibrium;
- Channel migration towards the slope;
- Initiation of erosion of the toe (disturbing agent);
- Over-steepening of the slope with subsequent rotational failure. This forms a localized circular back-scarp in plan view divided by spines of steeper material;
- The steeper spines lose support and material gradually fail as blocks (wedge failure); and,
- Surface water, progressive slumping and establishment of vegetation further modify the slope until it reaches equilibrium

Figure 2. Elbow River Bank near the Dam Toe.

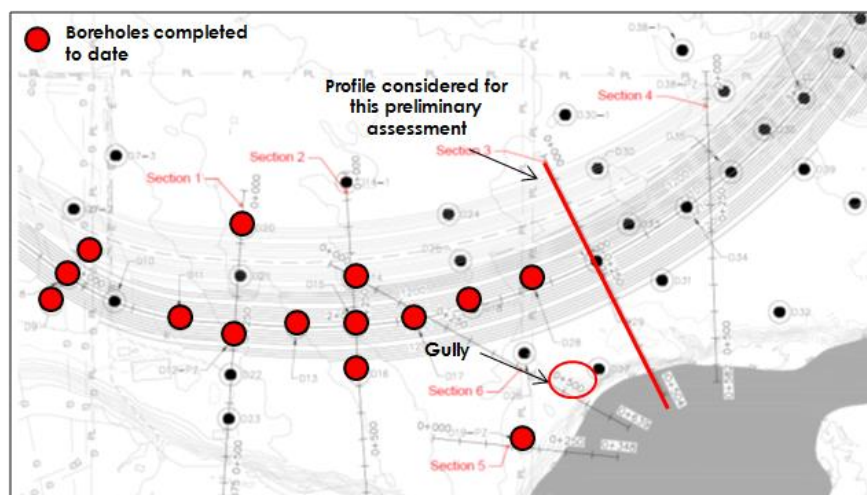
Stantec performed drilling and laboratory testing at 15 boreholes as of May 18, 2016; the boreholes completed are shown below in Figure 3.

Figure 3. Boreholes Completed and Location of the Analyzed Slope/W Section

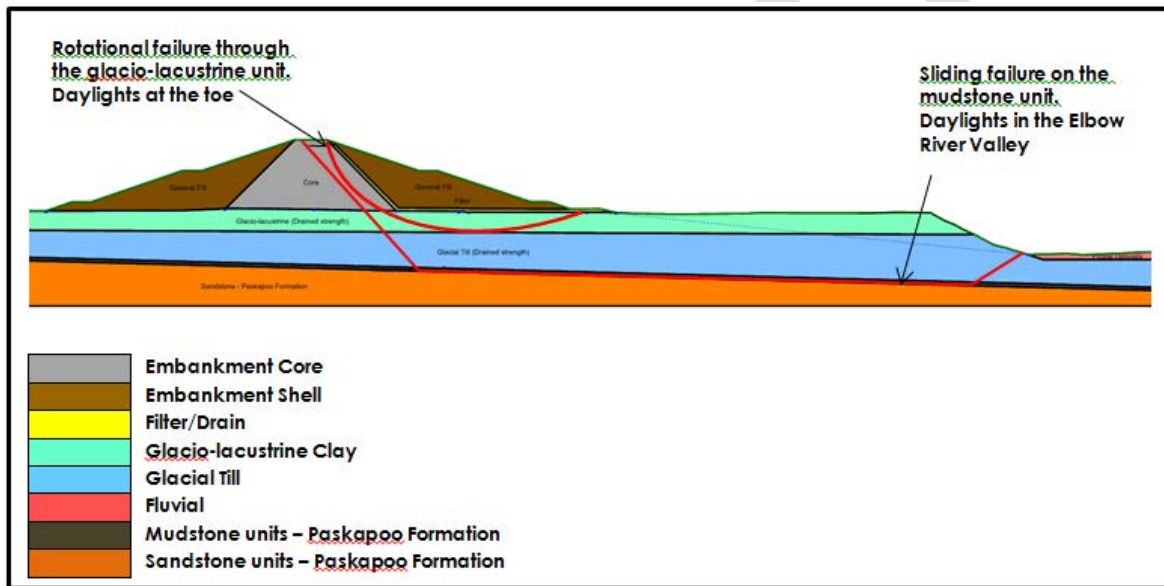
The results of the existing conditions stability analysis are summarized in Table 3 and the generalized location of the failure surfaces are shown in Figure 4.

Figure 4. Generalized Failure Surfaces

The generalized location of the failure surface is shown in Figure 4. The failure surface goes through the weaker mudstone layer. As the river bank was moved closer to the toe of the dam in order to model future lateral erosion of the river bank, the failure surface continued to go through the mudstone layer.

The analysis for the current alignment conditions with the dam constructed ignoring potential lateral river bank erosion showed adequate factors of safety (1.5) for long term conditions with the reservoir full using a c/p ratio to characterize the strength of the glacio-lacustrine clay. The critical failure

surface for this scenario was a rotational failure through the toe of dam in the foundation glacio-lacustrine clay.

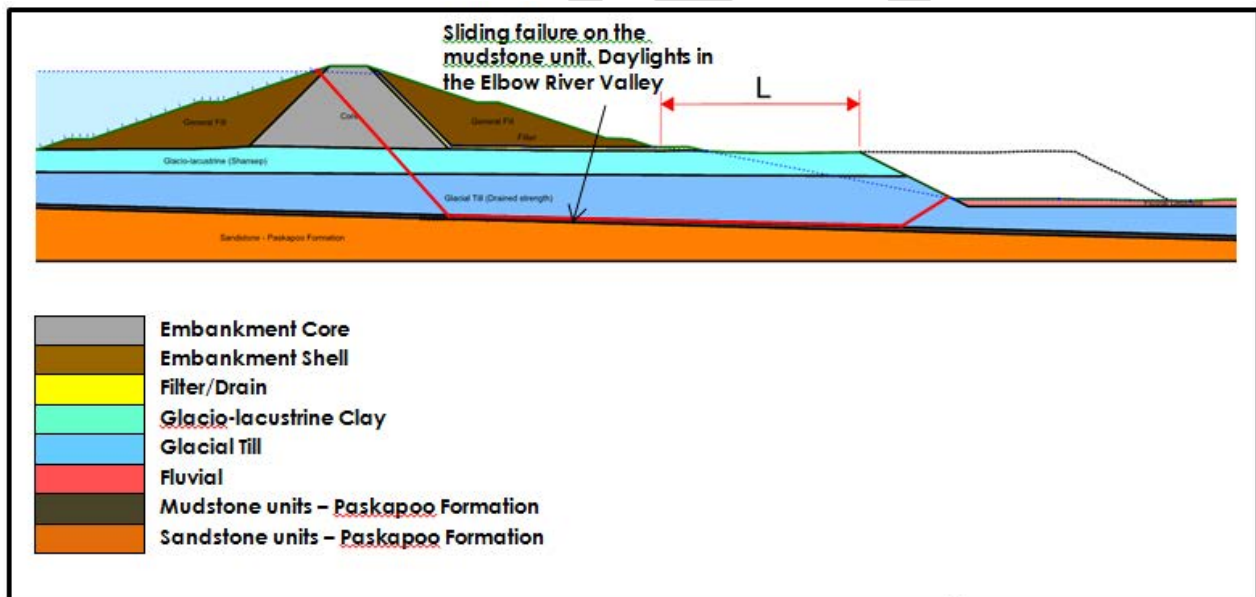
Once the current design alignment conditions were analyzed for drained and undrained strength conditions, lateral erosion of the river bank was modeled using an iterative process to move the river bank closer to the toe of the dam at varying distances. This condition was analyzed assuming the reservoir is full at elevation 1212 m with the phreatic surface following the filter drain and then straight lined from the toe of the dam to the river surface. Both the entry / exit method and the fully specified failure surfaces were evaluated to determine the lowest factor of safety. It was assumed river erosion would occur long after the construction of the dam, so construction loading with excess pore pressure analysis was not considered. The results of this stability analysis are summarized in Table 4.

Figure 5. Iterative Lateral Erosion Analysis

The potential impact of lateral river bank erosion was evaluated. The lateral river bank erosion does not impact the critical failure surface until the top of the river bank is 70 metres from the toe of the dam. This equates to approximately 44 metres of lateral erosion. At this distance, the factor of safety is equal to 1.5 and the critical failure surface is no longer the rotational failure through the toe of the dam but a sliding failure along the mudstone unit in the Paskapoo formation toward the river.

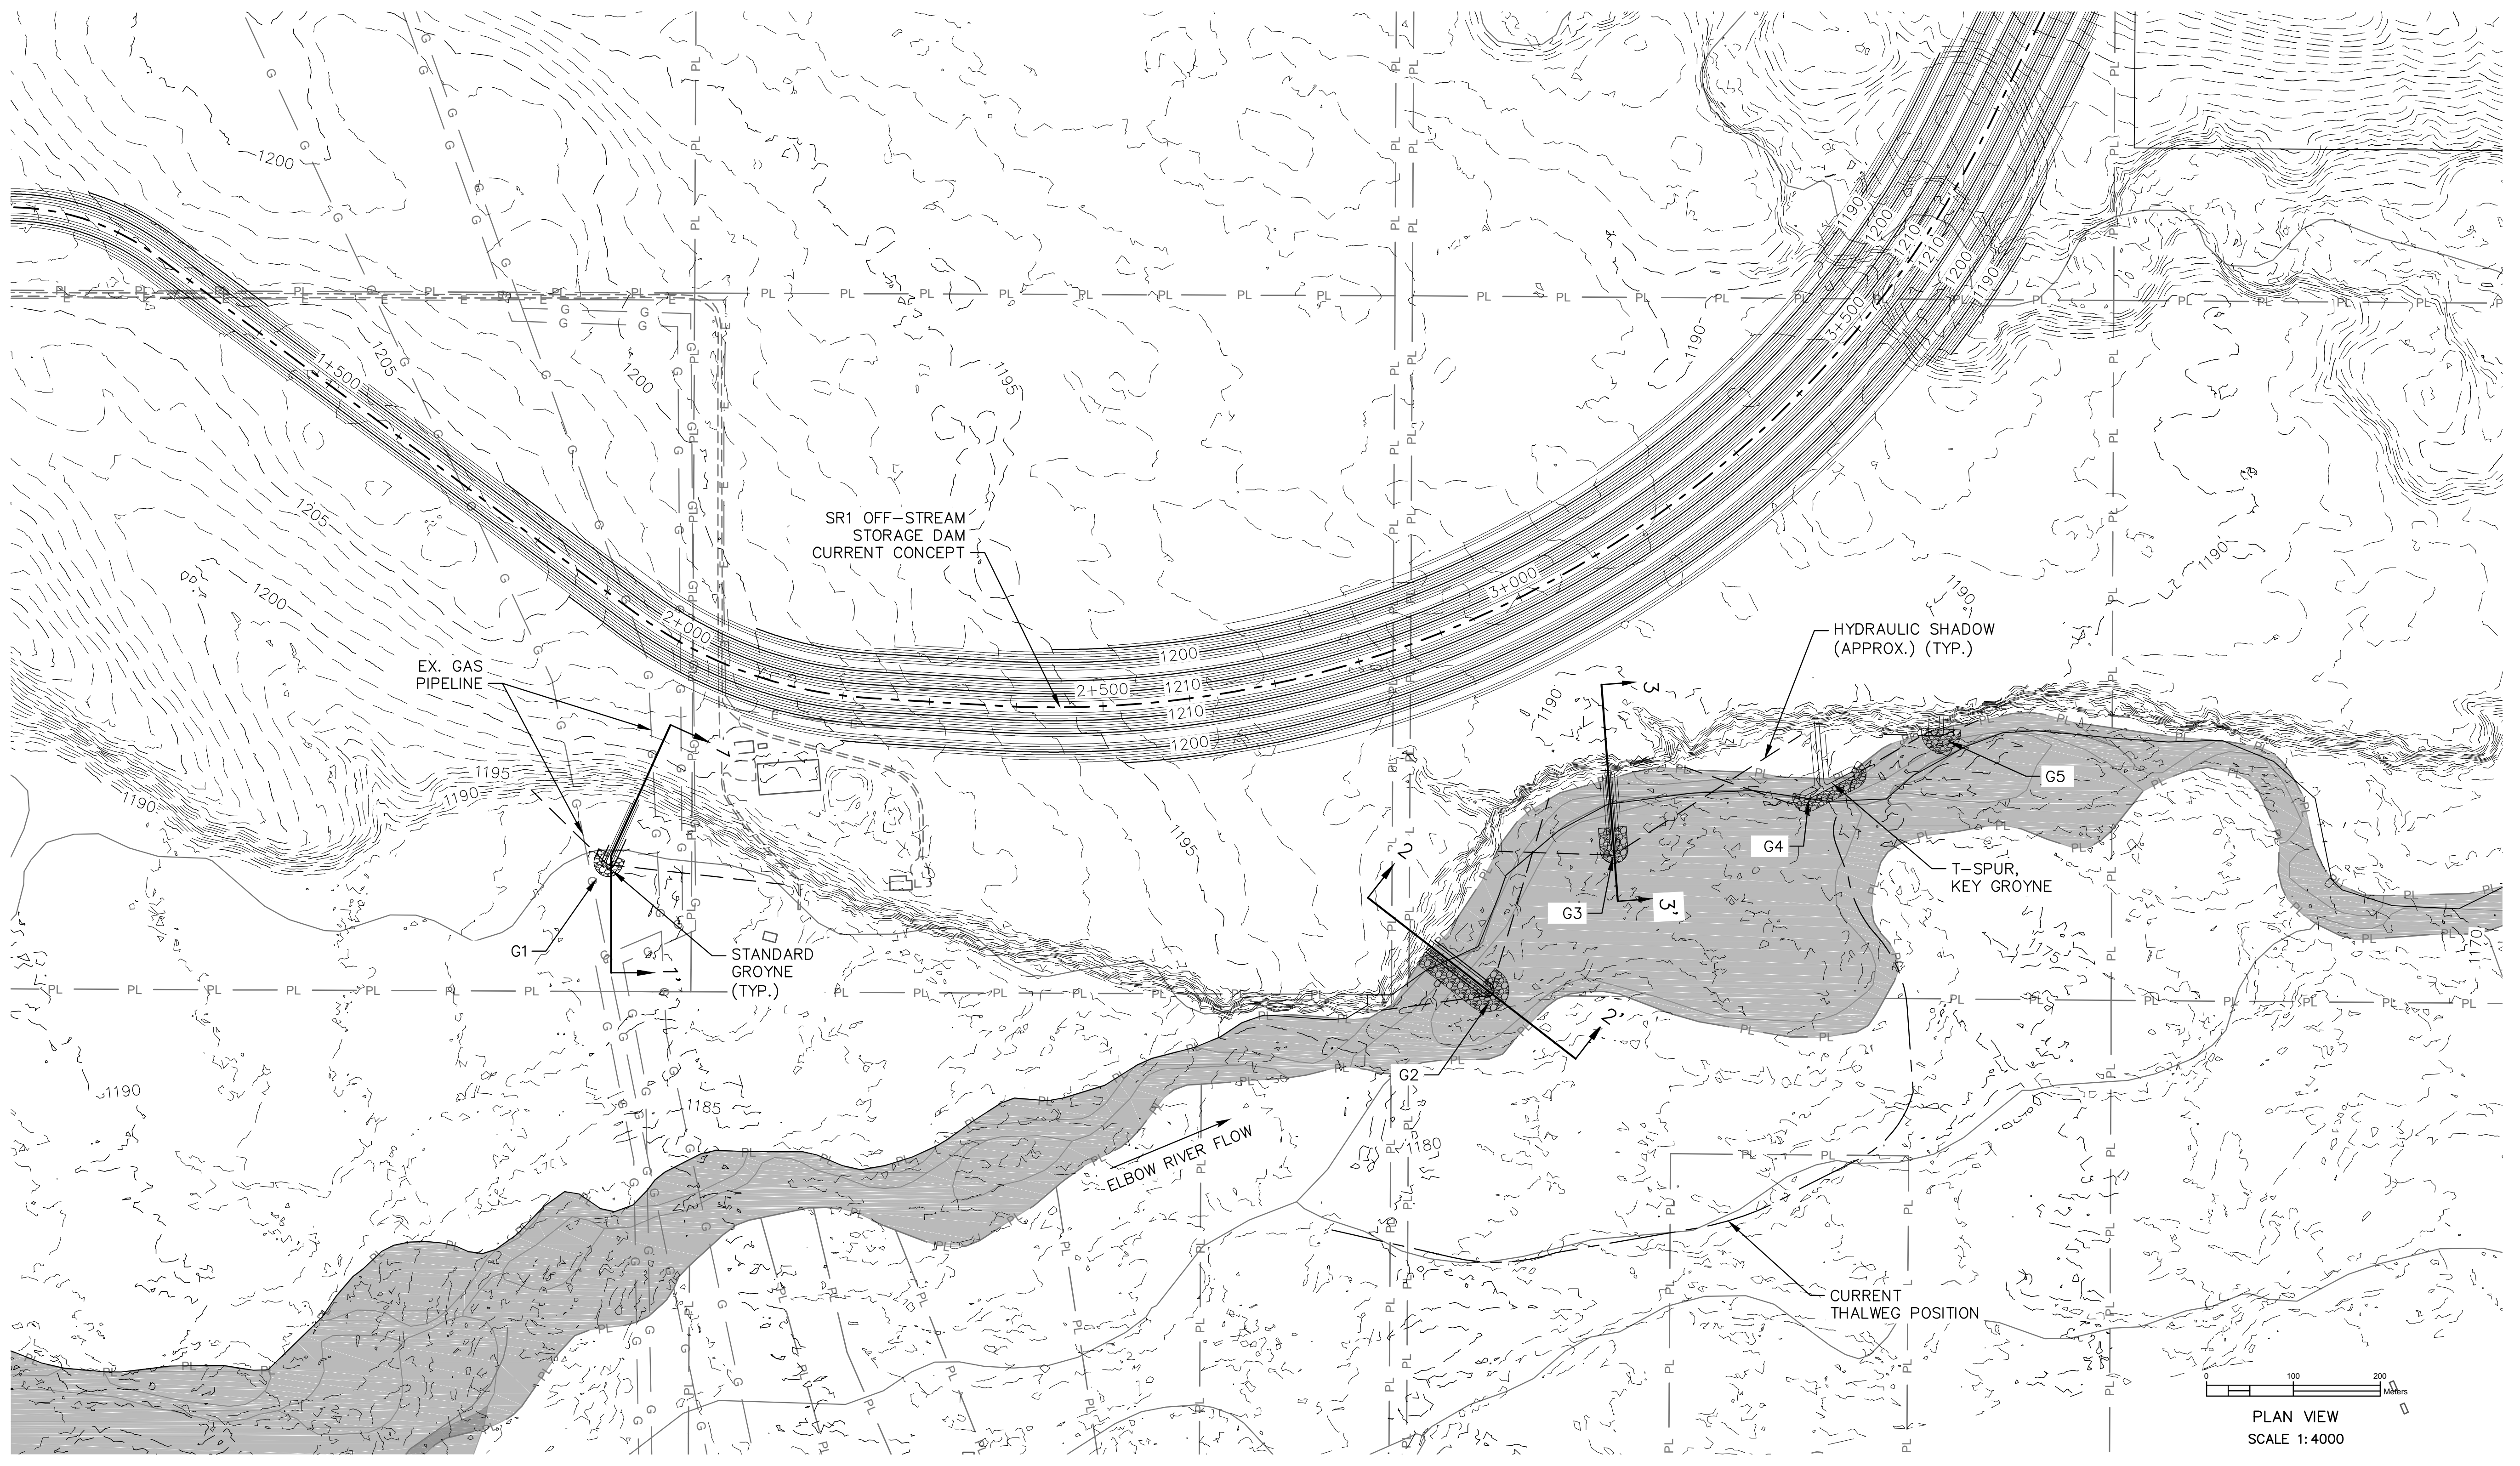
Groynes G1, G2 and G3 are located entirely on sub-channels and floodplain areas and not within the current active main channel. Groynes G4 and G5 do affect the alignment of the main channel and *Fisheries Act* authorization would be required for the realignment. The location of these groynes in the main channel may also challenge environmental aspects of the *Water Act* approval; however, appurtenances like small vanes off the armored nose, boulder runs and joint planting of willows in the riprap voids can be added to the design to help offset impacts to the aquatic environment and facilitate regulatory approval.

Groynes are long projections of earth or rock fill that disrupt flow patterns and can be used to effectively 'push' the river away from areas of high erosion potential. There are several types of groyne configurations available; however, a key consideration when determining the type and arrangement of groynes is the availability of materials and the length of reach which is to be altered. Attachment 2 identifies an arrangement that uses 5 non-overtopping, repelling groynes to achieve the desired protection.

The proposed groynes are comprised of vegetated earth fill with a class II riprap cap on their ends and a self-launching apron for scour protection. The use of non-armoured earth fill is recommended because of the length of the spurs and the amount of material required to cover the length of the reach to be protected. The use of earth fill means the spurs cannot be overtopped during the design event and therefore a 1 metre freeboard has been applied to their height. Non-overtopping groynes produce a hydraulic shadow of ineffective flow area that extends at a 1:1 angle upstream and a 4:1 angle downstream as shown in Attachment 2 and is the basis for this conceptual arrangement. Shorter groynes reduce the length of this zone of influence; and thus, would require additional groynes to achieve the same length of protection.

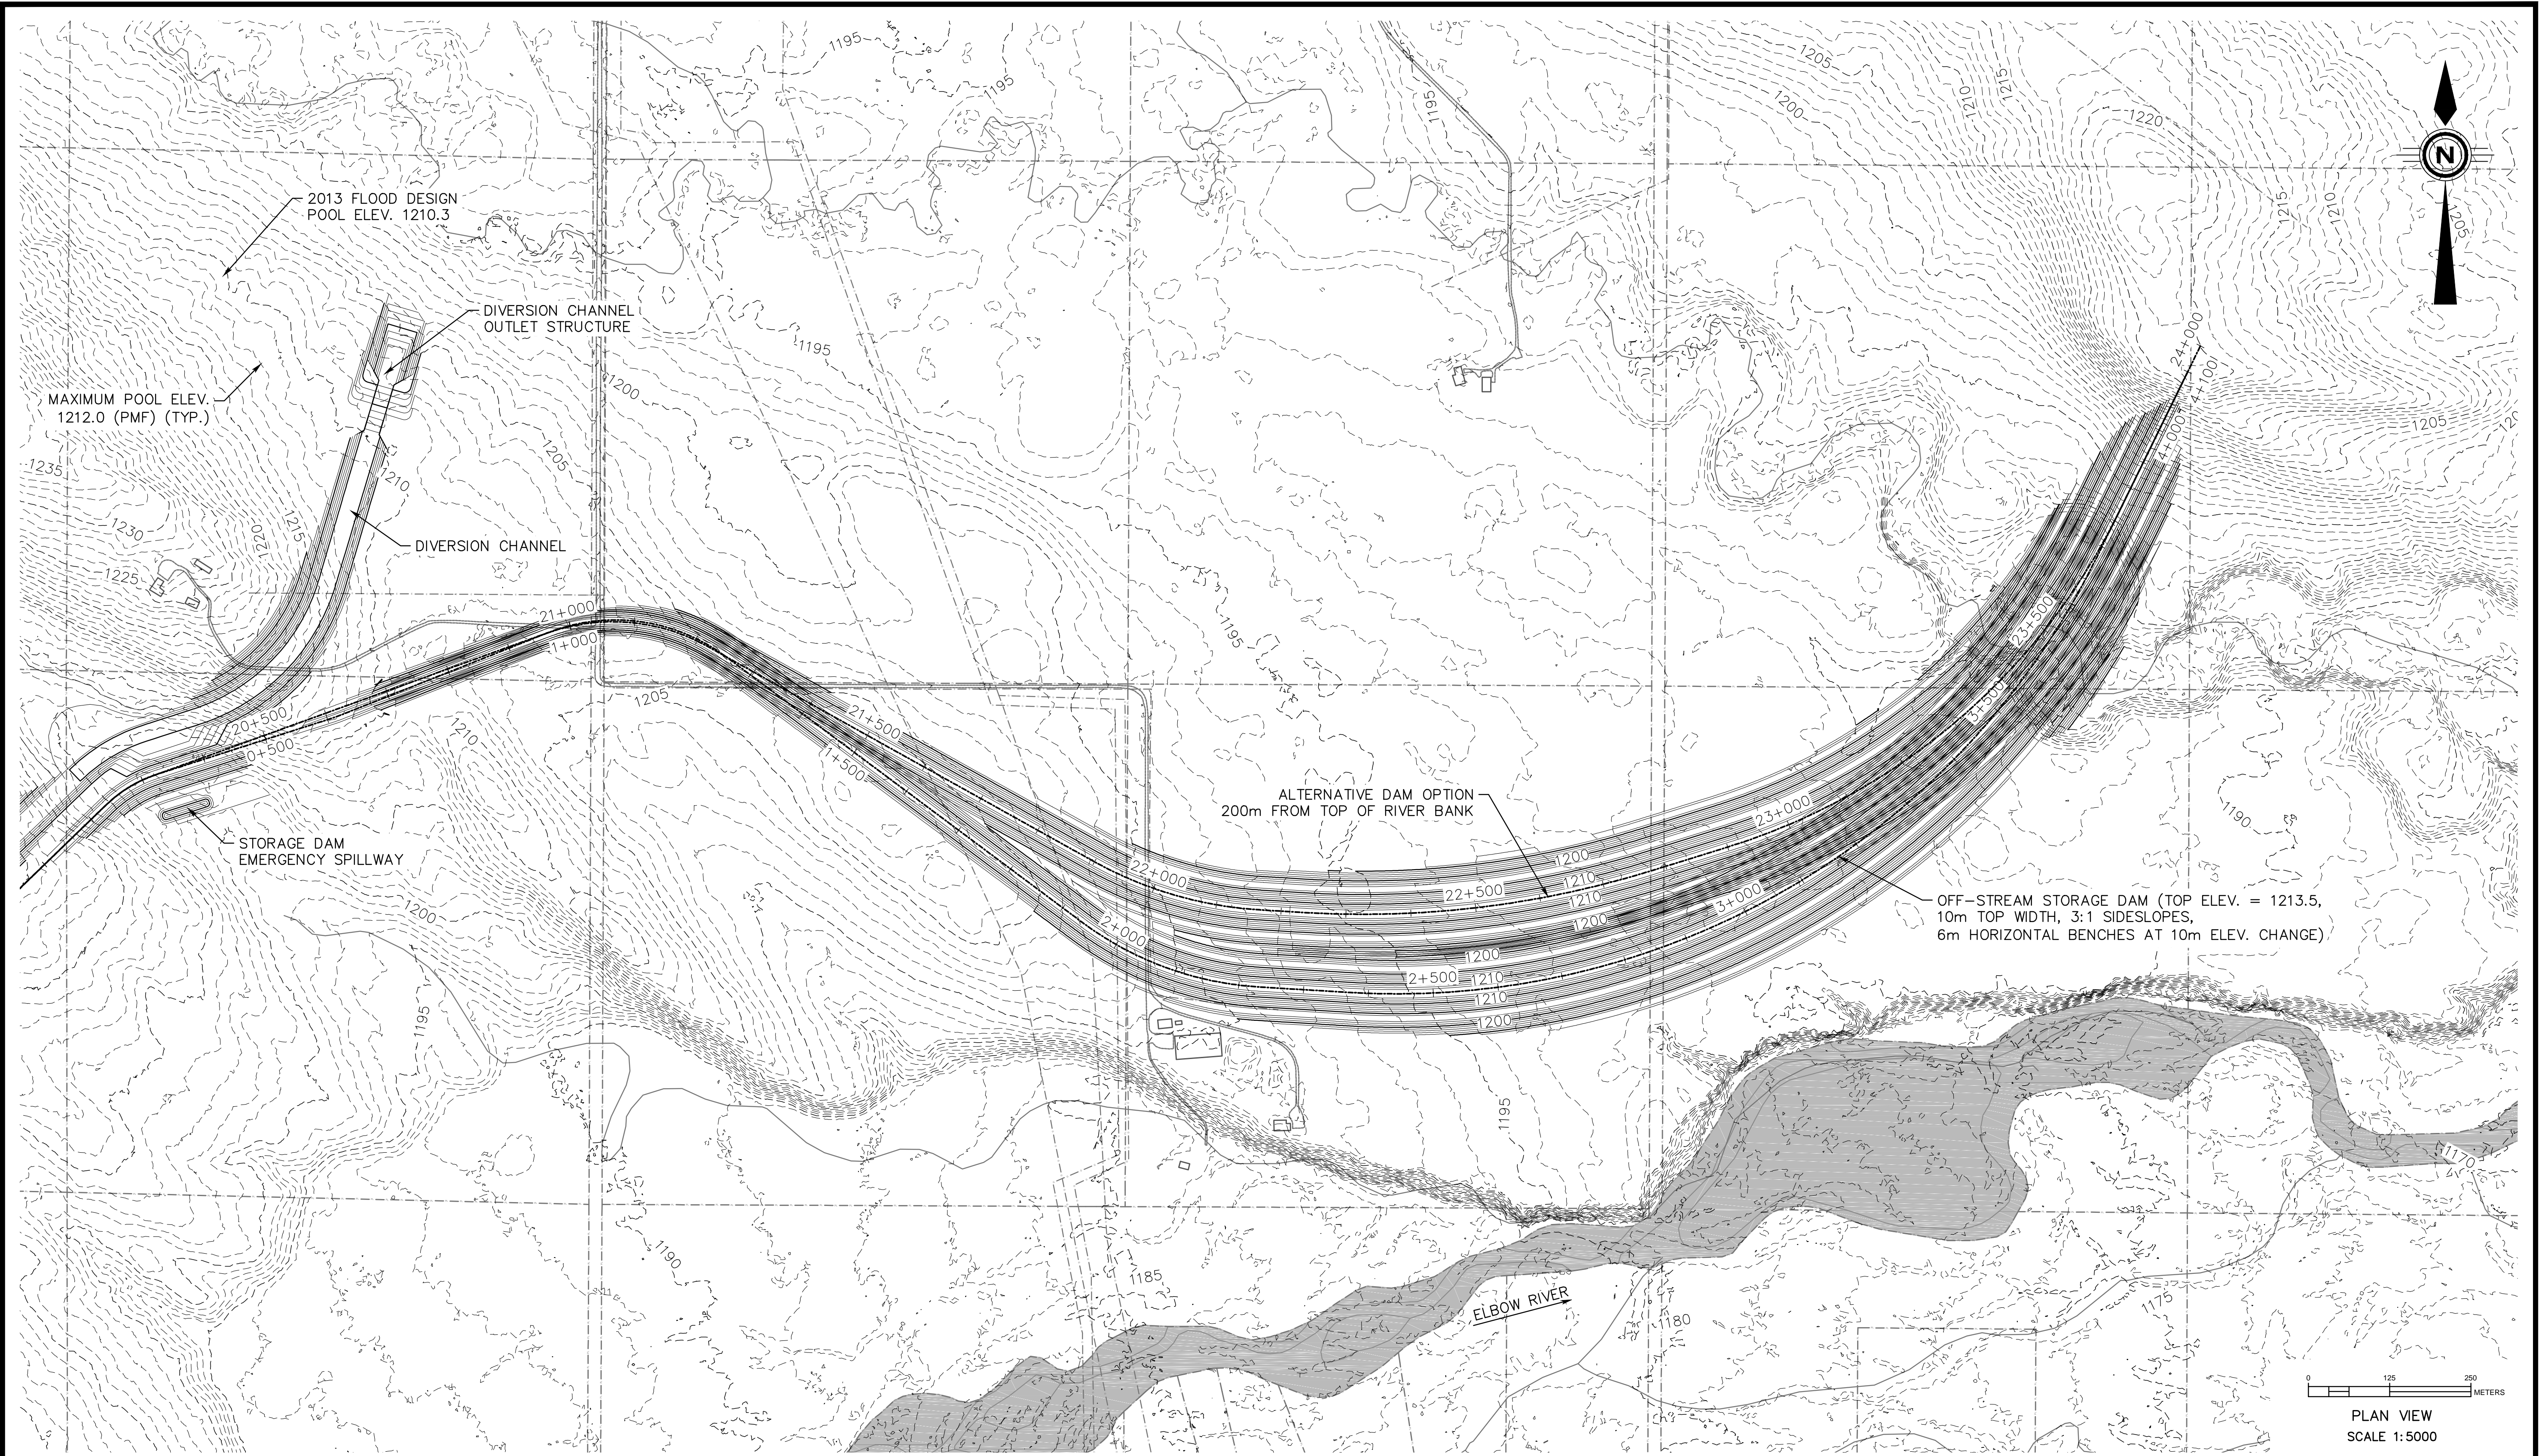
Attachment 4 shows this alternative dam alignment. Conceptual versus alternative storage dam quantity impacts are shown in Table 5.

The third alternative for addressing bank erosion risks is to relocate the dam approximately 100m upstream from the current concept, locating it approximately 200 m from the top of bank of the Elbow River at its closest location. Relocation of the storage dam further upstream would have a relatively small impact on reservoir storage. SR1 storage needs of the 2013 storm event produces a level flood pool elevation of 1210.3 m for the current concept. Moving the dam upstream would raise the pool elevation to 1210.6 m given the same storage needs.

Stantec recommends moving the Dam up-valley 100 metres from the preliminary design concept location presented in April 2015. The impacts of this change are negligible for cost (fill quantity and emergency spillway) and footprint area.
