WORKER DIES OF HEAD INJURY

Type of Incident: Fatality

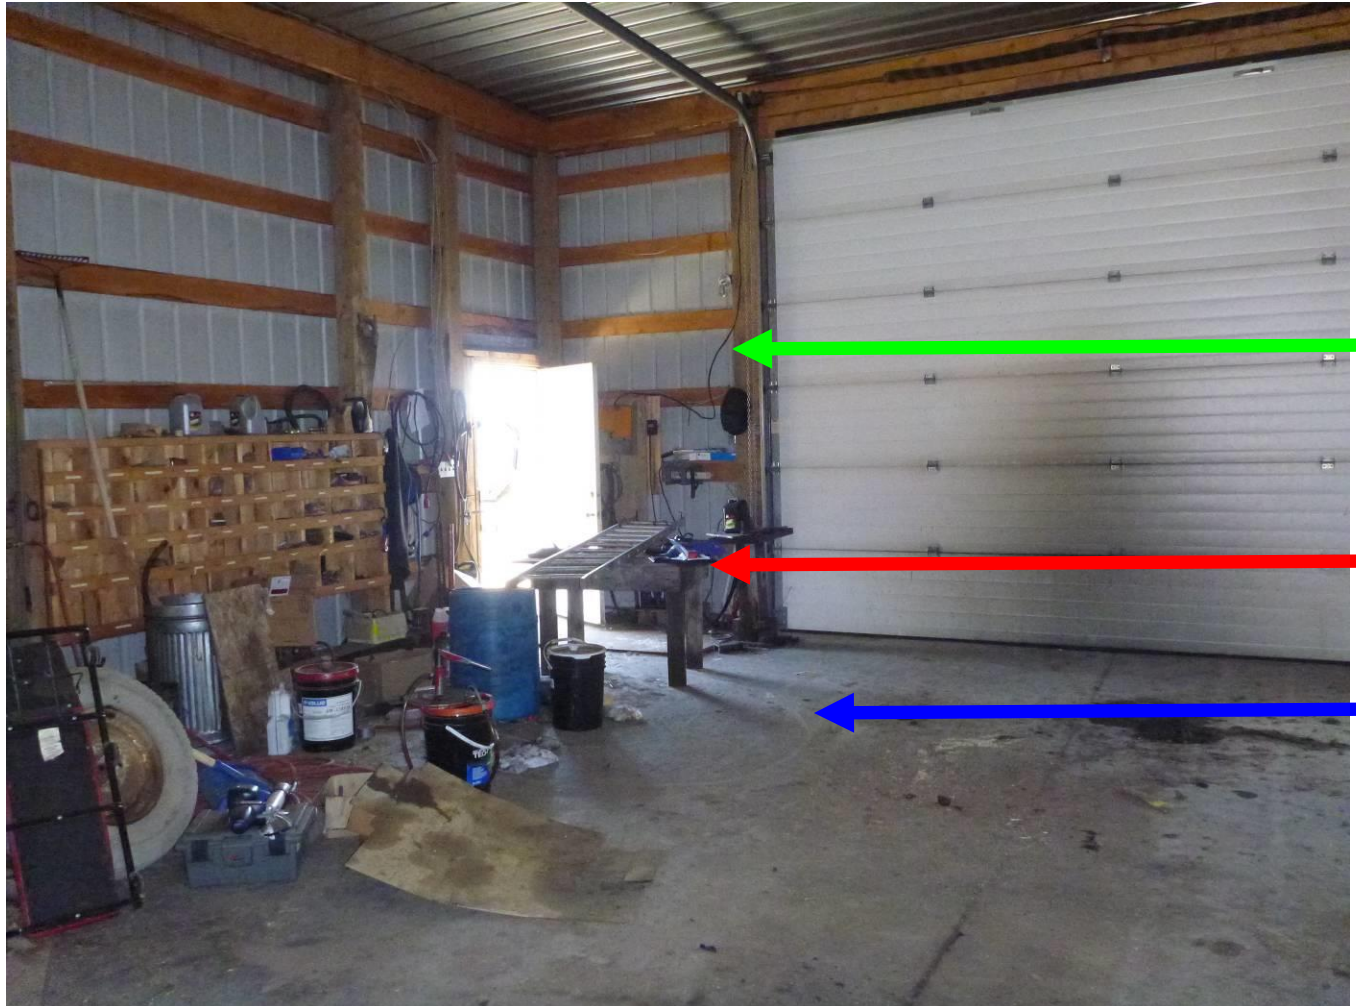
Photograph 3 – Re-creation of the scene by the employer (*****)) shows the approximate location where he found the ladder lying on top of a wooden work bench. The blue arrow points to drag marks on the floor. The red arrow points to the wooden work bench. The green arrow points to the electrical wire.

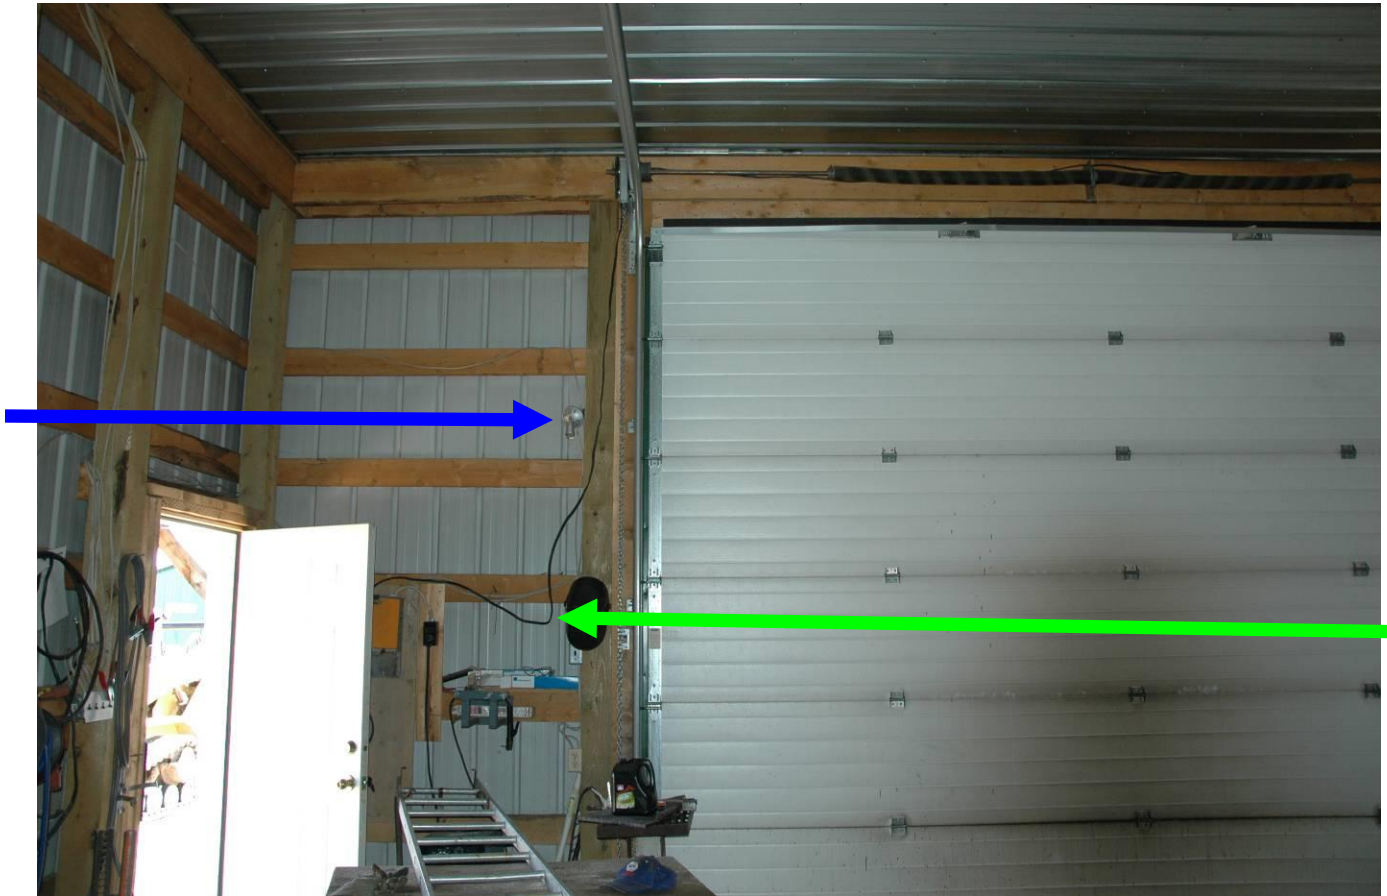
Photograph 4 – Re-creation of the scene by the employer (*****)) shows the approximate location of the ladder lying on top of a wooden work bench, in relation to the wire the Foreman (*****)) was planning to secure. The green arrow points to the bend in the electrical wire. The blue arrow points to the light fixture with a broken bulb.

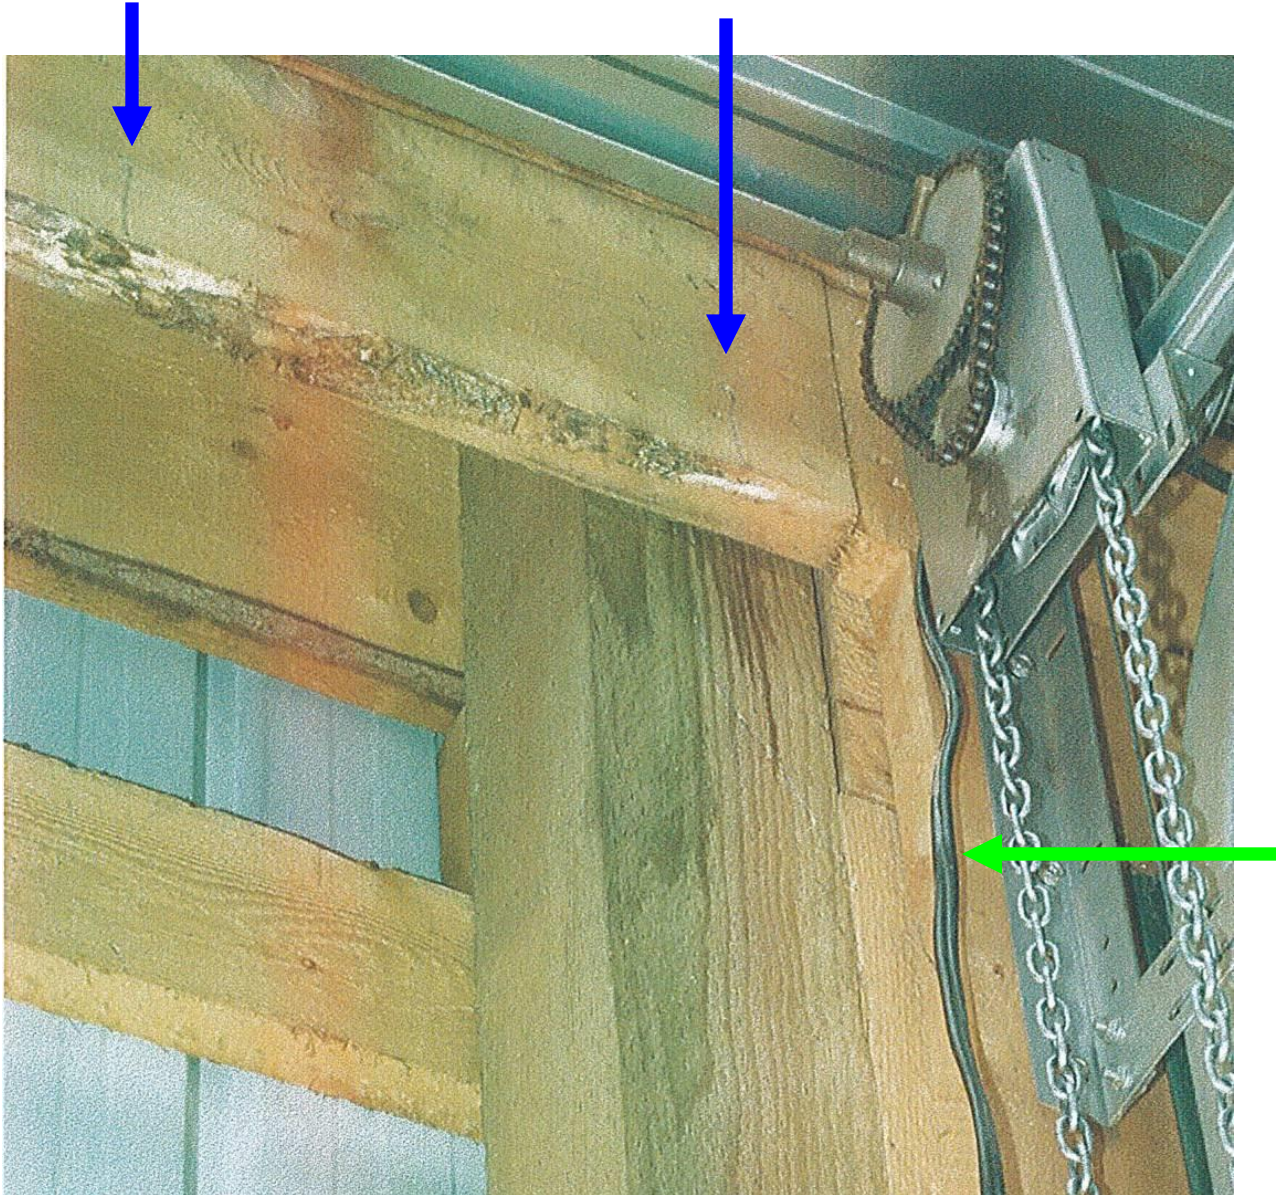
Photograph 5 – Shows the electrical wire running up and over the overhead door. The blue arrows point to the marks on the upper cross member. The green arrow points to the electrical wire.
