Investigation Report

Worker Fatally Injured When Struck
and Run Over by Skid Steer Loader

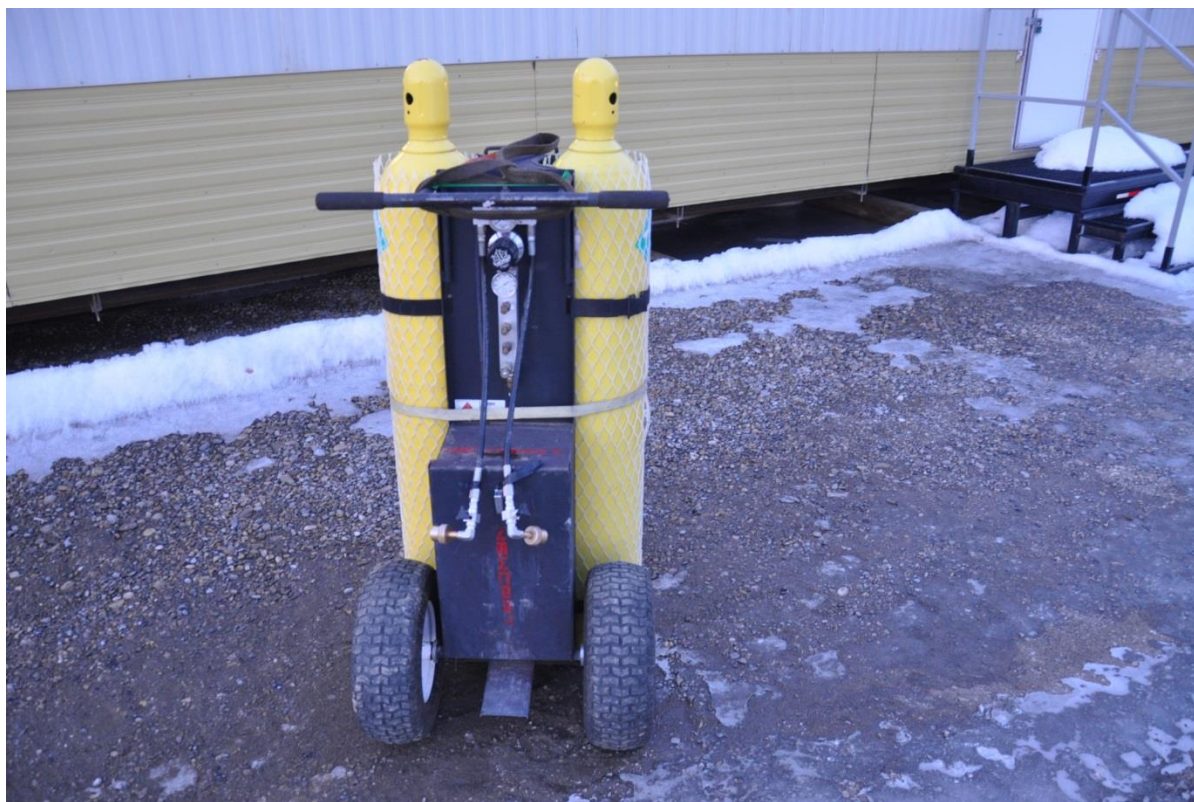
Figure 6. Air cart as moved from behind the tech trailer to the front of the tech trailer for examination by OHS.
