# **Worker fatally crushed between precast concrete panels**

November 25, 2017

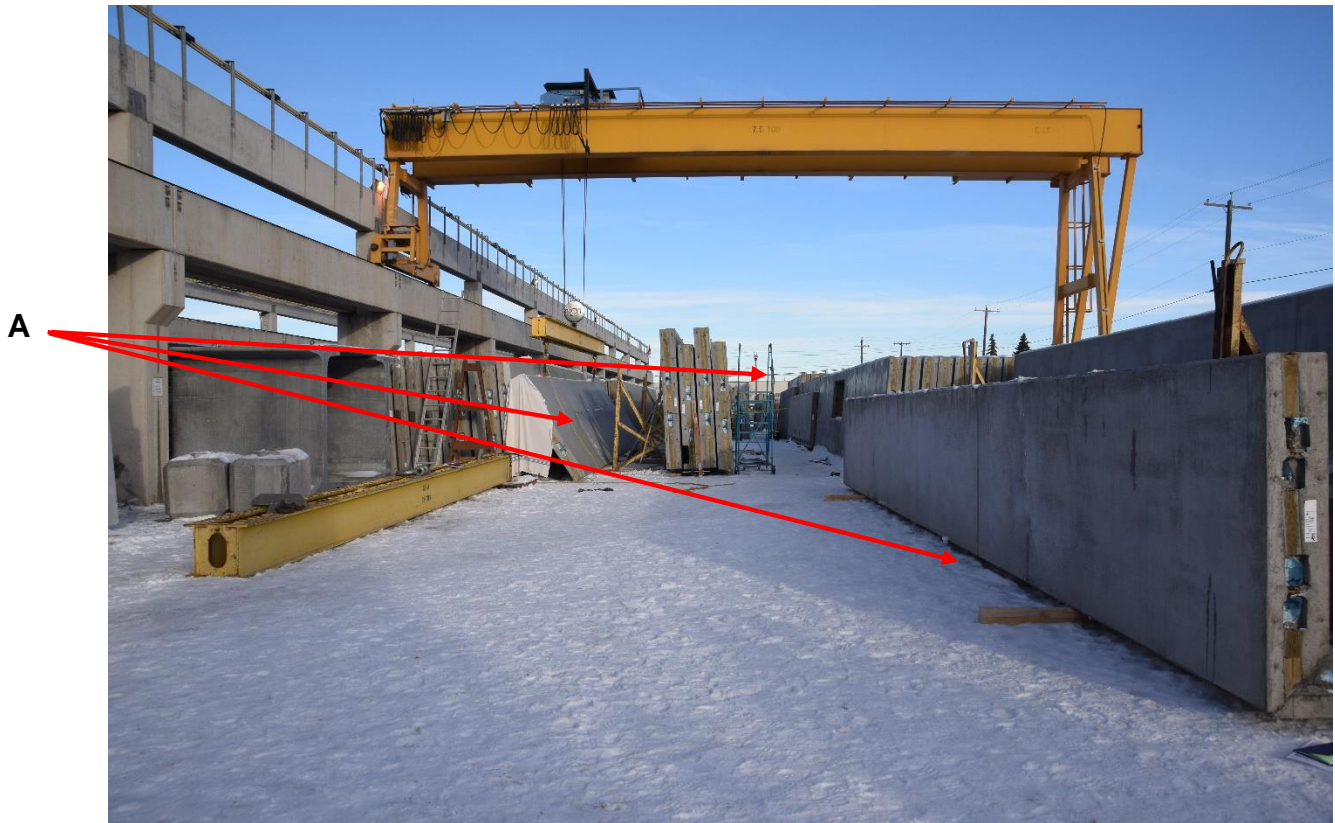
Figure 2. Insulcore precast panels in storage in gantry crane bay  
A. Insulcore panels

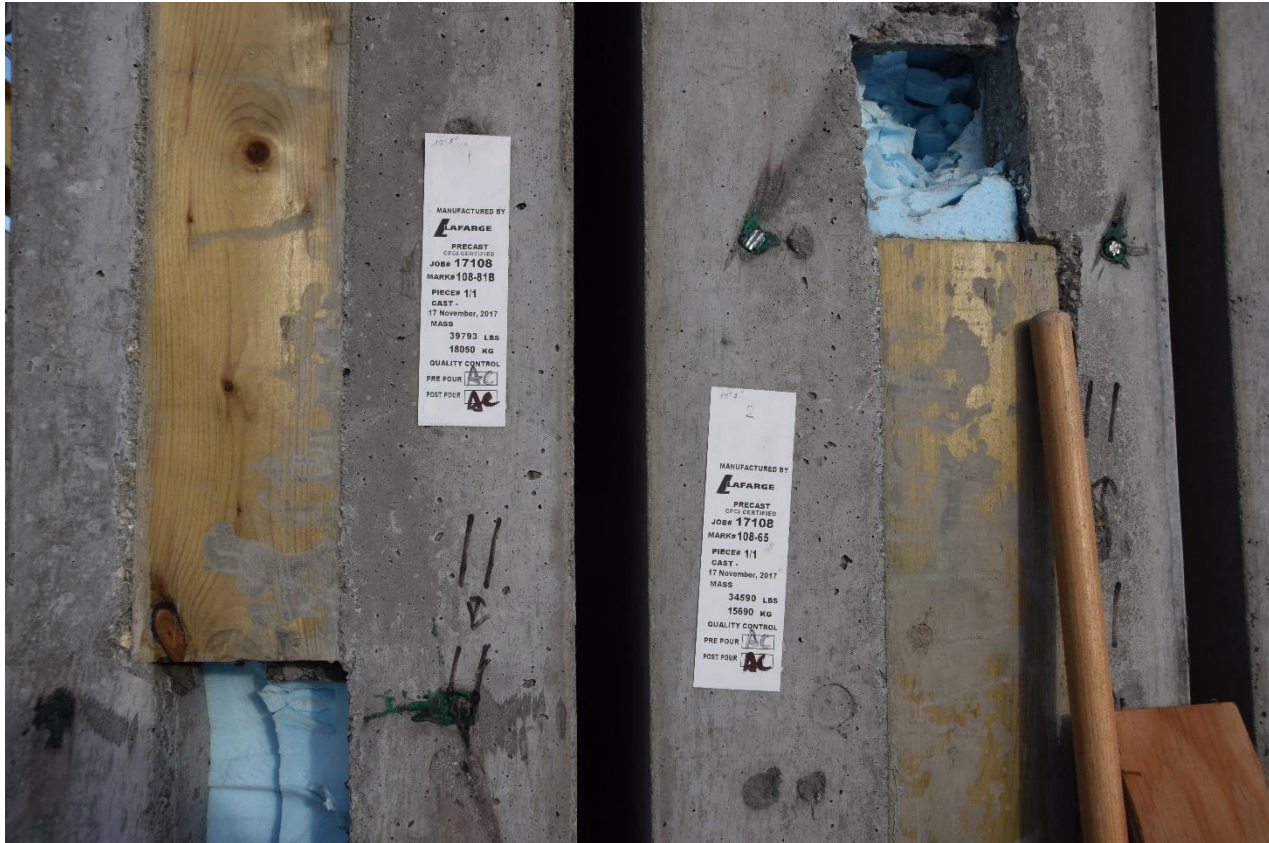
Figure 3. Manufacturing labels affixed to Insulcore panels stored in the gantry crane bay
