Worker found deceased in water tank

February 19, 2022

Summary of investigation and outcomes

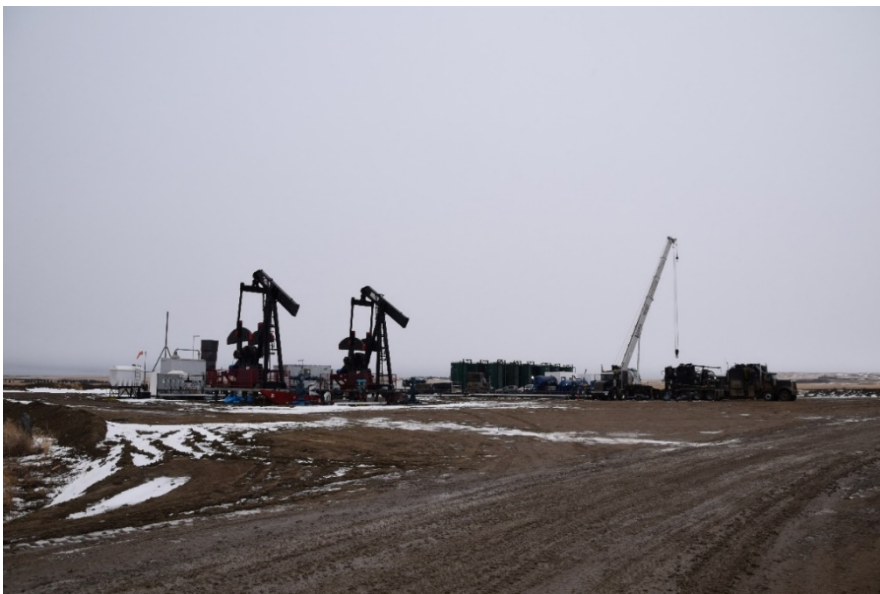
Figure 2. Twining Field (14-8) as viewed from lease gate looking west. The two active wells are shown in the foreground. The incident area is located near the crane.

At the time of the incident, there were two operational wells and two wells that were undergoing completion (Figure 2).

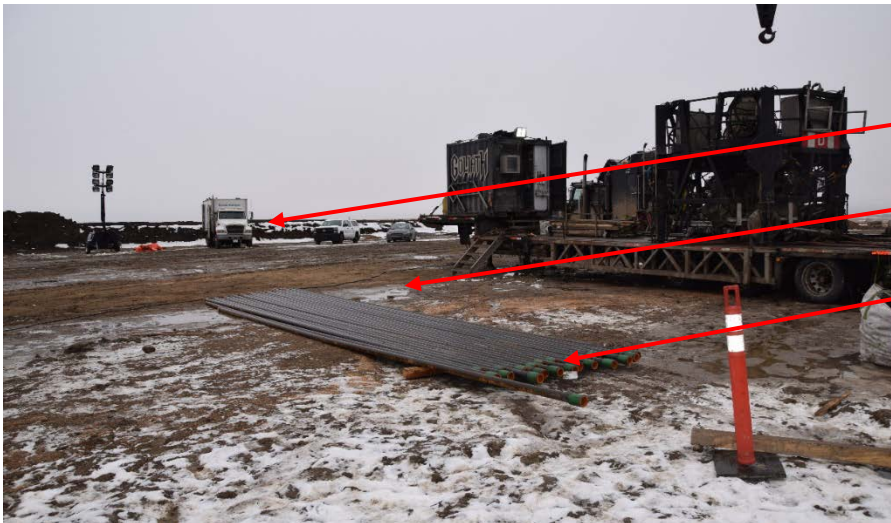
Figure 3. Goliath work site with Horizon Oilfield Services steam truck in the background. The steam truck had been moved by the Horizon Oilfield Services operator 1 prior to the discovery of the Horizon Oilfield Services operator 2.

- A. Horizon Oilfield Services steam truck after being relocated by operator 1
- B. Approximate position of the Horizon Oilfield Services steam truck while providing steam for Goliath's snubbing activities
- C. Casing being steamed by Goliath personnel

On the day of incident, operator 2 was operating the steam truck during the night shift, providing steam for various activities at the site, including the snubbing activities undertaken by the Goliath snubbing crew (Figure 3).

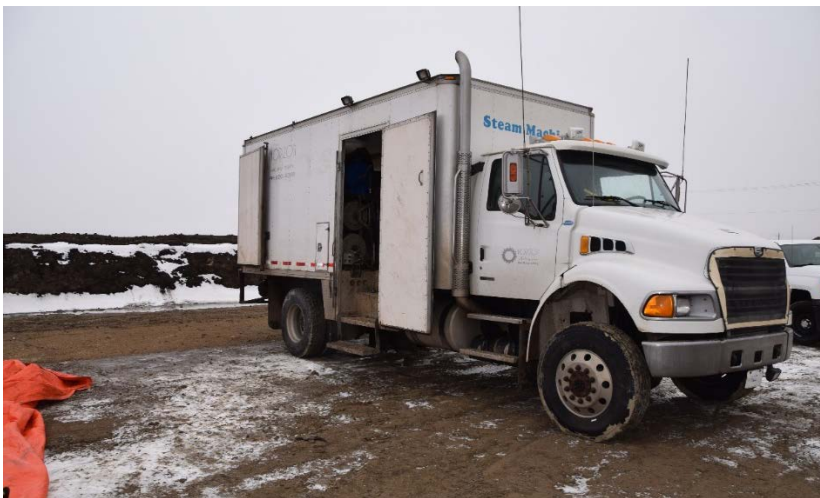
Figure 4. Horizon Oilfield Services steam truck on the Twining Field (14-8) showing the side access to the cargo area open.

The steam truck involved in the incident was a Thermo King Western Inc. cube van that was owned by Horizon Oilfield Services (Figure 4).

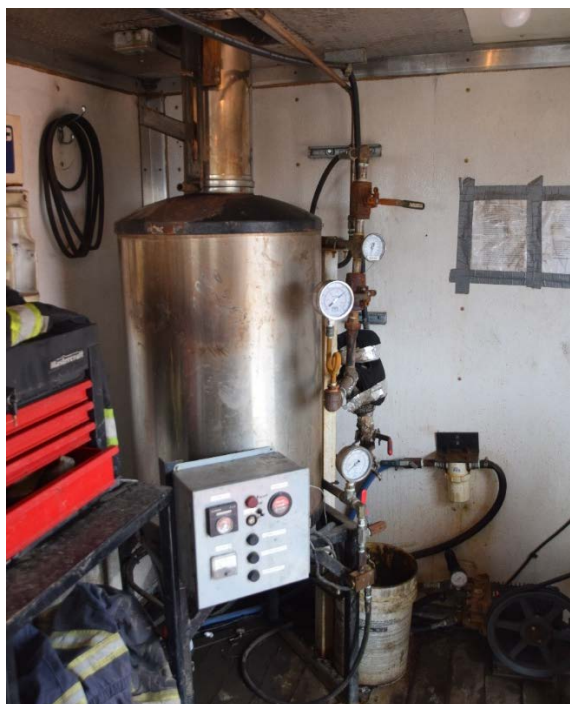
Figure 5. Oil-fired water boiler in the cargo area of the steam truck.

In the cargo area of the steam truck was a PowerJet PJ Oil Fired Water Heater (Figure 5), Isuzu diesel engine, and two water tanks with a combined capacity of 4 cubic metres (m³).

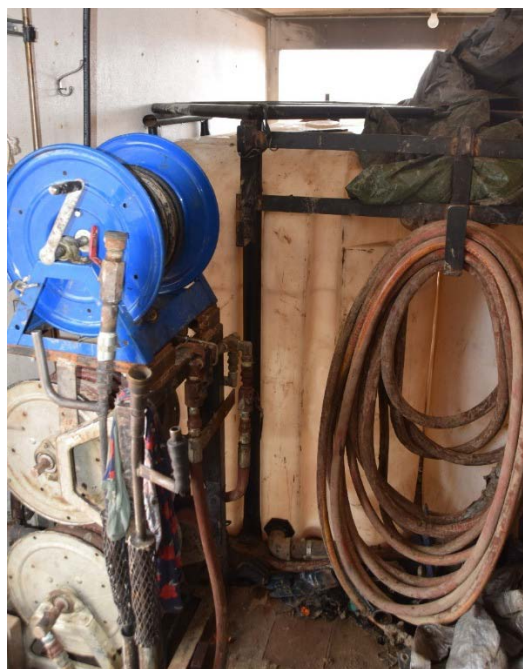
Each water tank was 1.82 metres (m) long by 1.47 m tall by 1.22 m wide (Figure 6). Each were fitted with a 0.40 m diameter circular access on the top (Figure 7). The two tanks were connected together and drained into the boiler system simultaneously.

Figure 6. One of the two water tanks in the back of the cargo area of the steam truck, with the steam hose reels in the foreground. This was the tank that was involved in the incident.

On February 18, 2022, Horizon Oilfield Services was providing steam services for well completion activities being undertaken at the Artis site. At approximately 5:30 a.m., on February 19, 2022, operator 2 was found to be missing and was later discovered deceased in one of the water supply tanks in the steam truck.

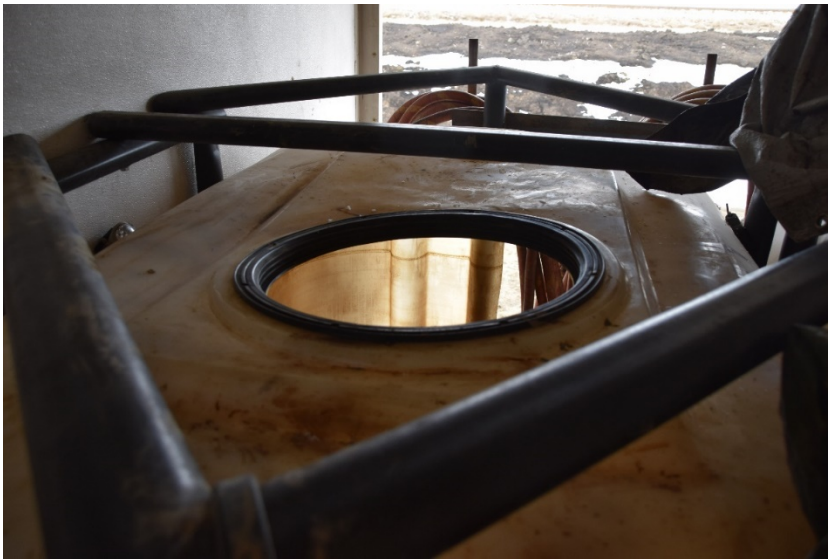
Figure 7. The access opening on the top of the water tank that was involved in the incident.
