**Aquatic and Riparian Condition Assessment
of the
South Saskatchewan River Basin**

Alberta Environment

June, 2007

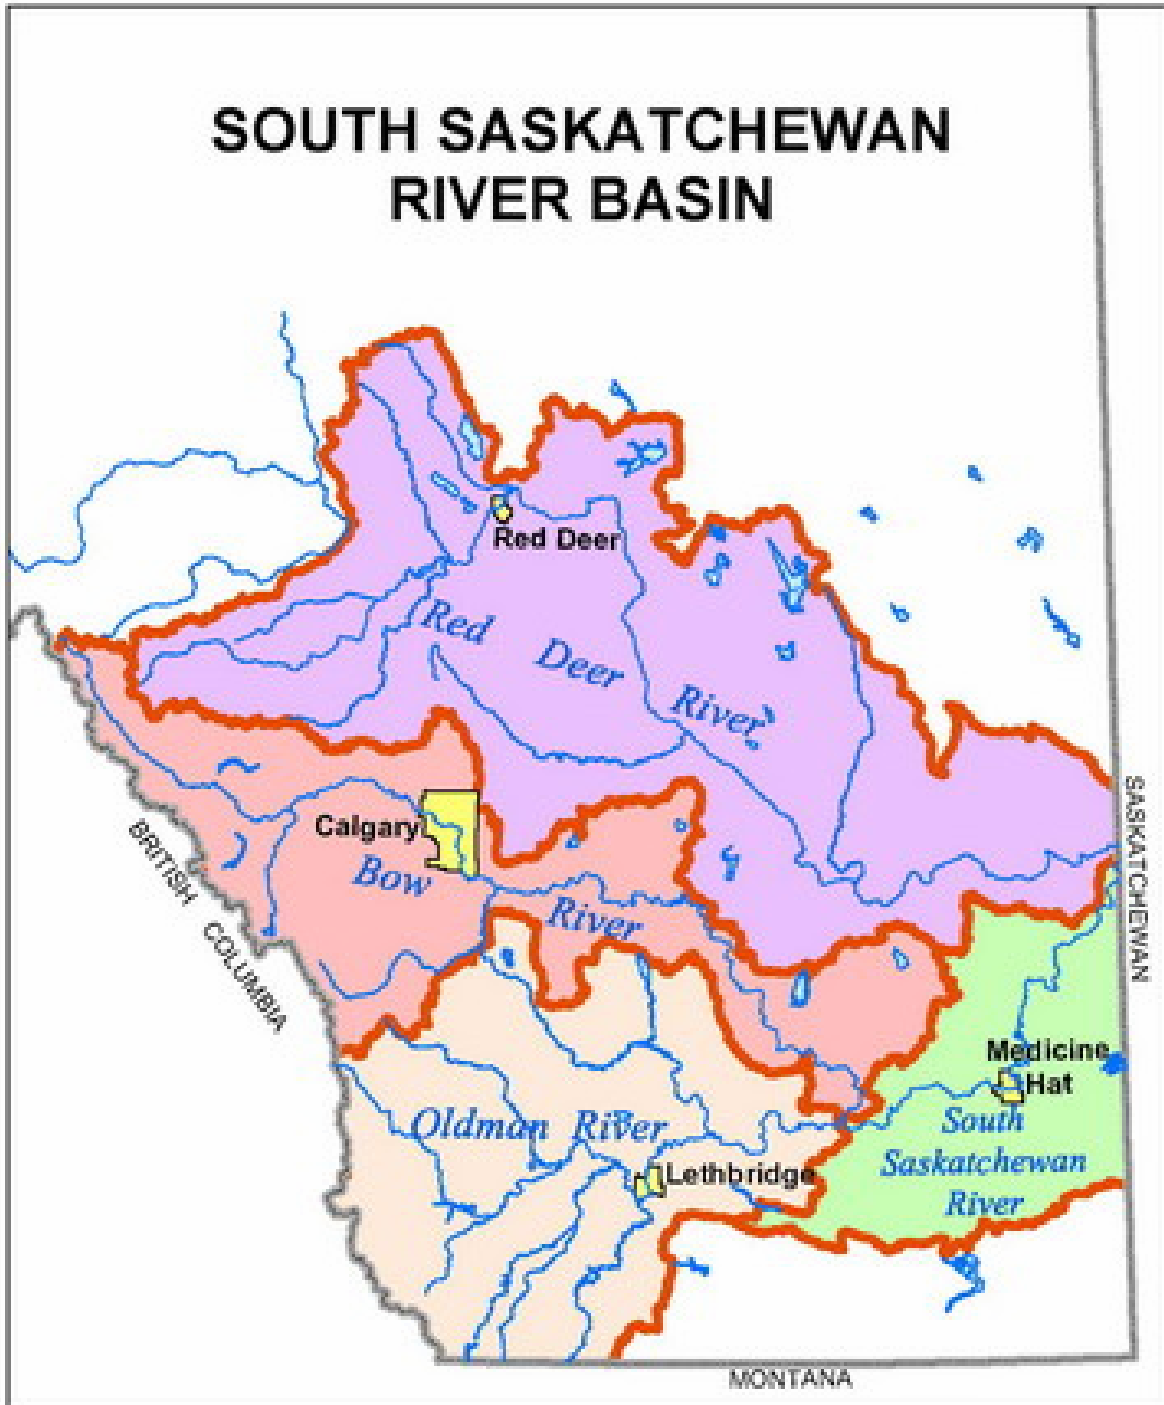
Figure 1. Map of South Saskatchewan River Basin

The Aquatic and Riparian Condition Assessment of the South Saskatchewan River Basin examines three important factors affecting aquatic condition in the basin: riparian health, water quality and hydrology. The purpose of the assessment is to provide a strategic evaluation of the state of all main-stem river reaches in the South Saskatchewan River Basin (SSRB), using a combination of existing and new information. Figure 1 shows a map of the SSRB.

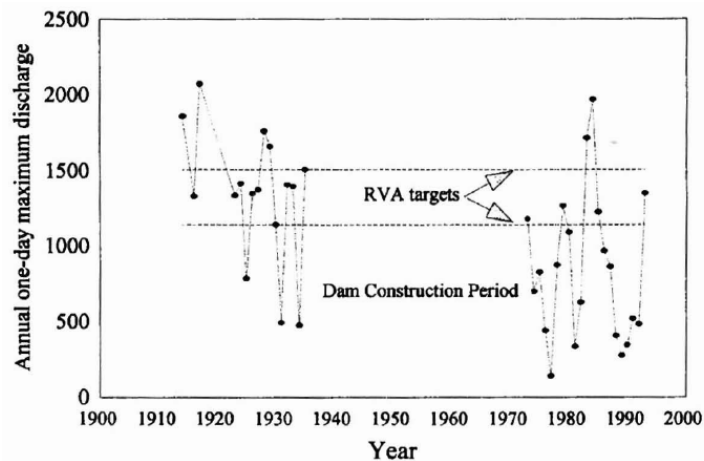
Figure 2. IHA parameter analysis showing RVA targets in the 25-75th percentile for pre and post impact regimes.

Data requirements for calculating IHA parameters are daily mean water conditions by reach. The RVA uses as its starting point either measured or synthesized daily stream flow values from a period during which human perturbations to the hydrological regime are negligible. The stream flow record is then characterized using 32 different hydrological parameters, using the IHA approach as described by Richter et al. (1996). Using the RVA, a range of variation in each of the 32 parameters (e.g., the values at a +/- 1 standard deviation from the mean or the 25th to 75th percentile range), is selected as an initial flow management target. Next, daily-recorded flow data for a post-impact period (e.g., after dam construction) are used to generate a new set of 32 IHA parameters for each year to the post-impact period. These values then are compared with the RVA target values (Figure 2).

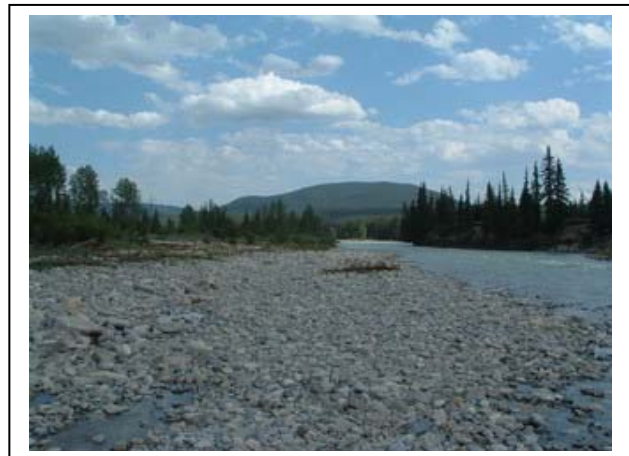
- Ⓢ A positive attribute of the Red Deer River reach RD-08 riparian areas is the moderately low presence of invasive plant communities. Graminoids and forbs are diverse, and primarily native species.
- Ⓢ Disturbance-caused species are present at low to moderate levels.

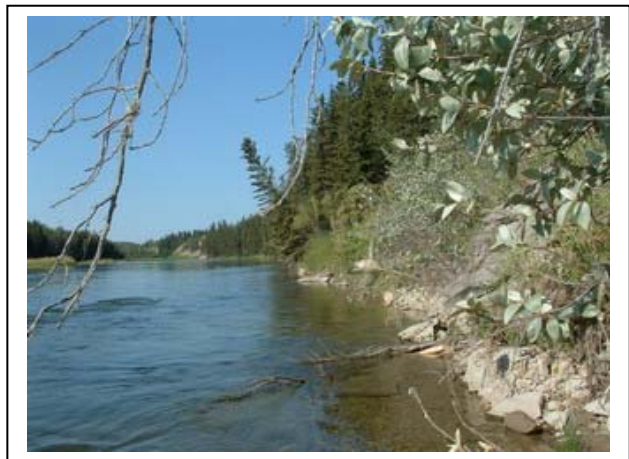
- Ⓢ Five different plant communities were

identified, with tree and shrub cover abundant, covering over half of the area assessed. 70% of the sites inventories are occupied by tree and shrub communities. As in upstream reaches, regeneration and establishment of trees and shrubs is good to excellent, with light to no utilisation on preferred trees and shrubs. Some ornamental or domestic woody plants were found in this reach.

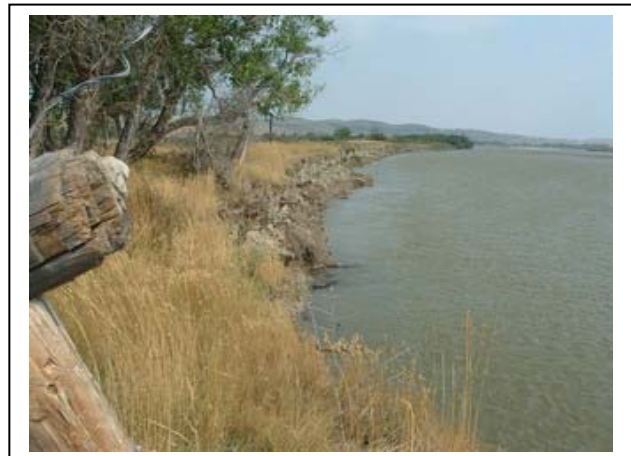
Overall, riparian health is rated as healthy but with problems. This rating is based on two sample sites.

- Ⓢ Land use in this reach is more heavily dominated by grazing (98% by length) than any other reach along the Red Deer.
- Ⓢ Cottonwood regeneration varies from very good to poor, with very good regeneration of shrubs.

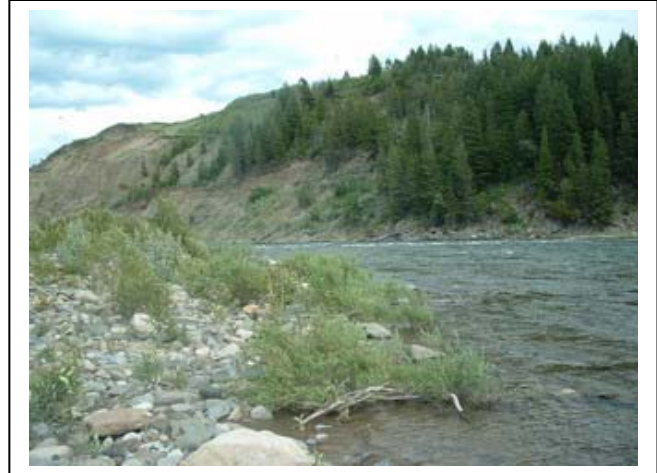
- ⑧ Invasive species are relatively low in number, but are widely distributed. Disturbance-caused species cover 14% of the area examined, resulting in decreased bank stability, however native species are abundant.
- ⑧ Riverbank root mass protection is moderate to poor within this reach. The presence of disturbance-caused species along the riverbank may be reducing bank stability along sections of this reach.

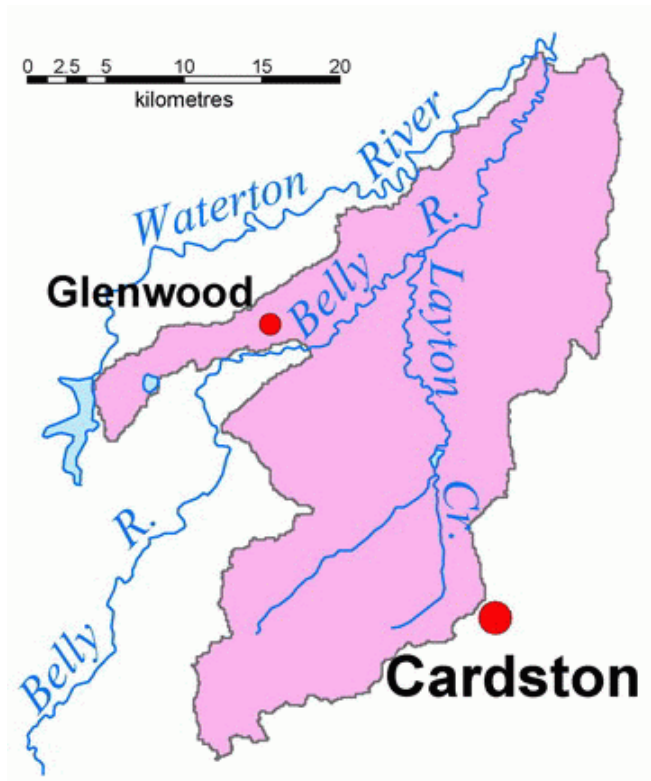
Belly River Reach #2

Reach Description: This reach drains a watershed of about 650 km², or 12% of the Oldman River Sub-basin. The key tree species in the riparian zone is narrow-leaved cottonwood. Key fish species in the river is bull trout. This reach of the Belly River is located within the Foothills Fescue and Foothills Parkland Subregions.

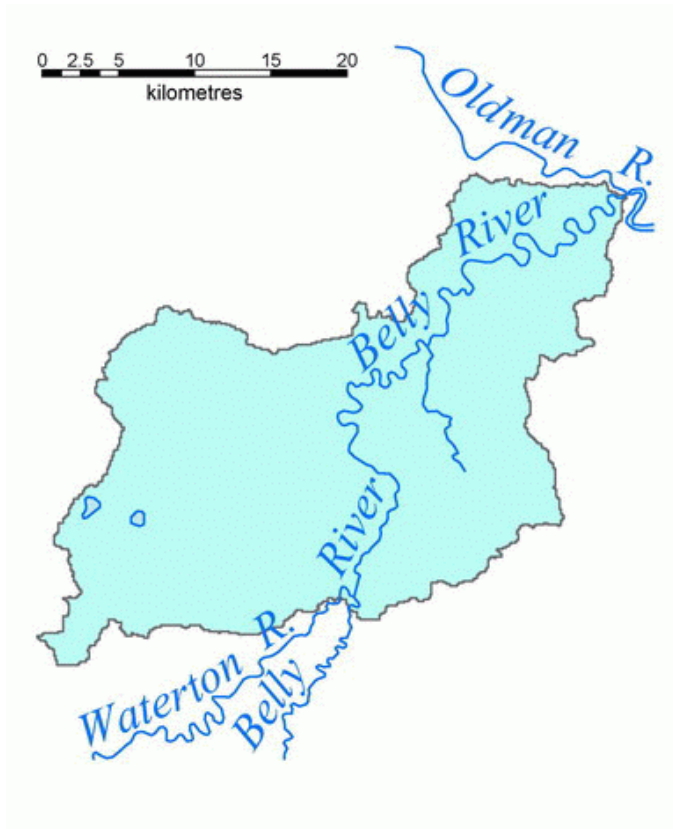
Belly River Reach #1
Waterton River Confluence to Oldman River Confluence

Reach Description: This reach drains a watershed of about 660 km², or 12% of the Oldman River Sub-basin. The key tree species in the riparian zone is narrow-leaved cottonwood. Key fish species in the river are mountain whitefish and rainbow trout. This reach of the Belly River is located within the Mixedgrass Subregion.

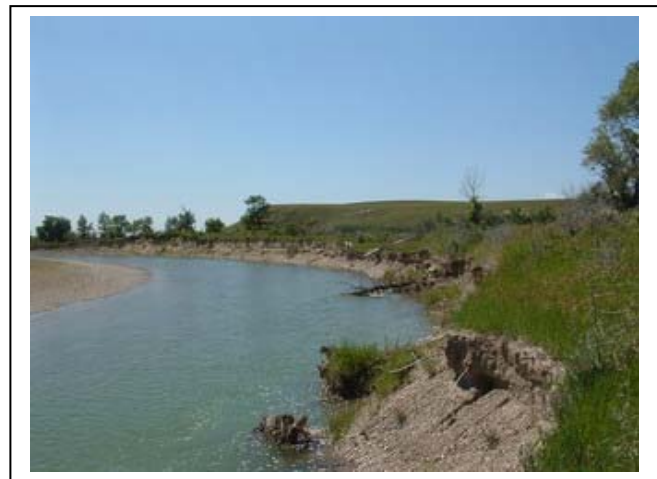
Overall, the riparian health of the Belly River in this reach is rated as varying from healthy but with problems, to unhealthy. This rating is based on two sample sites.

- ⑧ There is considerable coverage of invasive species, with invasive plants occupying 1%-15% of one site and greater than 15% of the other. There is also concern with the distribution of invasive plants, as they are widely spread throughout the reach in continuous occurrences with a few gaps in their distribution. Disturbance-caused plants are covering more than 50% of the assessed area and are reducing the amount of area occupied by native grasses, particularly at one of the sites. Native grasses are still reasonably prominent at the other site covering 25%-50% of the area.

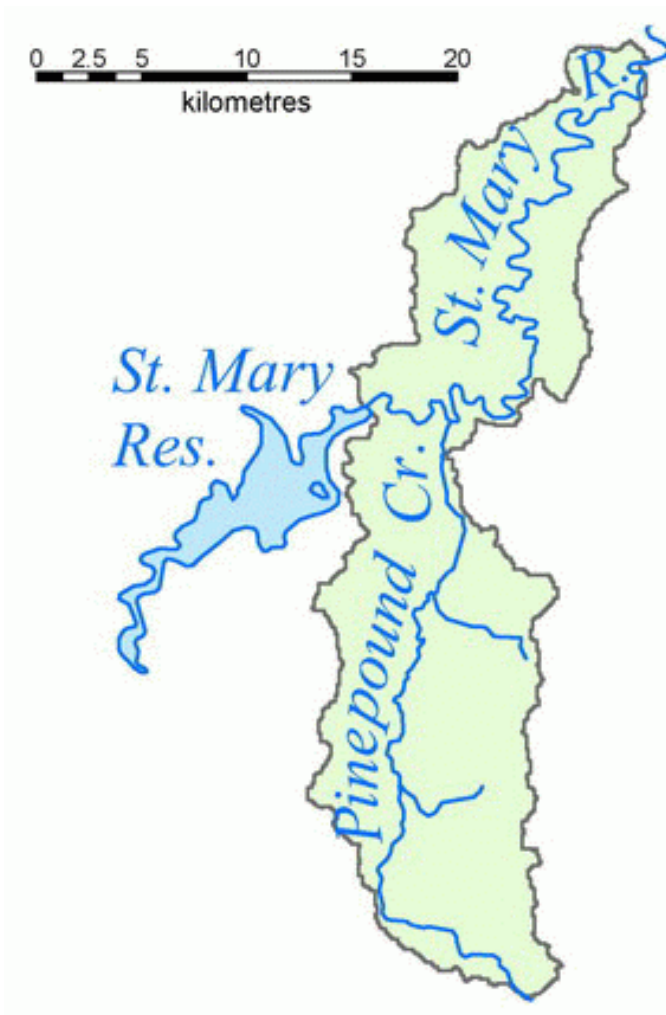
St. Mary River Reach #2

Reach Description: This reach drains a watershed of about 50 km², or 6% of the Oldman River Sub-basin. The key tree species in the riparian zone is narrow-leaved cottonwood. Key fish species in the river are walleye and rainbow trout. This reach of the St. Mary River is located within a transition zone between the Mixedgrass and the Foothills Fescue Subregion.

Human Uses: Grazing is the dominant land use in this reach, however there is a significant portion of the reach that is undeveloped. Cropping and development influence minor portions of the reach. This reach is downstream of the St. Mary Dam, altering the natural flow pattern of the river and significantly impacting riparian health.

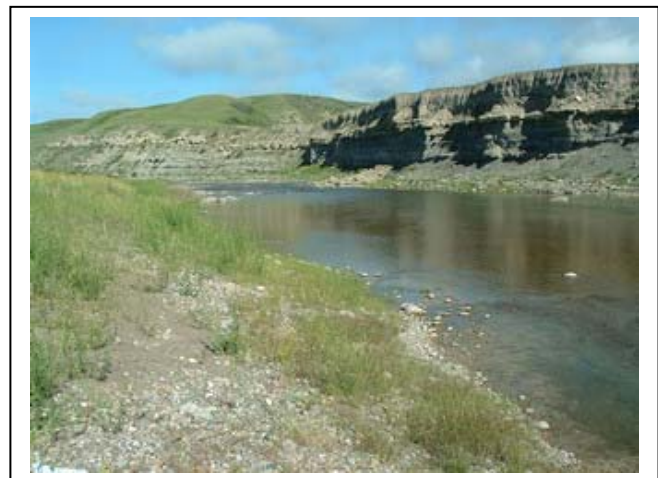
Overall, the riparian health of the St. Mary River in this reach is rated as unhealthy. This rating is based on two sample sites.

- ⑧ The presence of woody species dramatically decreases in this reach, with only 17% of the area assessed covered by woody plants. Shrubs are more abundant than trees covering 14% of the area; trees barely occupy 1% of the area assessed. Cottonwood regeneration is fair to excellent and there is also excellent regeneration of preferred shrub species. Cottonwoods are the only trees present. The levels of decadent and dead standing woody plants are normal and overall utilisation of preferred woody plants is light.

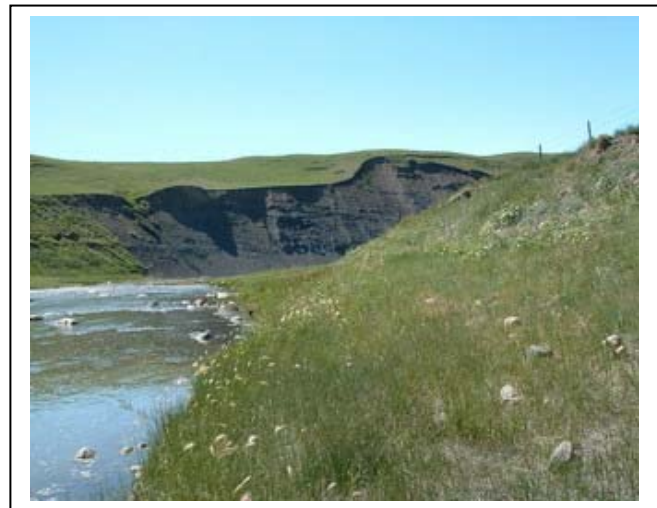
Overall, the riparian health of the St. Mary River in this reach is rated as varying from healthy, to healthy but with problems. This rating is based on two sample sites.

- ⑧ Woody plants continue to have little coverage, similar to the adjacent upstream reach, with total woody plants only occupying 13% of the area assessed. Trees have very little coverage (0.5%) and therefore shrubs make up the majority of the woody plant cover. Seedlings and saplings made up a significant portion of the cottonwood cover and therefore cottonwood regeneration was considered excellent. Cottonwoods were the only tree species observed in this reach. Preferred shrubs also have excellent regeneration within their communities, with normal levels of dead and decadence found throughout the woody plant communities. Utilisation/browse of preferred trees and shrubs is variable and ranges from nil to heavy.
