Investigation Report
Worker Fatally Injured by Forklift
September 19, 2017

Incident summary

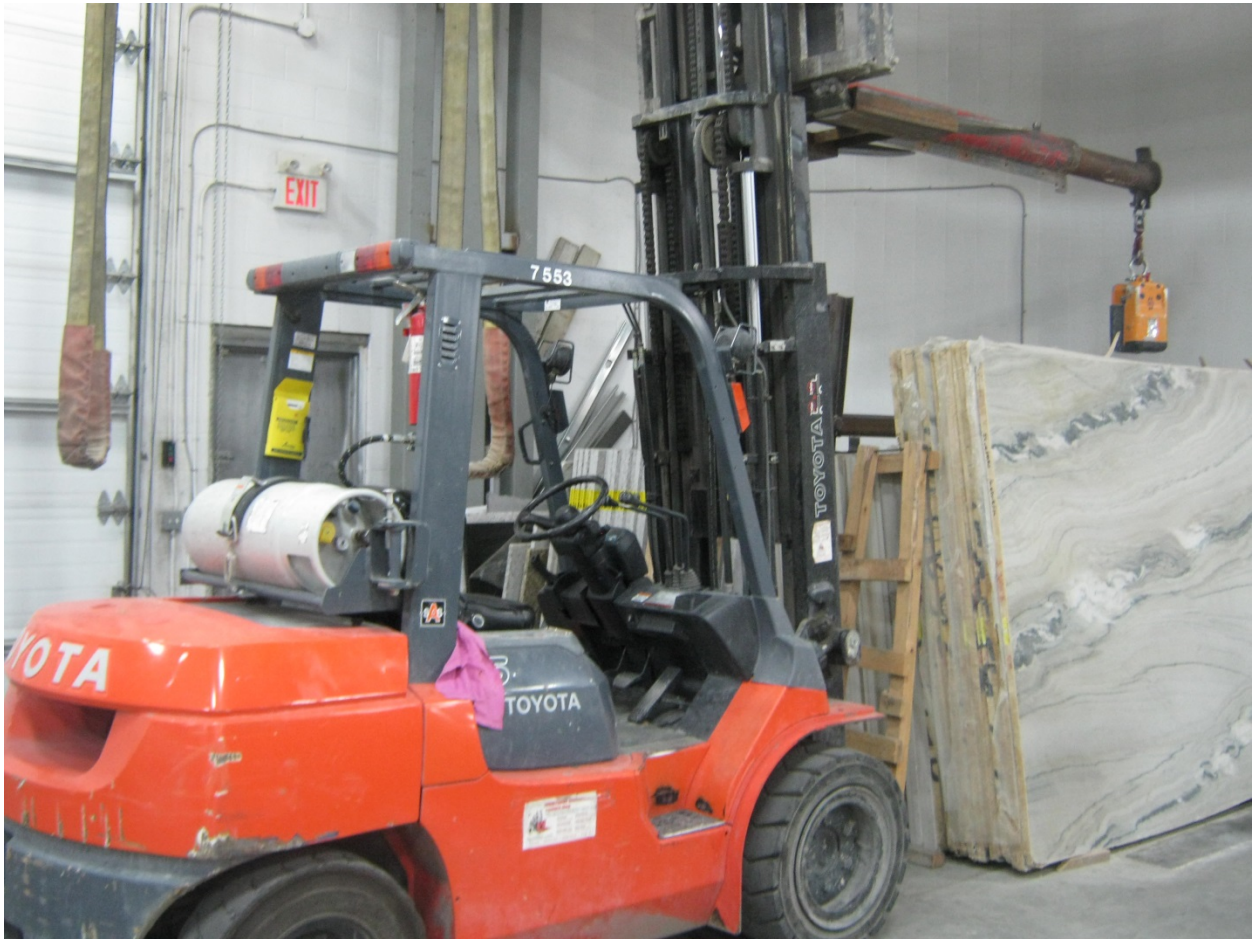
Worker 1 was operating a Toyota forklift truck model 7FGU35, unit number 7553 (forklift). It had its last inspection and maintenance June 9, 2017, with 3301 hours documented at the time of inspection. The forklift had an ABACO Little Giantlifter clamp on the end of the boom used to lift and transport granite slabs (Figure 1).

Figure 1. The forklift that was involved in the incident.

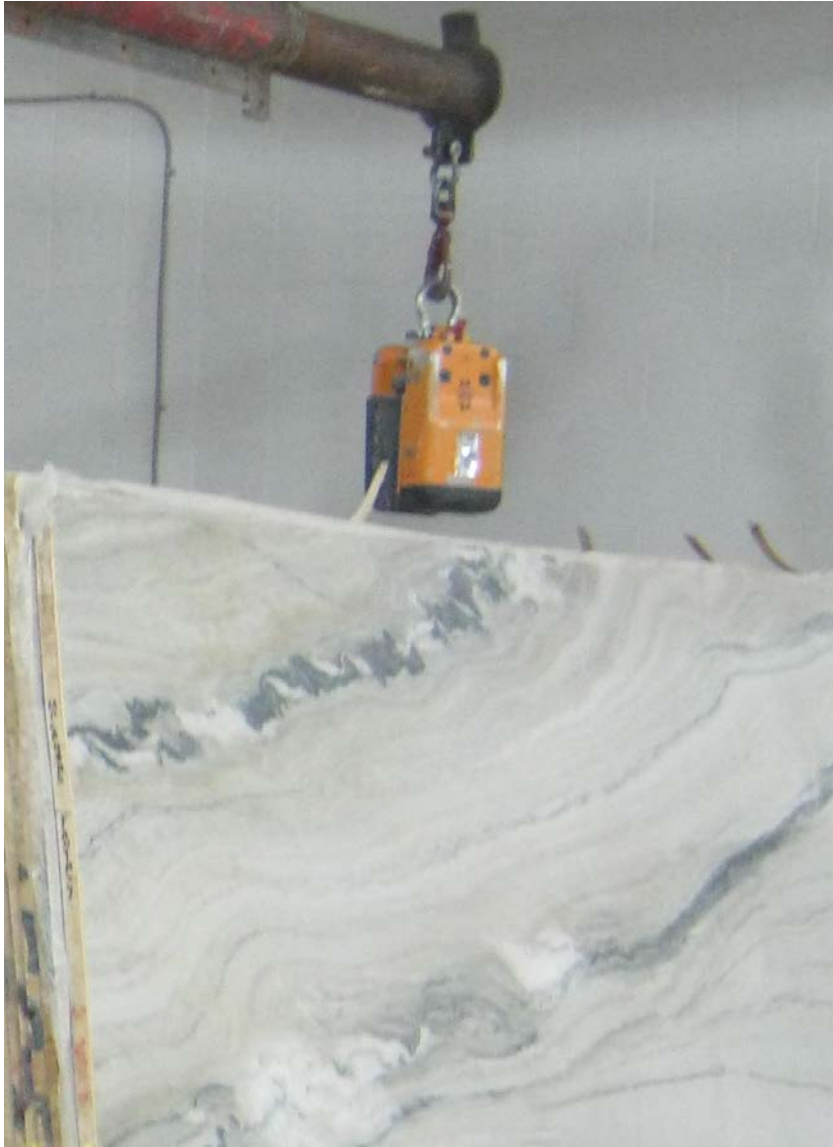
Designed for material thicknesses of 15 to 75 millimetres (mm), these lifters with rubber lined jaws were developed to handle material in slab or sheet form, stacked in racks, without damaging the material's surface (Figure 2).

Figure 2. The clamp attached to the end of the forklift without the granite slabs attached.
